Manufacturing Techniques and Process Challenges with CG-47 Class Ship Aluminum Superstructure Modernization and Repairs

Richard Schwarting, P.E. and Greg Ebel
BAE Systems – Ship Repair

Modernization of CG-47 Class

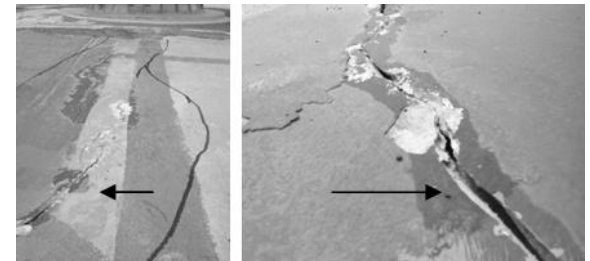
Superstructure Weather Deck Crack

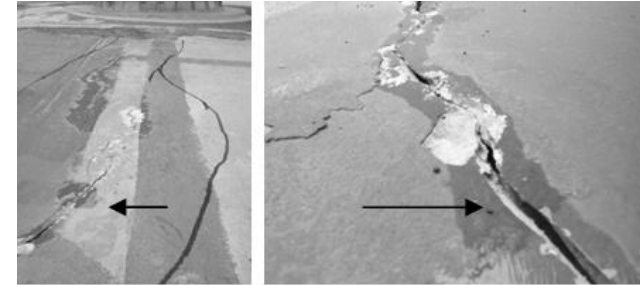
- Unusual cracks, of significant length began to appear 5 years ago
- Did not correlate with the usual stress concentrations
- Navy investigations revealed cracks caused by Stress Corrosion Cracking
 - Superstructure weather deck
 - Internal structure plates in gas turbine intakes
 - Transverse bulkheads
- All cracks located in 5456-H116 material
 - CG-47 class ship superstructure primarily 5456-H116

Superstructure Weather Deck Crack

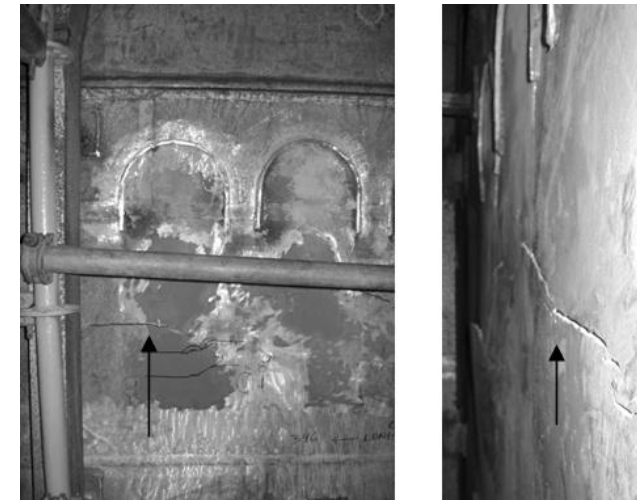
Internal Structure Gas Turbine Air Intake

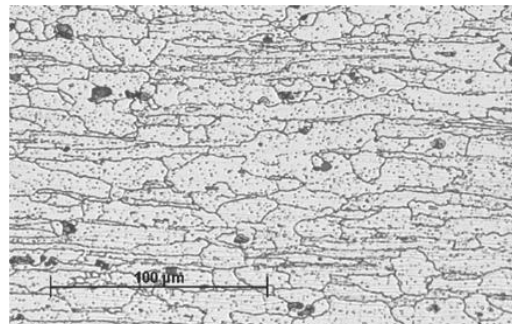
- 5456-H116 contains 4.5 to 5.7% magnesium (strengthening alloy element)
- Magnesium is very soluble in aluminum at high temperatures
- At temperatures above 150°F Mg₂Al₃ migrates and to grain boundaries creating a sensitized aluminum microstructure susceptible to SCC

- Exposure to elevated temperatures – e.g., solar loading suspected

Sensitized 5456-H116 Microstructure with Mg₂Al₃ precipitation preferentially at the grain boundaries.

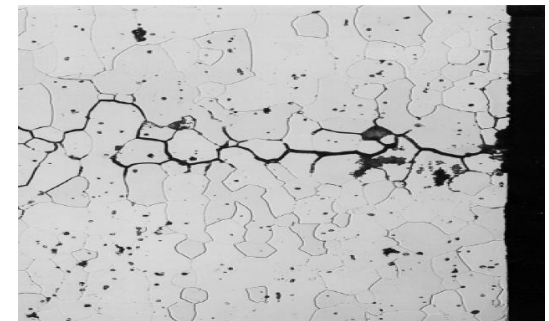
Intergranular Stress Corrosion Cracking in 5456-H116

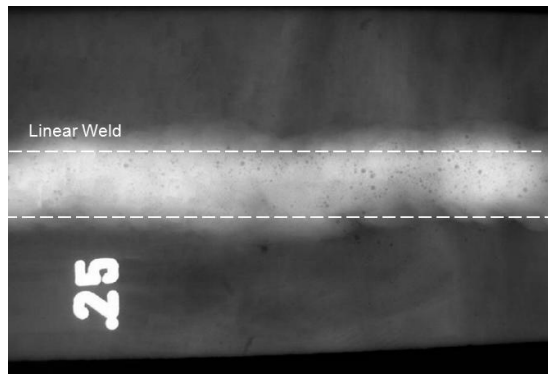
- Pits and surface corrosion traps contaminates which creates weld porosity
- Also cause “false positive” indications during dye penetrant testing
- Increased porosity as found by radiographic inspection

Radiograph of Sensitized Aluminum Alloy Base Material [5456-H116] Utilizing WPS/PQR for Semi-Automated GMAW-P

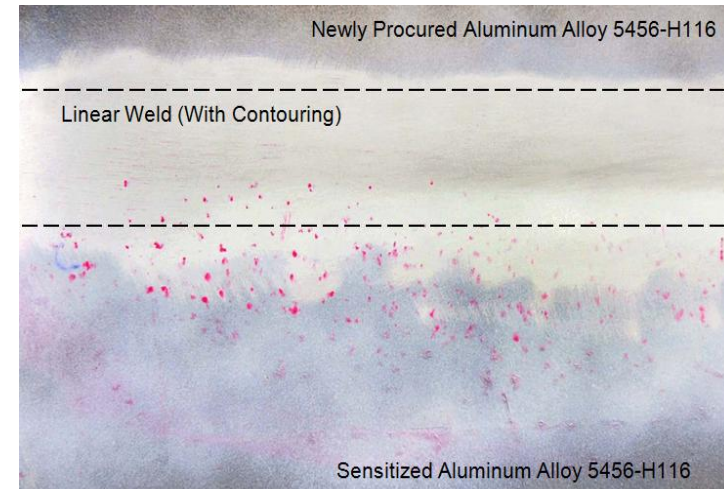
- Difficulty with interpretation and evaluation of relevant and non-relevant indications at stated acceptance limits
- Grinding surface of interest, weld reinforcement contouring, adds to instability with repeated PT inspections

Numerous non-relevant indications evaluation has been displayed on sensitized aluminum alloy base material during dye penetrant testing.

Liquid Dye Penetrant Testing on Aluminum Alloy Weldment with Sensitized Base Material and New Base Material.

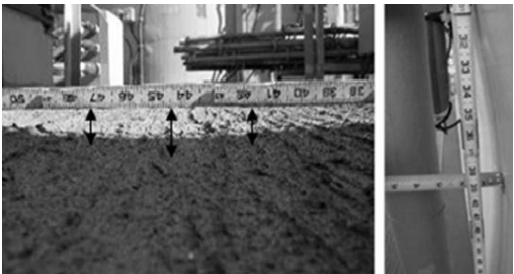
Ship Superstructure Plate Deflection Between Structural Members
