Review of Acceptable Flash Rusting for Ship Coatings

Final Report – March 24, 2009

Steve Cogswell, Pete Ault

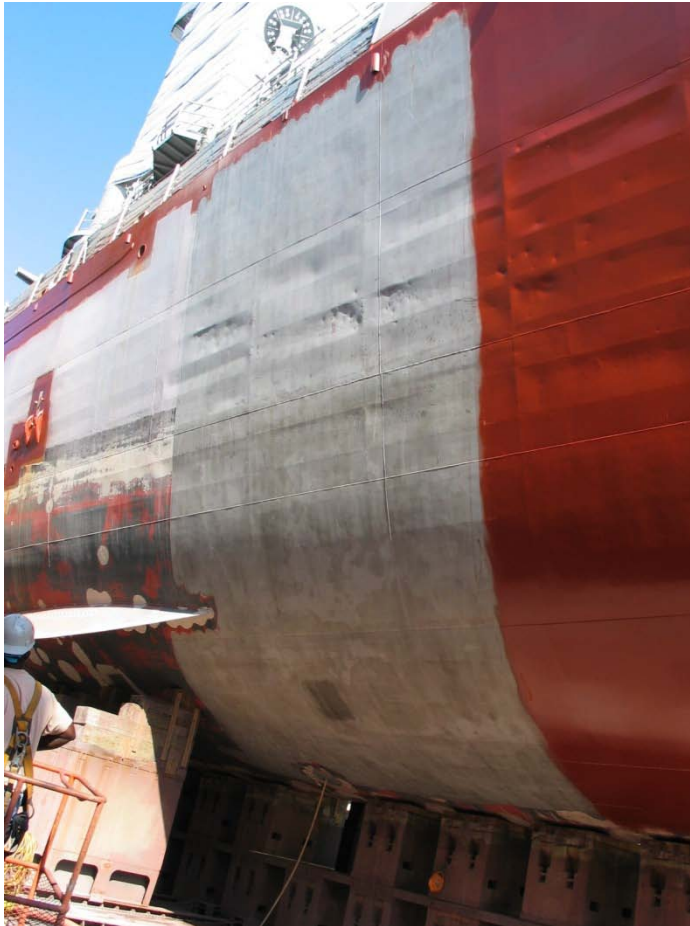
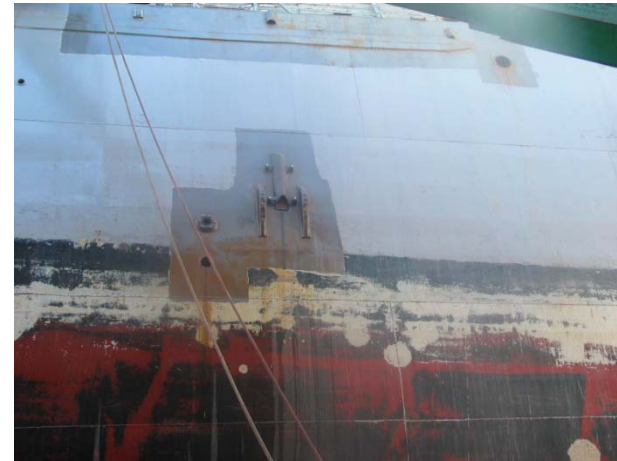
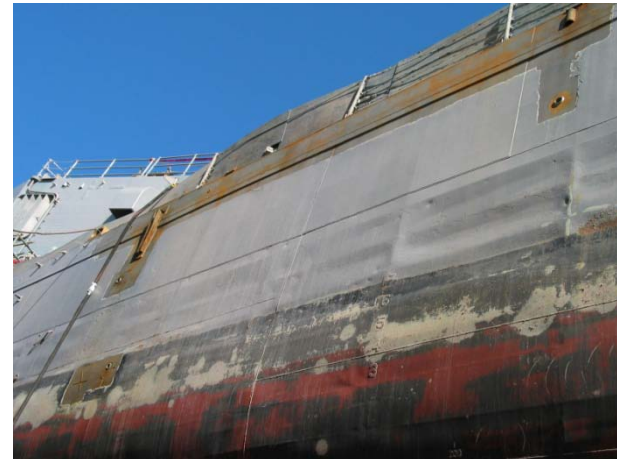
“Hand Lance Areas” Develop Moderate Flash Rust which must be Remediated

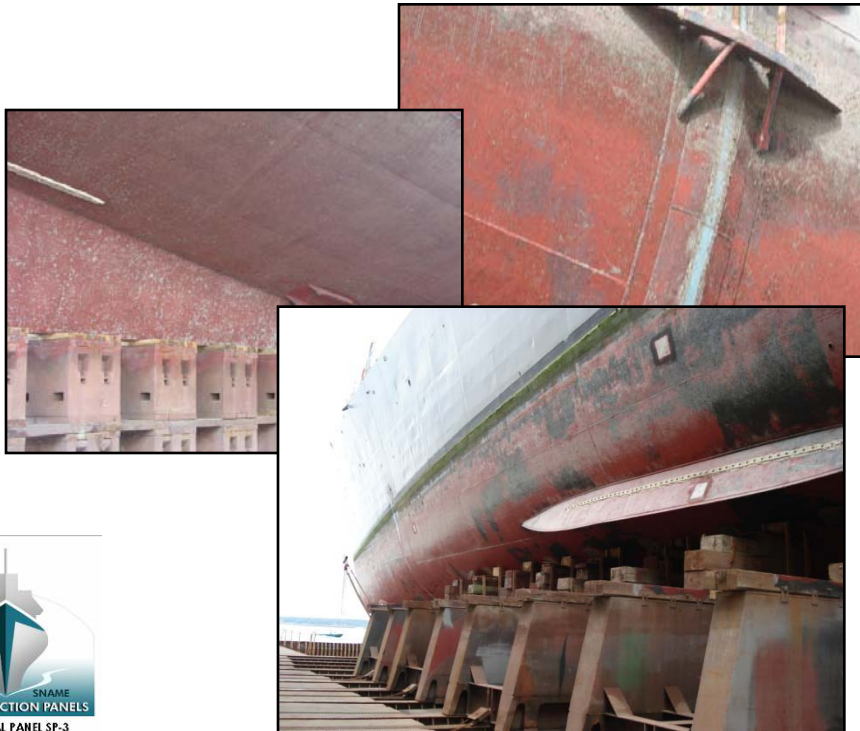
Navy Ships with Coating over MFR

- No evidence of catastrophic failure
- Work performed at multiple yards by various contractors
- Time in service up to 9 years
- USS KLACKRING (FFG 42)
- USS HUE CITY (CG 66)
- USS ROBERTS (FFG 58)
- USS BOONE (FFG 28)
- USS STENNIS (CVN-74)
- USS ENTERPRISE (CVN-65)
- USS HALYBURTON (FFG-40)
- USS THE SULIVANS (DDG-68)
- USS BELLEAU WOOD (LHA-3)
- USS LAMOURE COUNTY (LST-1194)
- USS ASHLAND (LSD-48)
- USS ESSEX (LHD-2)
- USS NASSAU (LHA-4)
- USS DULUTH (LPD-6)

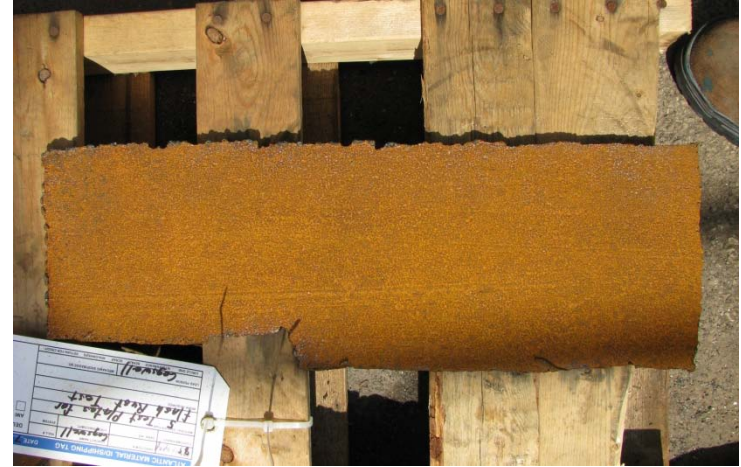
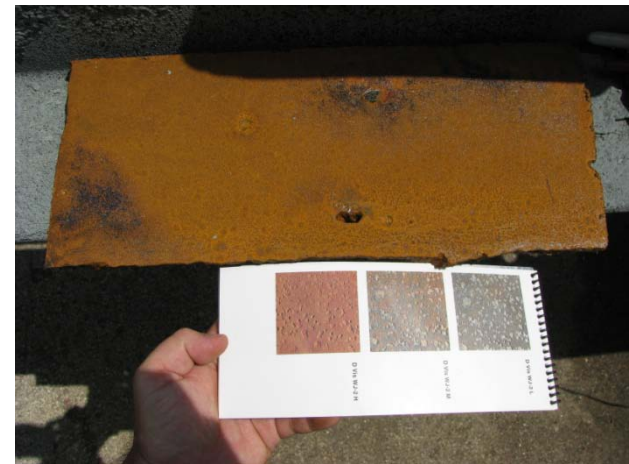
Panel Preparation

- Panels cut from heavily rusted steel plate
- Hand lance UHPWJ
- Flash rust developed over 8 days exterior exposure at Atlantic Marine in late July

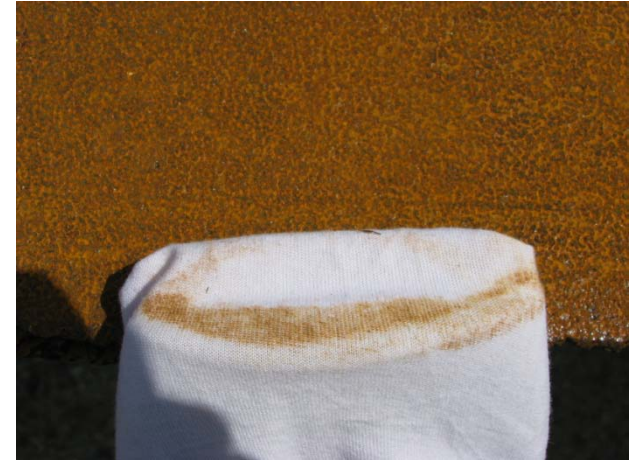
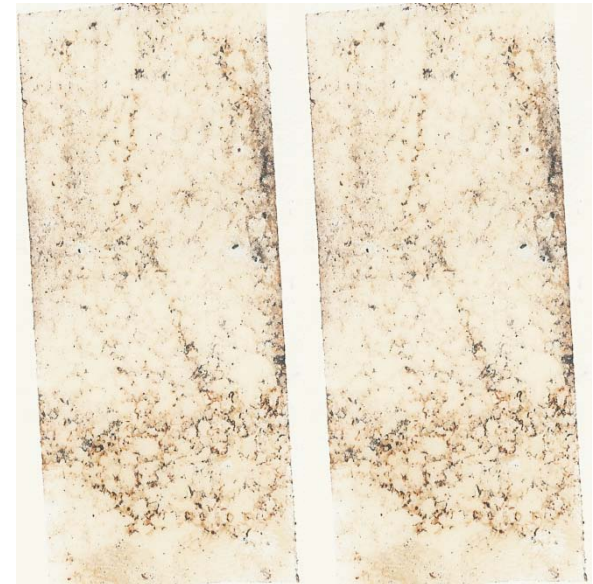
“Heavy” Flash Rust Characterization – Current Methods

- SP-12 Evaluation
 - Red-brown
 - Hides the initial surface condition completely
 - Exhibits a layer of heavy...rust
 - Evenly distributed
- Wipe Test
 - Exhibited significant marking when lightly wiped with a white cloth wrapped around a 4-inch paint brush.
- Tape Test
 - All panels transferred some flash rust to the 10th tape applied in the same location
- Surface Conductivity
 - <30 to 72 uS
- Pull-off adhesion
 - Could adhesion tests with quick-cure epoxy be a viable QA tool?

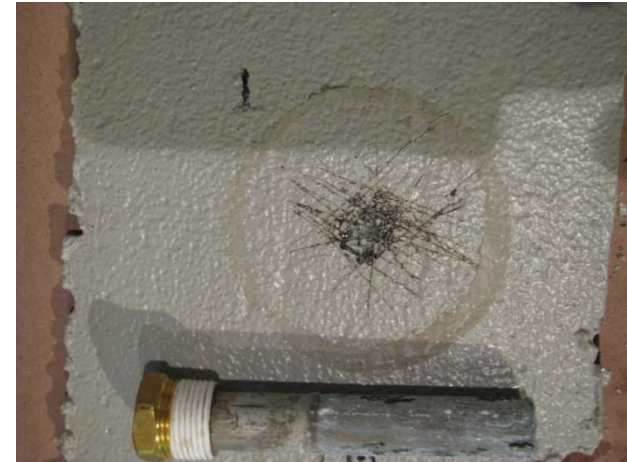
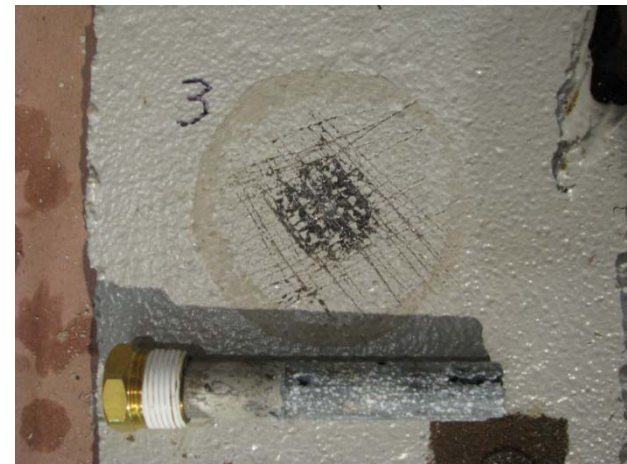
Coating Performance over Heavy Flash Rust

- Pull off Adhesion
 - Glue failures between 1300 and 2600 psi (Good result)
- Cathodic Disbondment Test
 - Failure radius similar to that previously observed

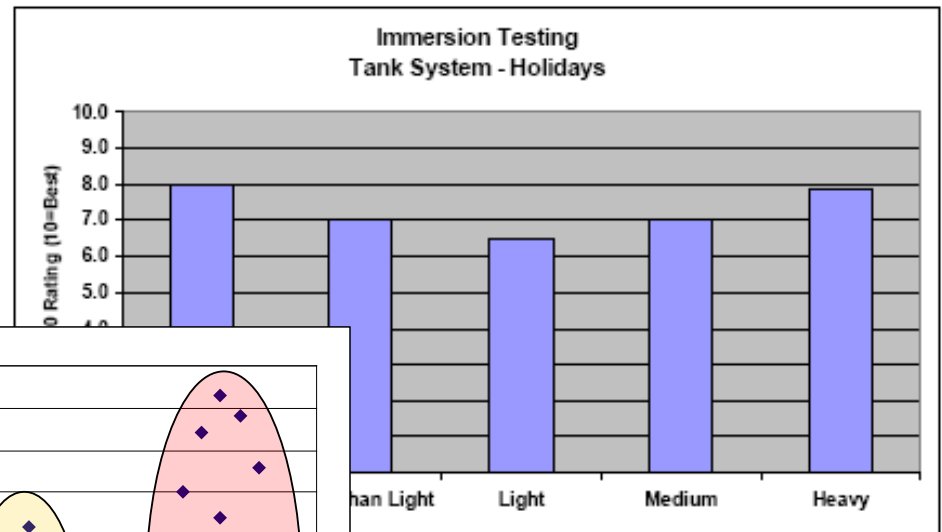
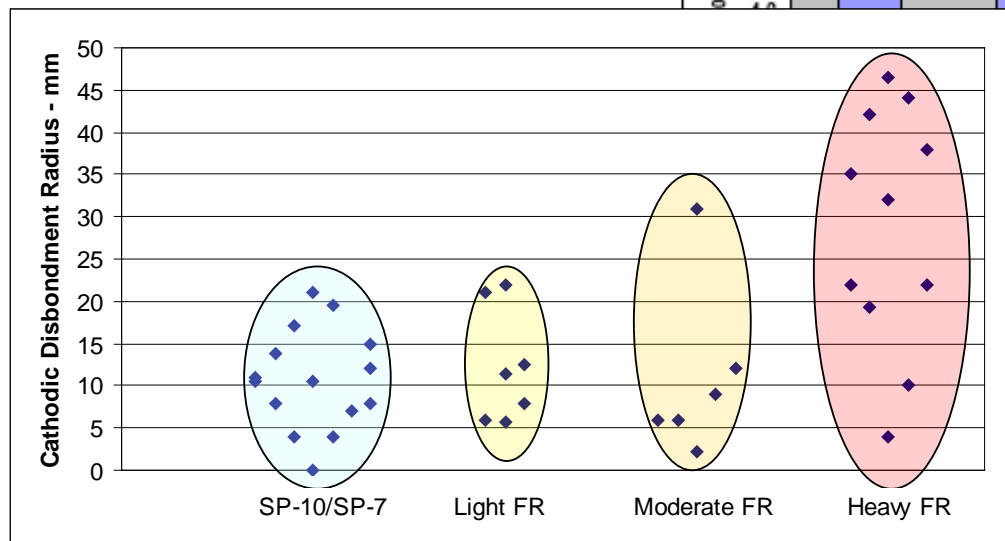
Corroborated by Laboratory Data

- Navy-sponsored lab testing suggests Heavy Flash Rust does not catastrophically impact coating performance
- More testing by CWP-351

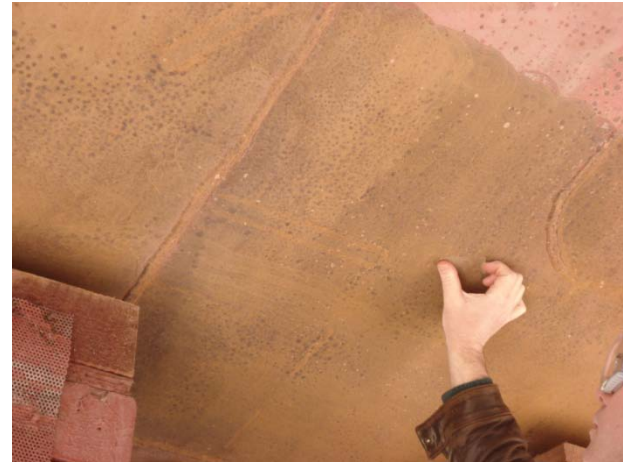
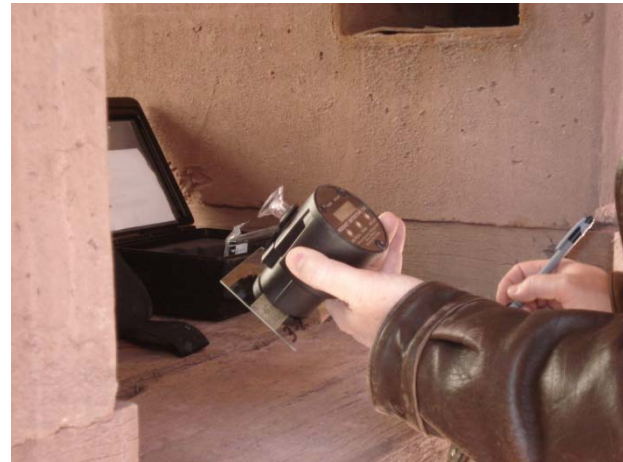
Tape Test w/Transmittance Measurement

- Adaptation of Hempel “10 tape” test
 - Apply tape to flash rust
 - Rub ~10X with finger, using nail if necessary
 - Affix tape to clear glass slide
 - Measure transmittance at a location where the light intensity is less than 50 foot-candles
 - Retain glass with tape on it
