Review of Acceptable Flash Rusting for Ship Coatings

Status Report – June 18, 2008

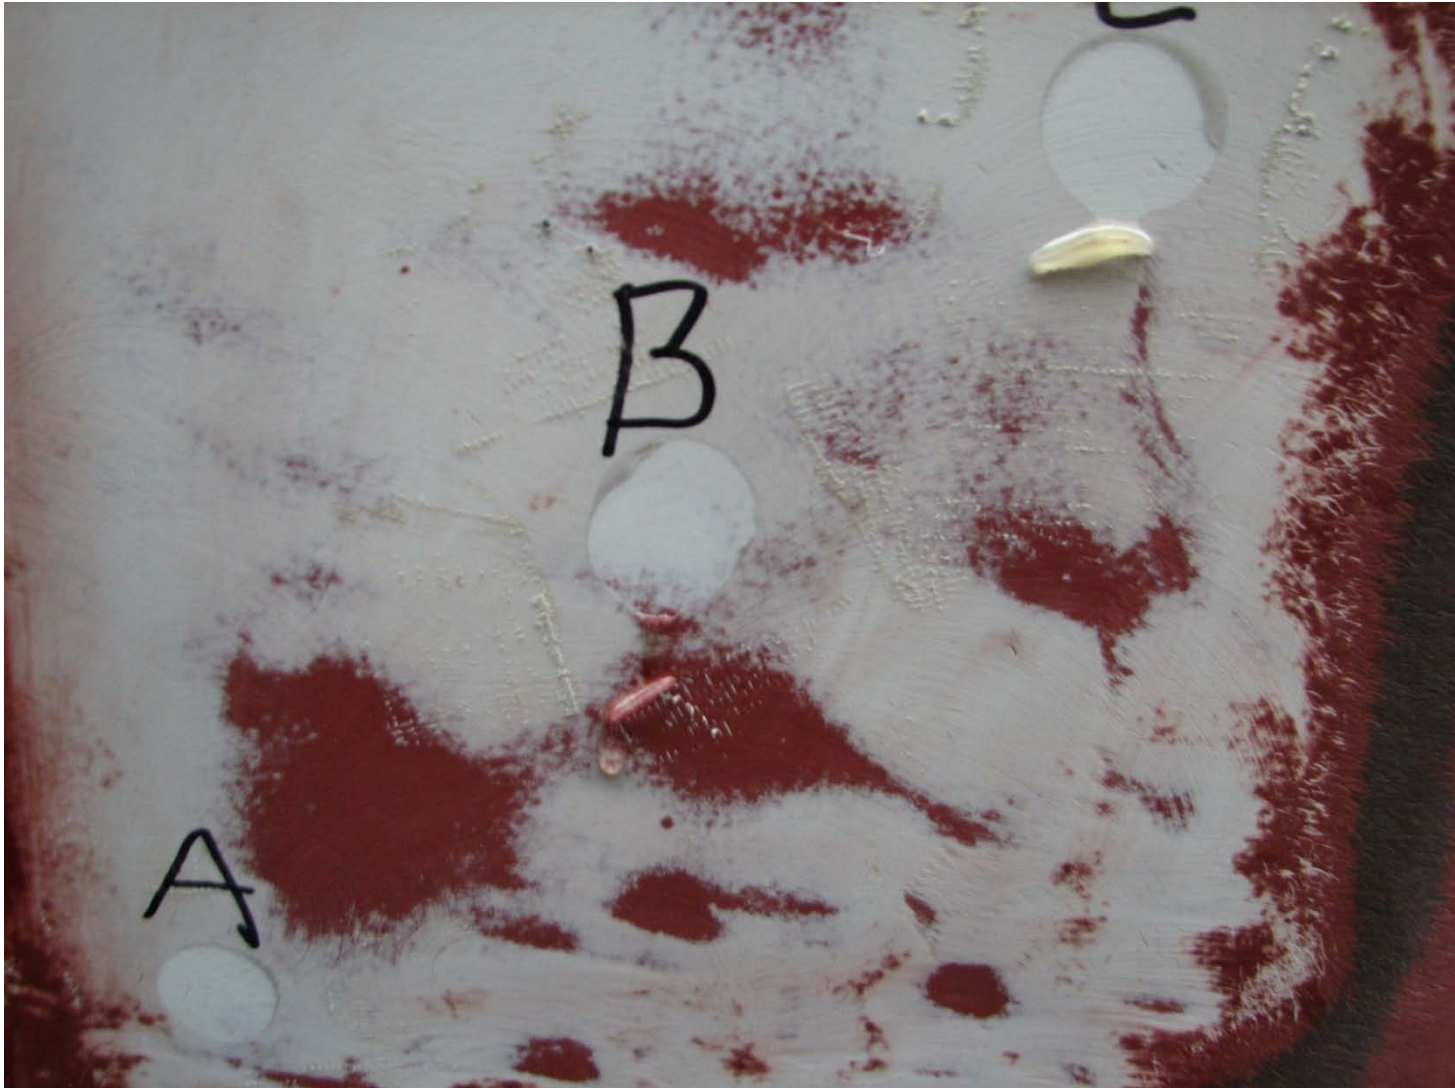
UHPWJ Cleaned Surfaces

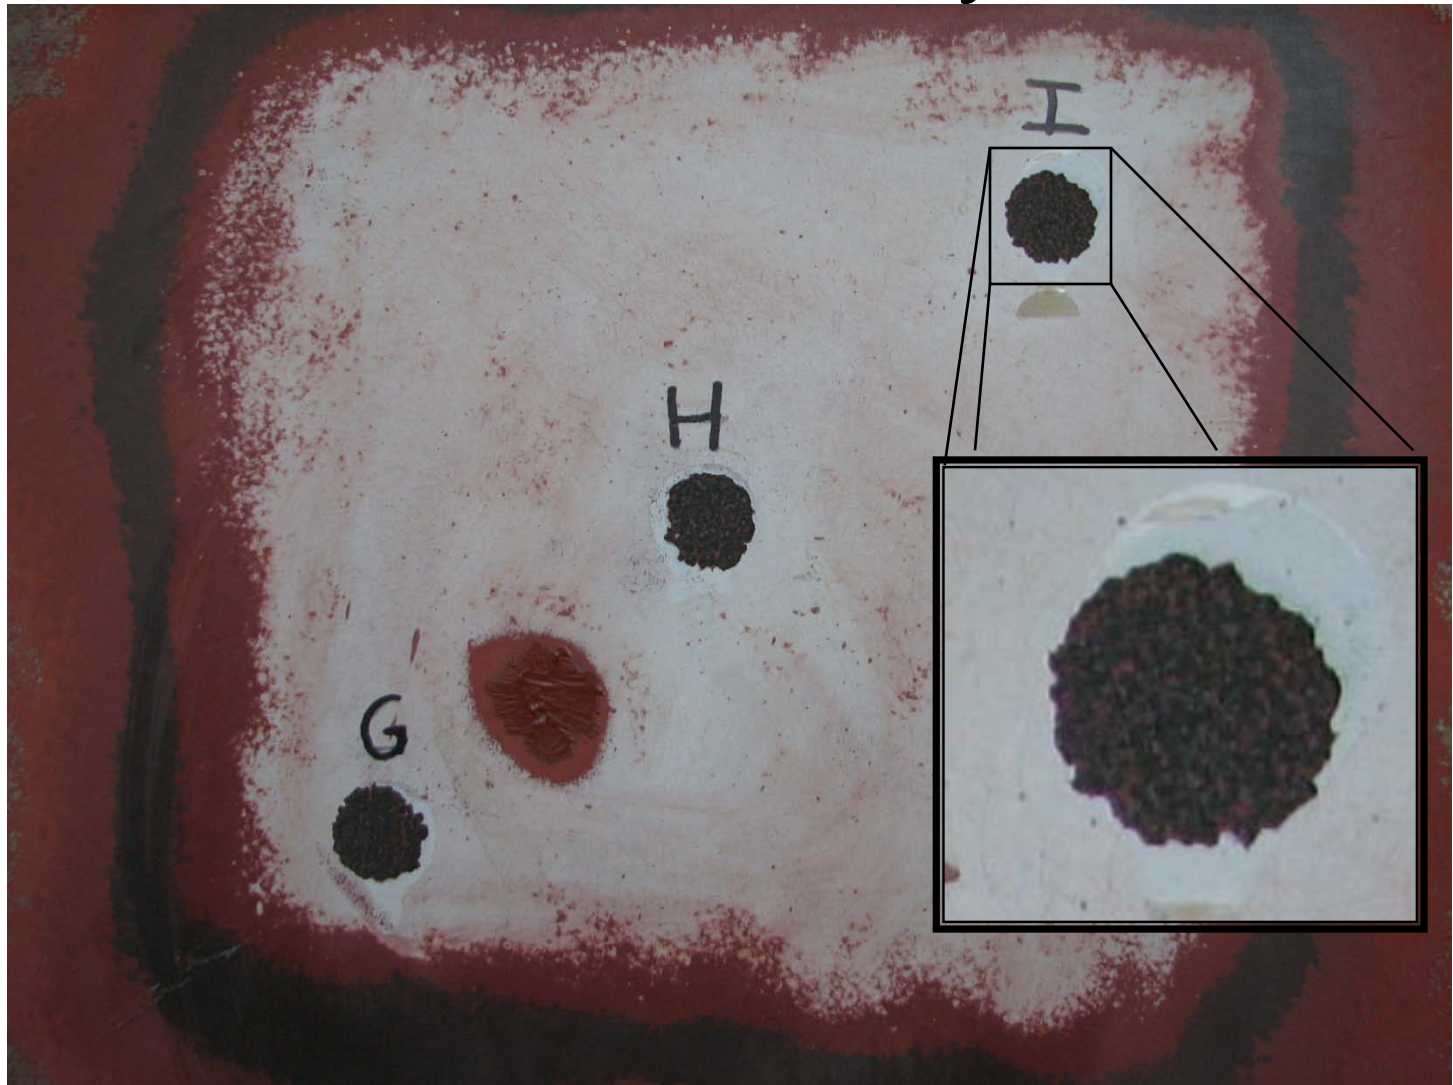
Hand Lance Remediated with Dry Ice Blast

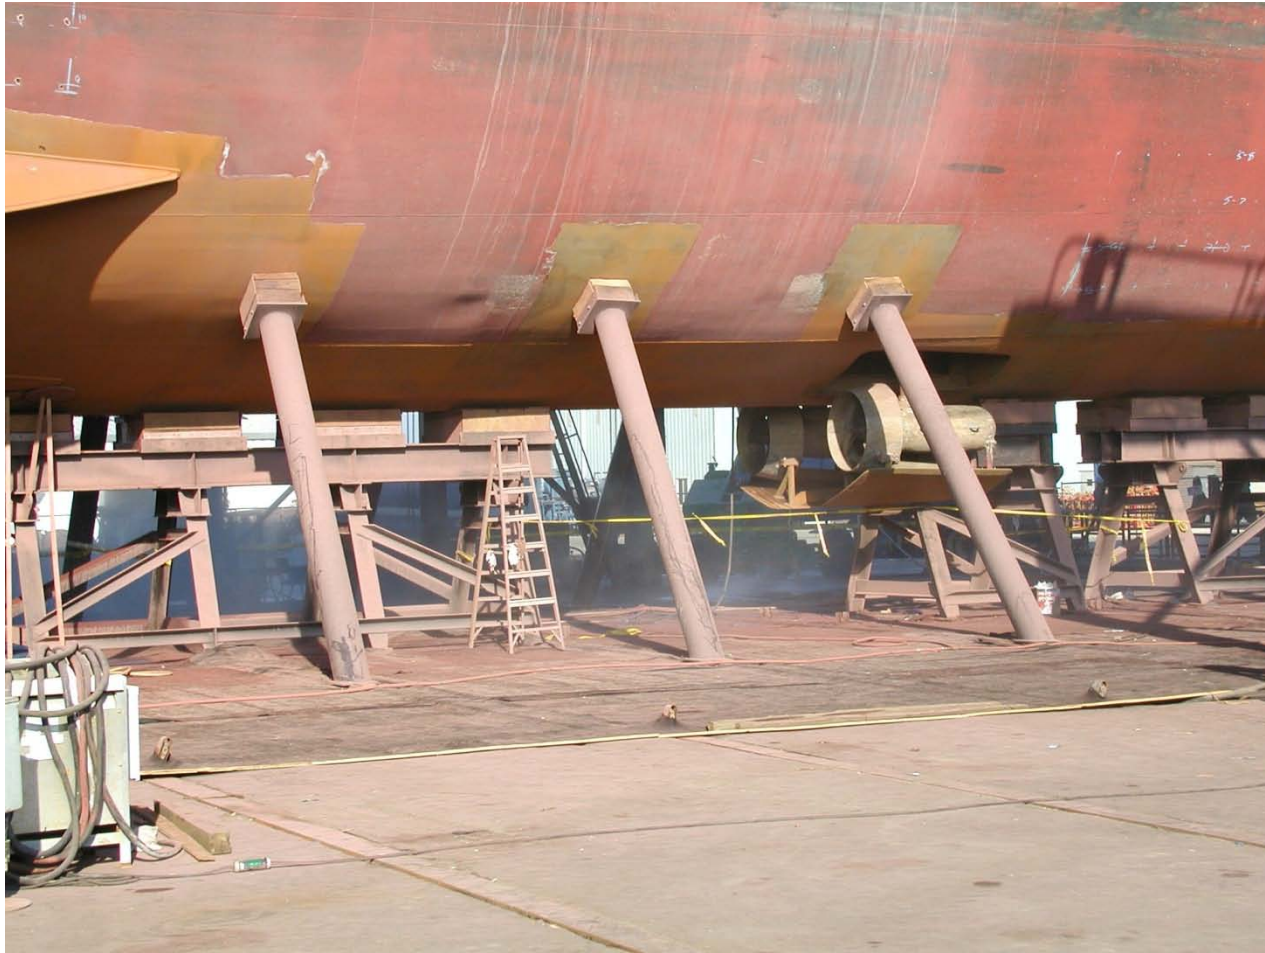
The Original Problem “Hand Lance Areas”
