Review of Acceptable Flash Rusting for Ship Coatings

Status Report – September 30, 2008

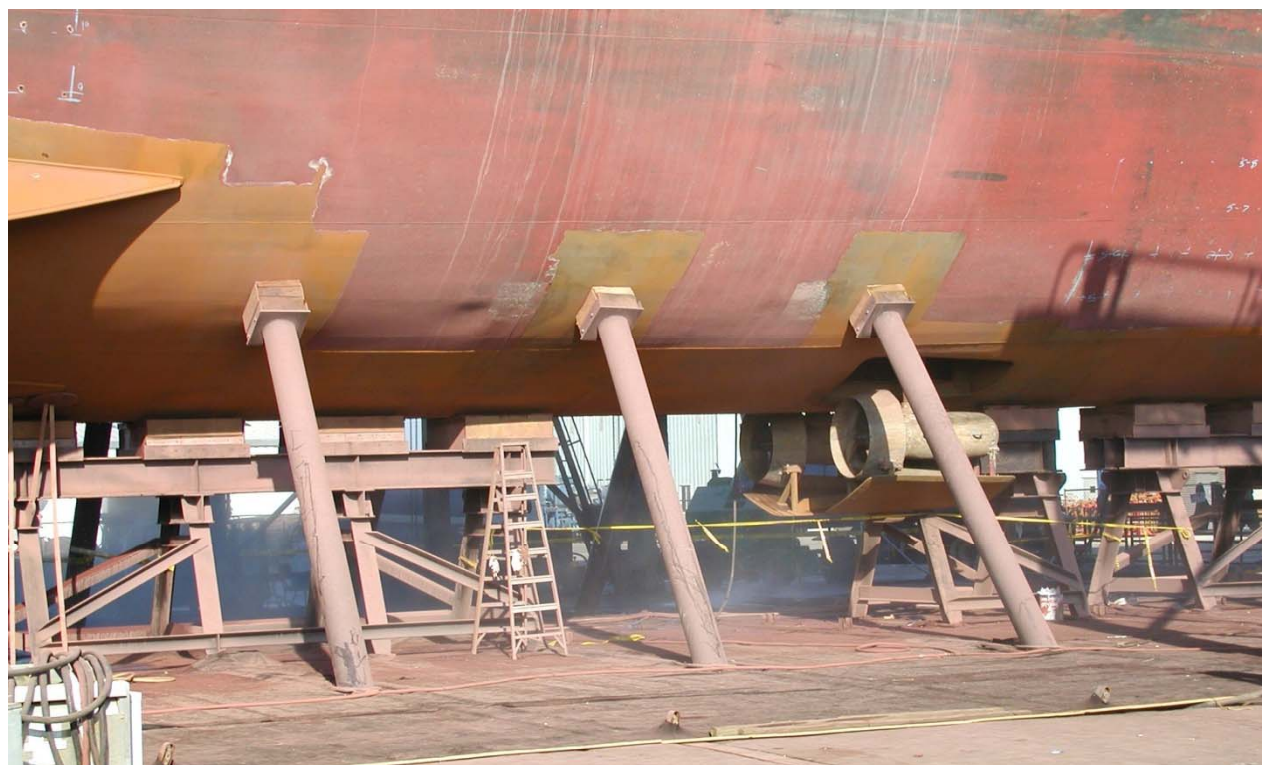
“Hand Lance Areas” Develop Moderate Flash Rust which must be Remediated

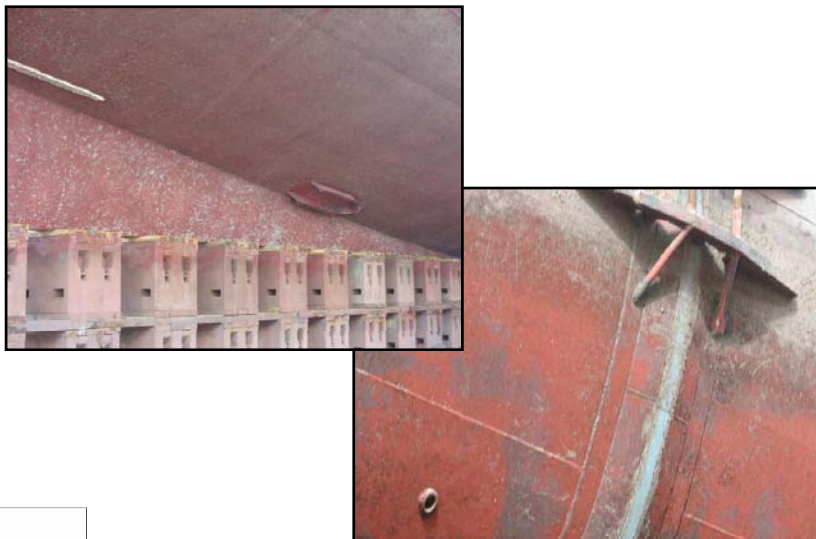
- No evidence of performance concerns
- Work performed at multiple yards by various contractors
- Time in service up to 9 years
- USS STENNIS (CVN-74)
- USS ENTERPRISE (CVN-65)
- USS HALYBURTON (FFG-40)
- USS THE SULLIVANS (DDG-68)
- USS BELLEAU WOOD (LHA-3)
- USS LAMOURE COUNTY (LST-1194)
- USS ASHLAND (LSD-48)
- USS ESSEX (LHD-2)
- USS NASSAU (LHA-4)
- USS DULUTH (LPD-6)

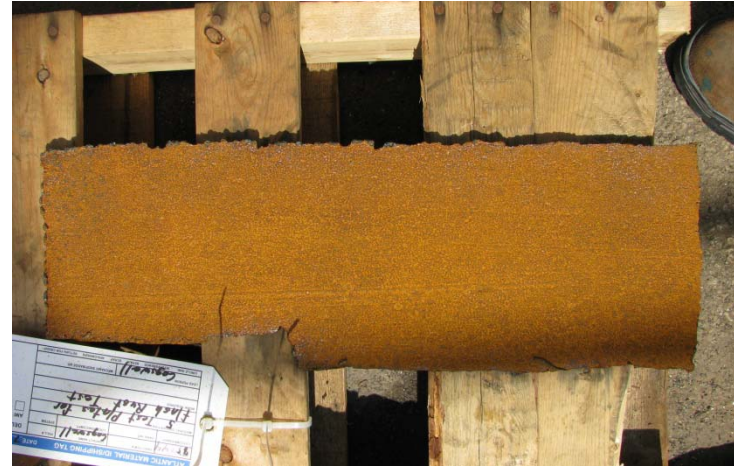
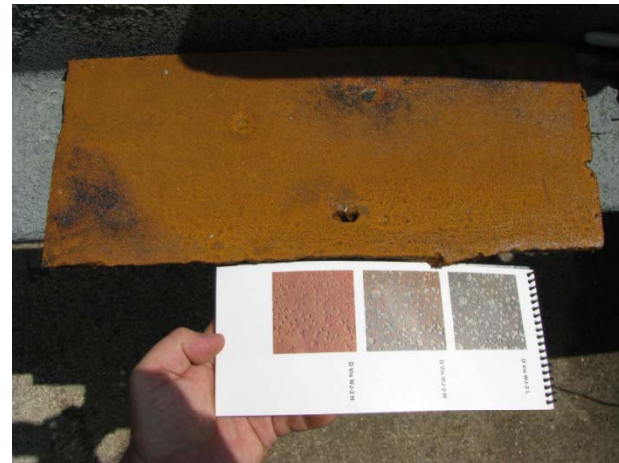
- Panels cut from heavily rusted steel plate
- Hand lance UHPWJ
- Flash rust developed over 8 days exterior exposure at Atlantic Marine in late July

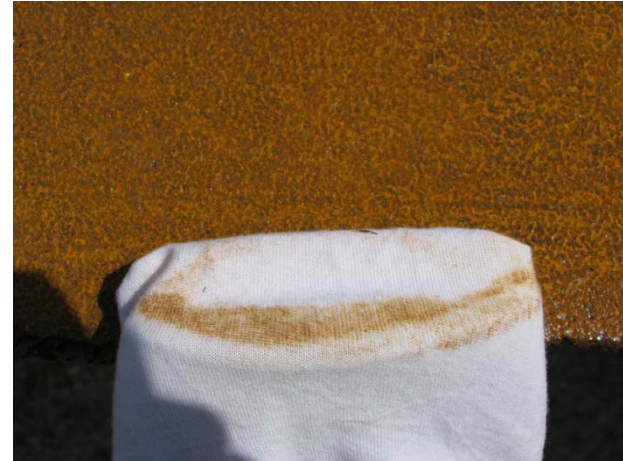
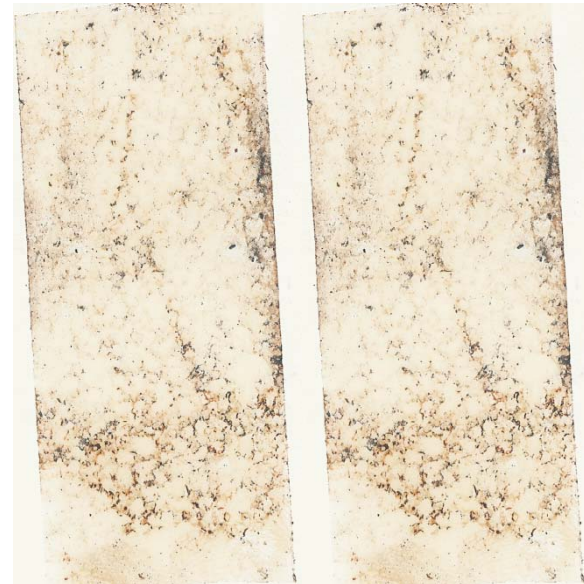
- SP-12 Evaluation
 - Red-brown
 - Hides the initial surface condition completely
 - Exhibits a layer of heavy...rust
 - Evenly distributed
- Wipe Test
 - Exhibited significant marking when lightly wiped with a white cloth wrapped around a 4-inch paint brush.
- Tape Test
 - All panels transferred some flash rust to the 10th tape applied in the same location
- Surface Conductivity
 - Panel 1 – 72 uS
 - Panel 2 – < 30 uS
 - Panel 3 – 30 uS

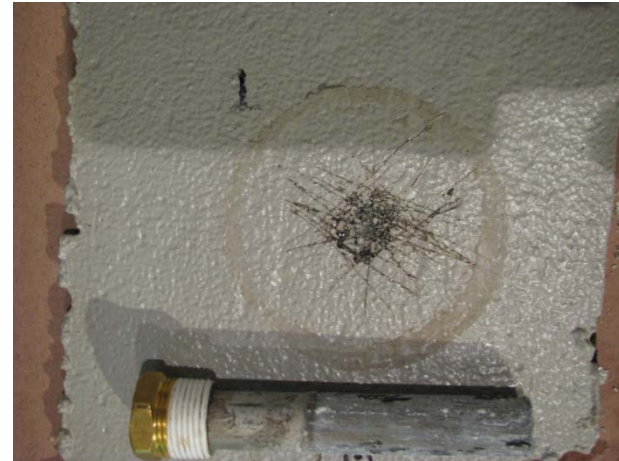
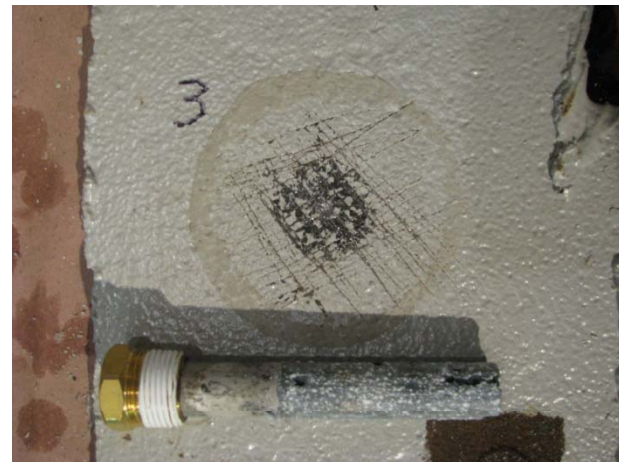
- Pull off Adhesion
 - Glue failures between 1300 and 2600 psi (Good result)
- Cathodic Disbondment Test
 - Failure radius similar to that previously observed
