Review of Acceptable Flash Rusting for Ship Coatings

Final Report

Advanced Technology Institute

Atlantic Marine Florida, LLC
Elzly Technology Corporation

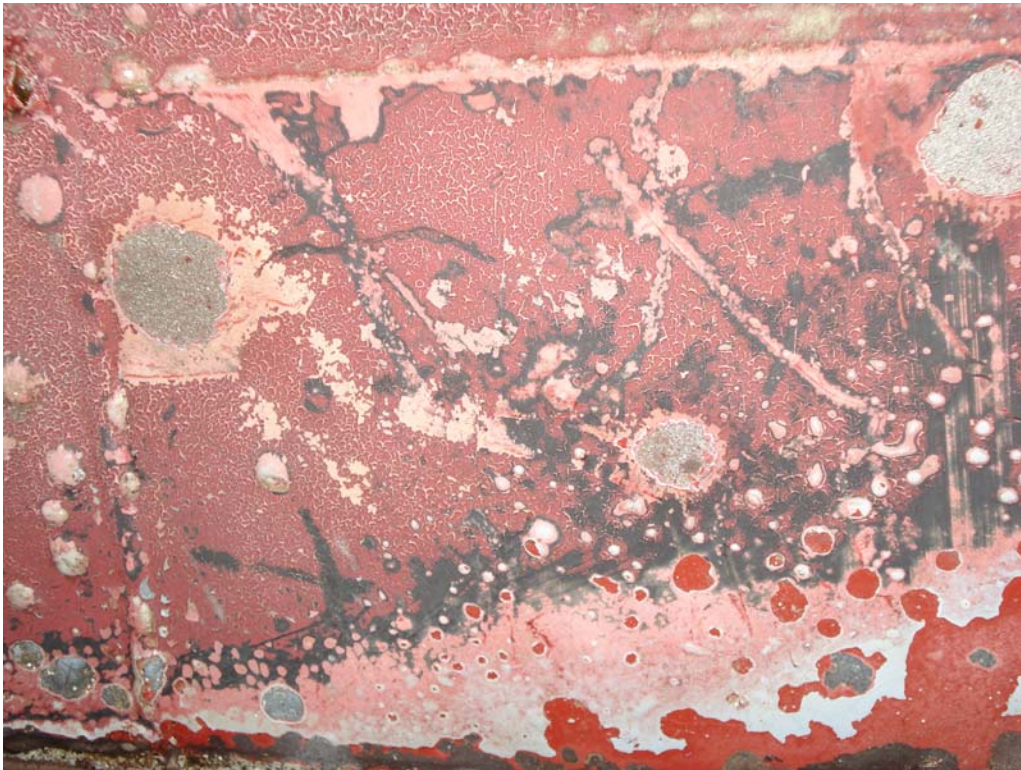
In summary, the physical inspection revealed no evidence of coating failure which would logically be traced to a systematic or process problem associated with hand lance cleaning. Of the surfaces inspected, all had tightly adherent epoxy primer. Blistering of the underwater hull coating was observed along the keel.

Figure 5. Representative blistering along the keel in the vicinity of the stern air masker.

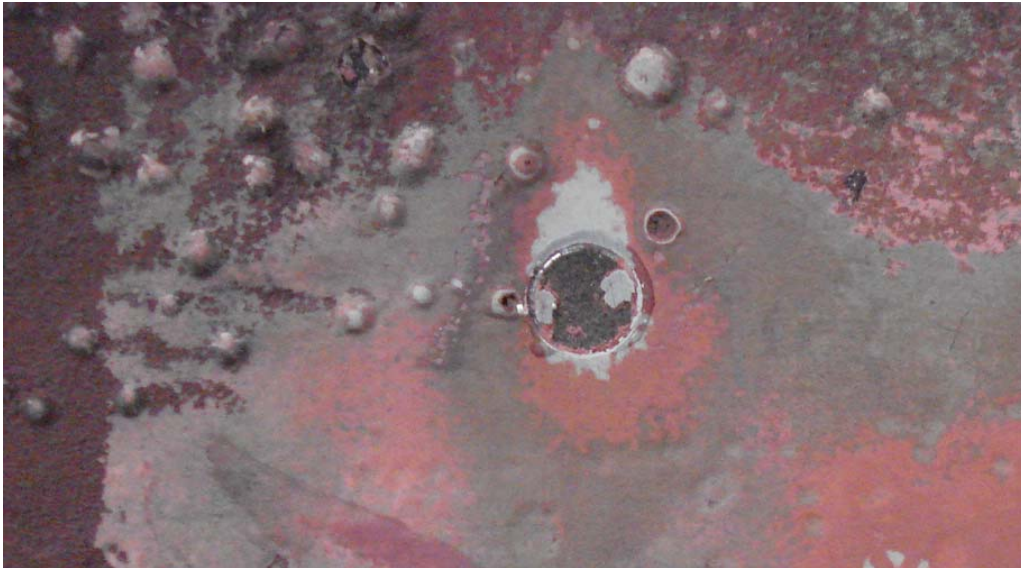
- Only two areas showed indications of compromised adhesion. Figure 6 shows a close-up of one pull-off test was placed over a latent blister (test 1-7). This test failed to the substrate at 240 psi. Figure 7 shows two small areas comprising 2% of the coating removed from patch 8 (0.25 in²) was easily removed to the substrate with mechanical force. Remaining tests on both of these areas demonstrated excellent adhesion.

Figure 6. Pull-off adhesion test 1-7, situated near blistering on keel.

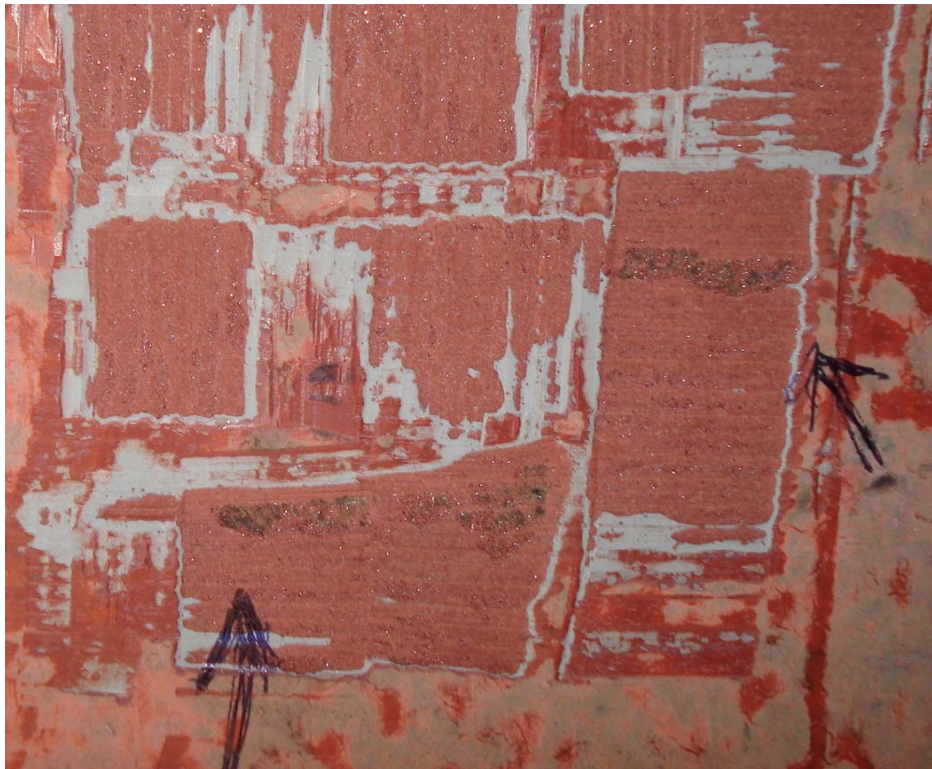
Figure 7. Small areas of substrate revealed when excavating at test location 8.

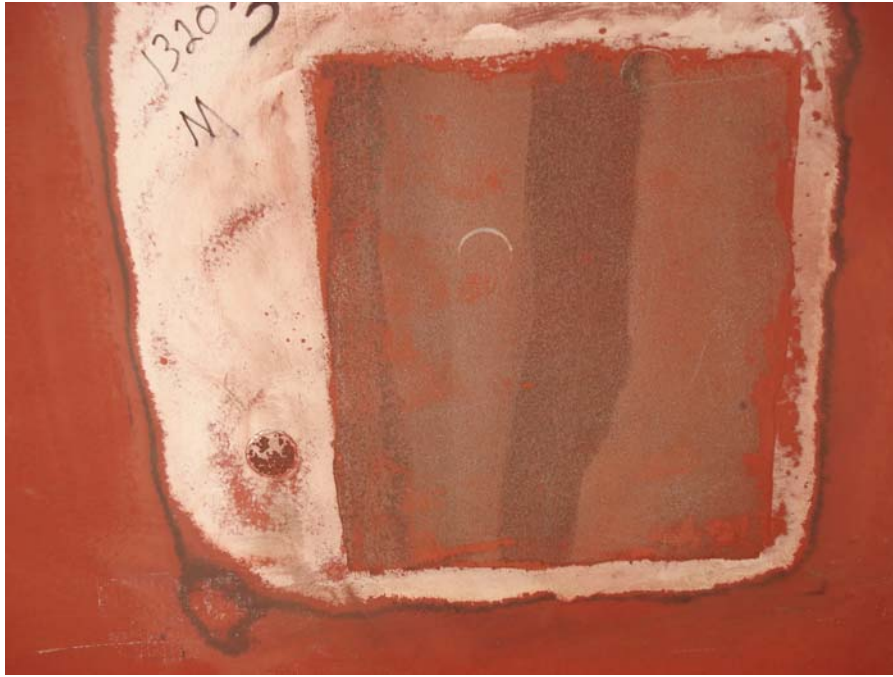
Subsequent to the physical testing, the coating was removed from a 10 by 10 inch area of patches 3 and 4. Coating removal was accomplished with repeated application of a paint stripper and scrubbing with a brass brush. Figure 8 and Figure 9 show the substrate of patch 3 and 4, respectively after coating removal.

Figure 8. Test Patch 3 with nominally 100 square inches of coating removed.

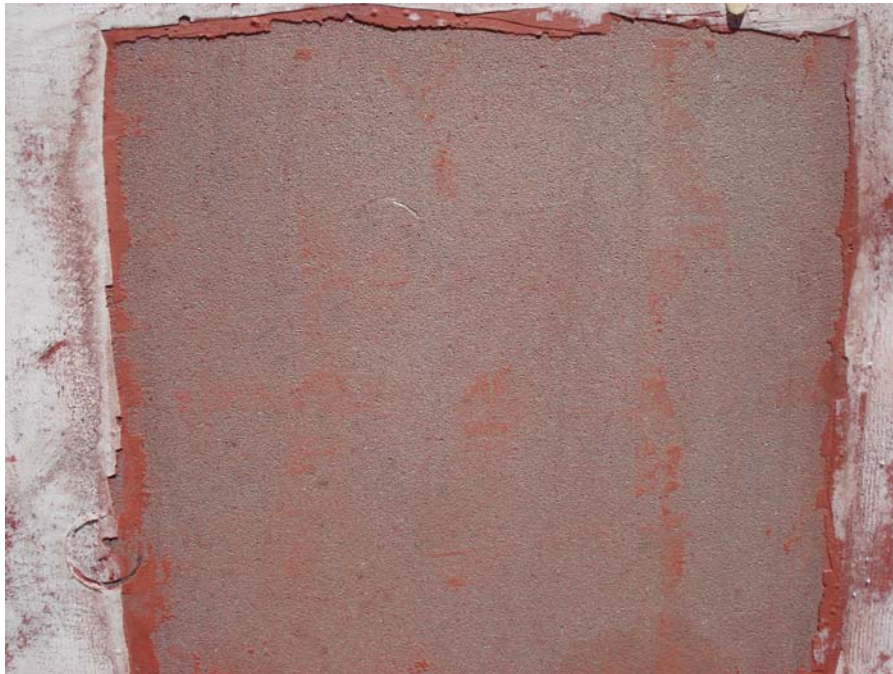
Figure 9. Test patch 4 with nominally 100 square inches of coating removed.

Physical removal of the coating showed further evidence that the primer was well adhered to a sound substrate. In both cases, the primer was difficult to clean from the depths of the profile. The exposed steel had a definite anchor profile which visually appeared to exceed 1 mil. Figure 10 shows a close-up of the steel surface at patch 4.

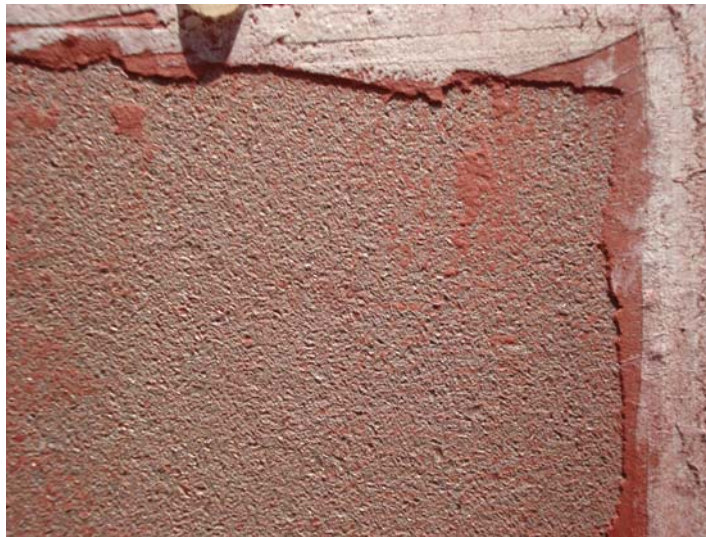
Figure 10. Close-up of the substrate revealed at patch 4.

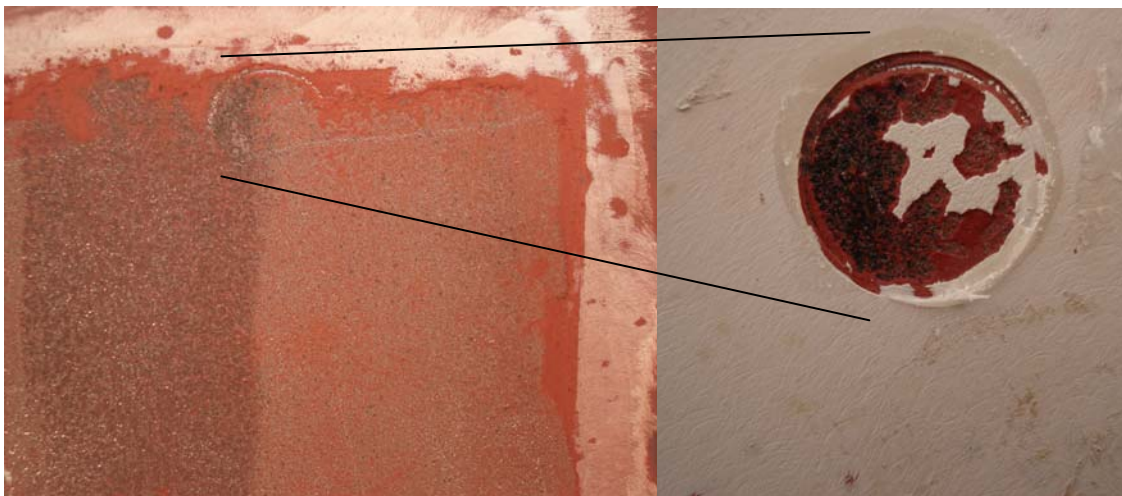
The lower patch (patch 3) had a stripe of stain through the center. Adhesion test 3-1 was situated such that part of the dollie was on the stained area and part was on the clean area. While the adhesion test failed to the substrate on the stained area, the pull test failed at 1968 psi – far in excess of most manufacturers’ requirements for a new coating. Figure 11 shows a close-up of the stain in the area of adhesion test as well as the adhesion test after failure.

Figure 11. Close-up of adhesion test 3-1 and the test location after coating removal.

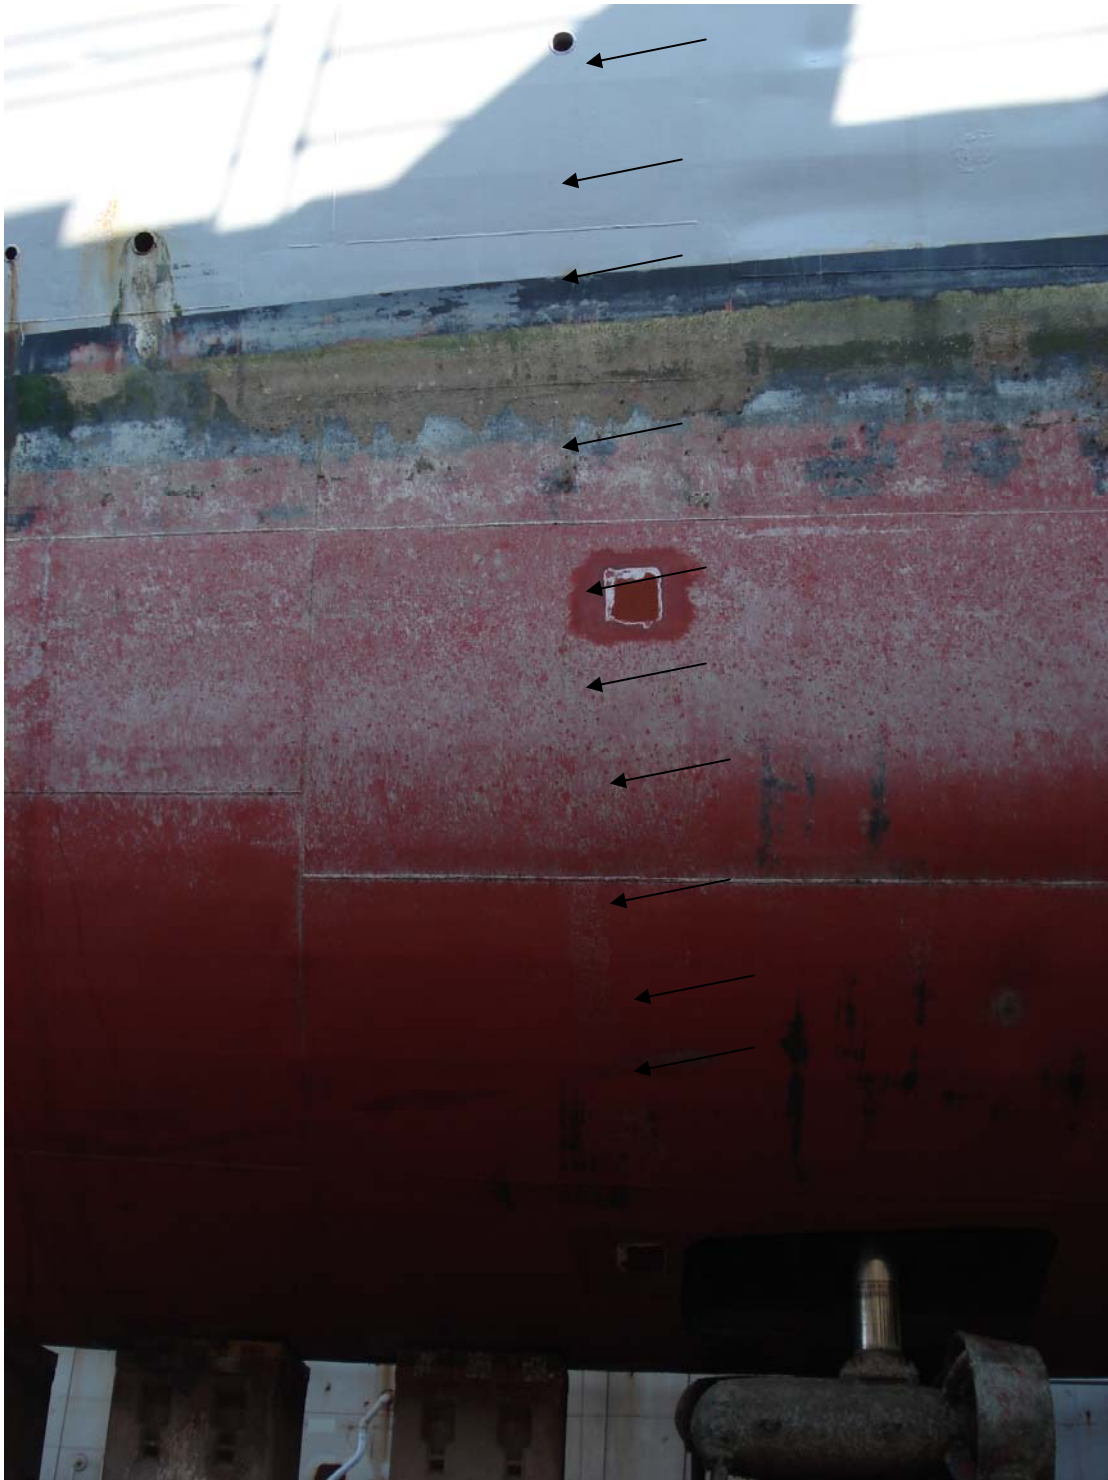
After further review of the stain, it was observed that the stain lined up with a streak of blisters that continued up to an overboard discharge. The type of discharge was not determined, but it is probable that the dark staining is associated with the discharge rather than an anomaly related to flash rust associated with hand-lance surface preparation. Figure 12 shows the relationship between the test patch, observed blistering, and the overboard discharge.

Figure 12. Location of test patch relative to overboard discharge. Note line of blistering highlighted by arrows in the photo.

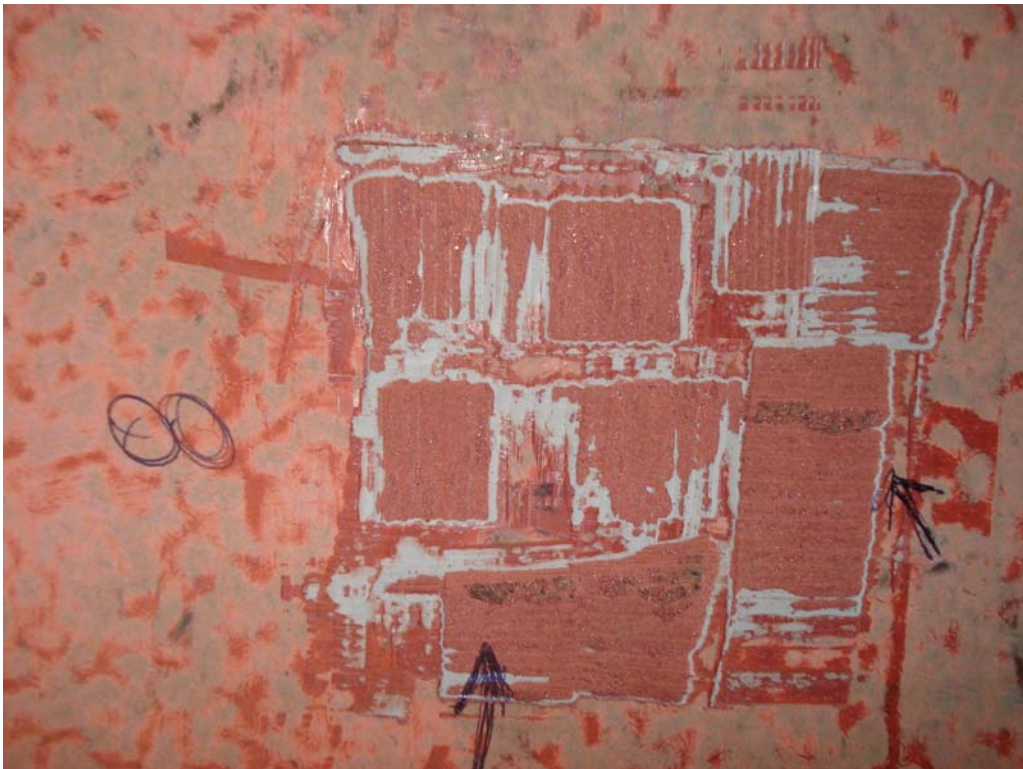
USS Boone Hull Coating Evaluation
Test Location 8

Mechanically exposed steel substrate at test location 8 – note two locations where corrosion is exposed.

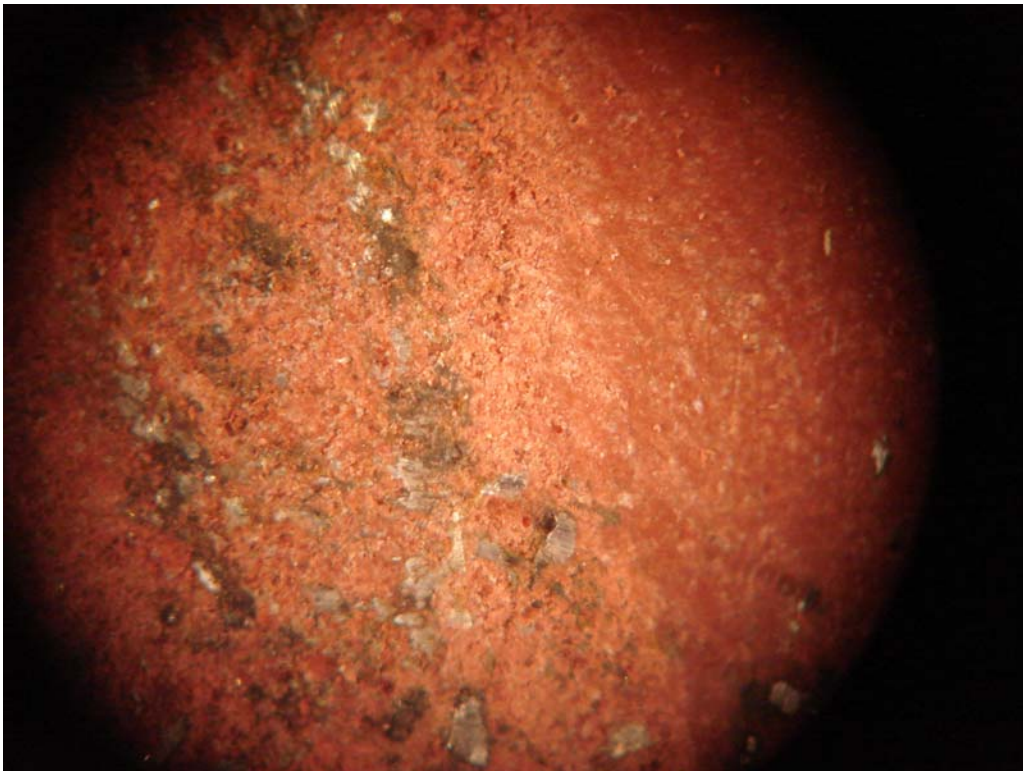
USS Boone Hull Coating Evaluation
Test Location 8

Close-up view of corrosion under the film at test location 8.
