NSRP SP-3 Panel Lessons Learned Project Final Report

Military Sea Lift Command

General Dynamics NASSCO

Safinah Ltd

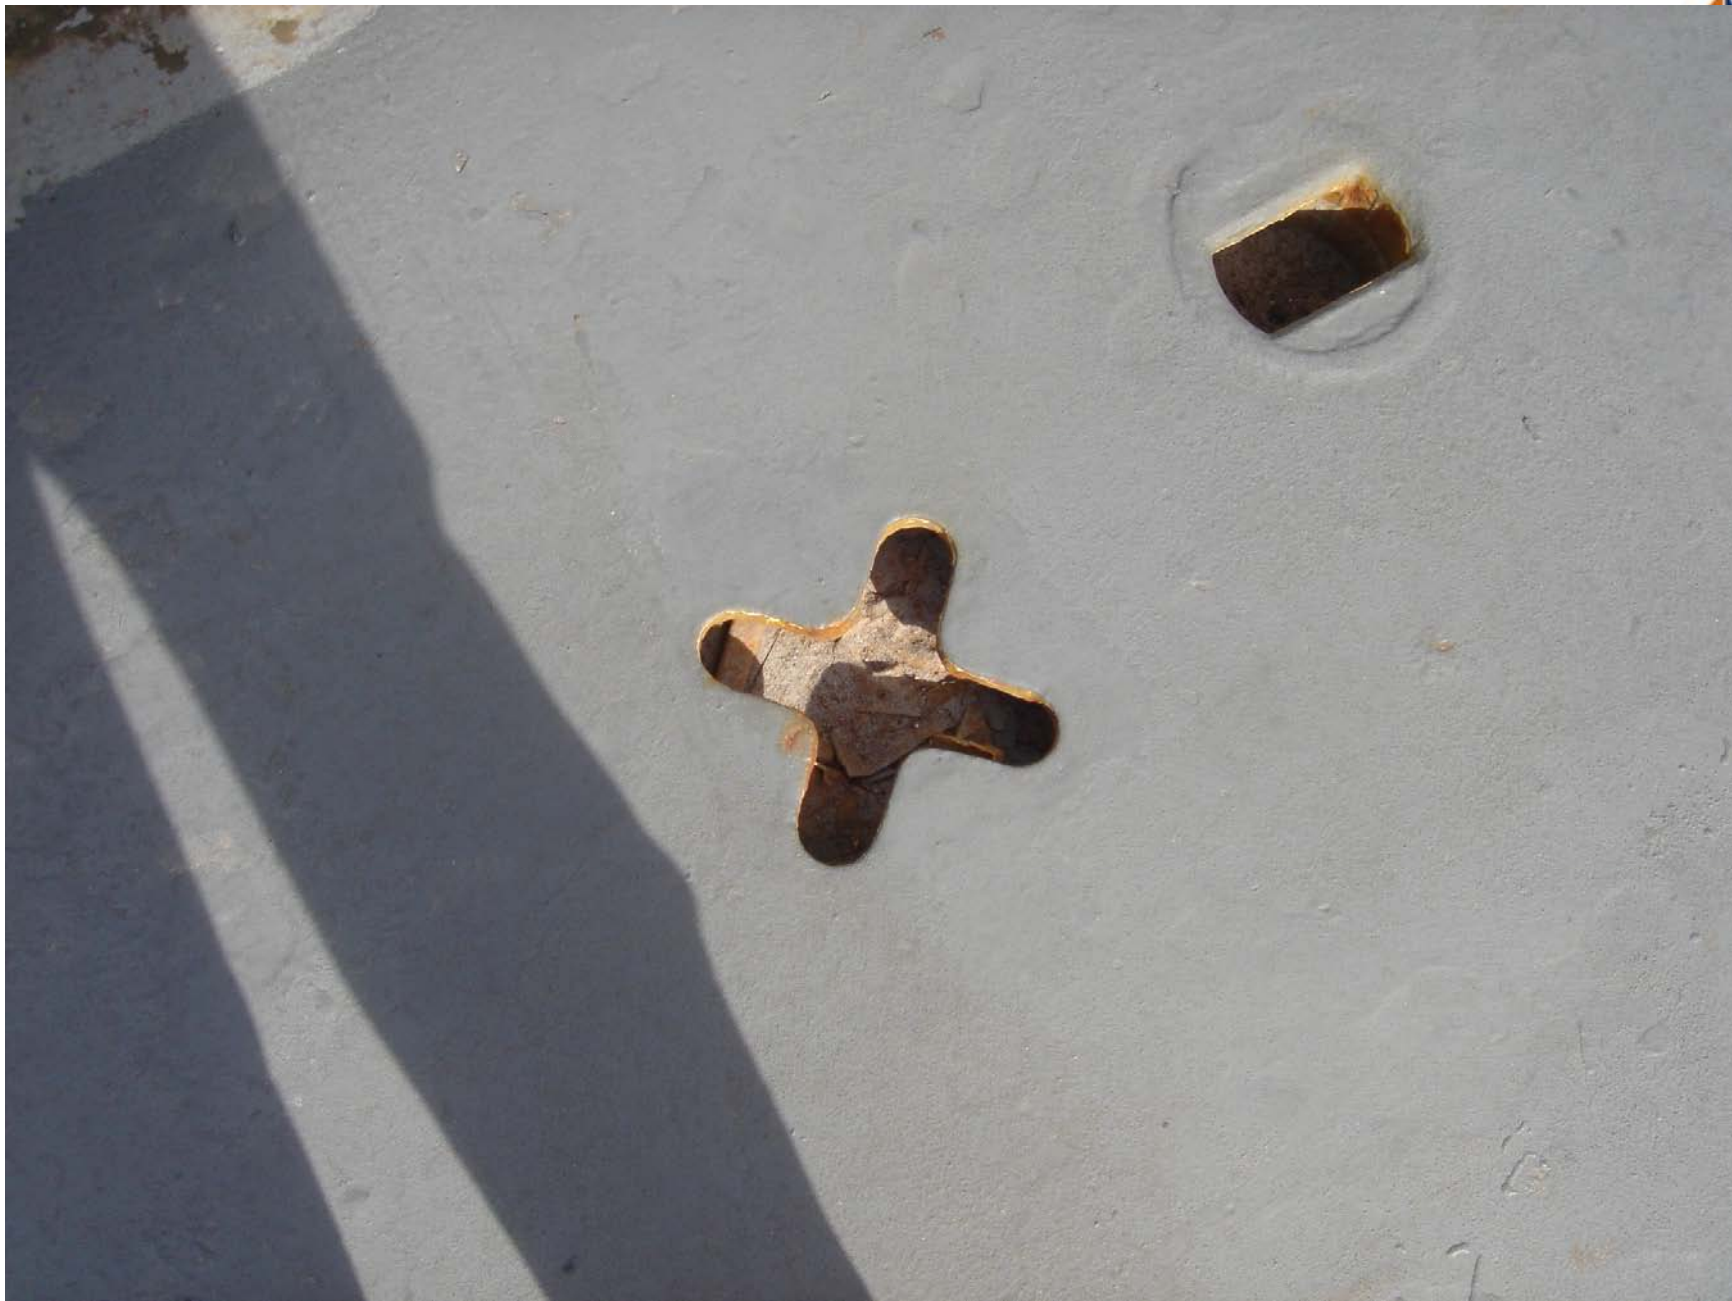
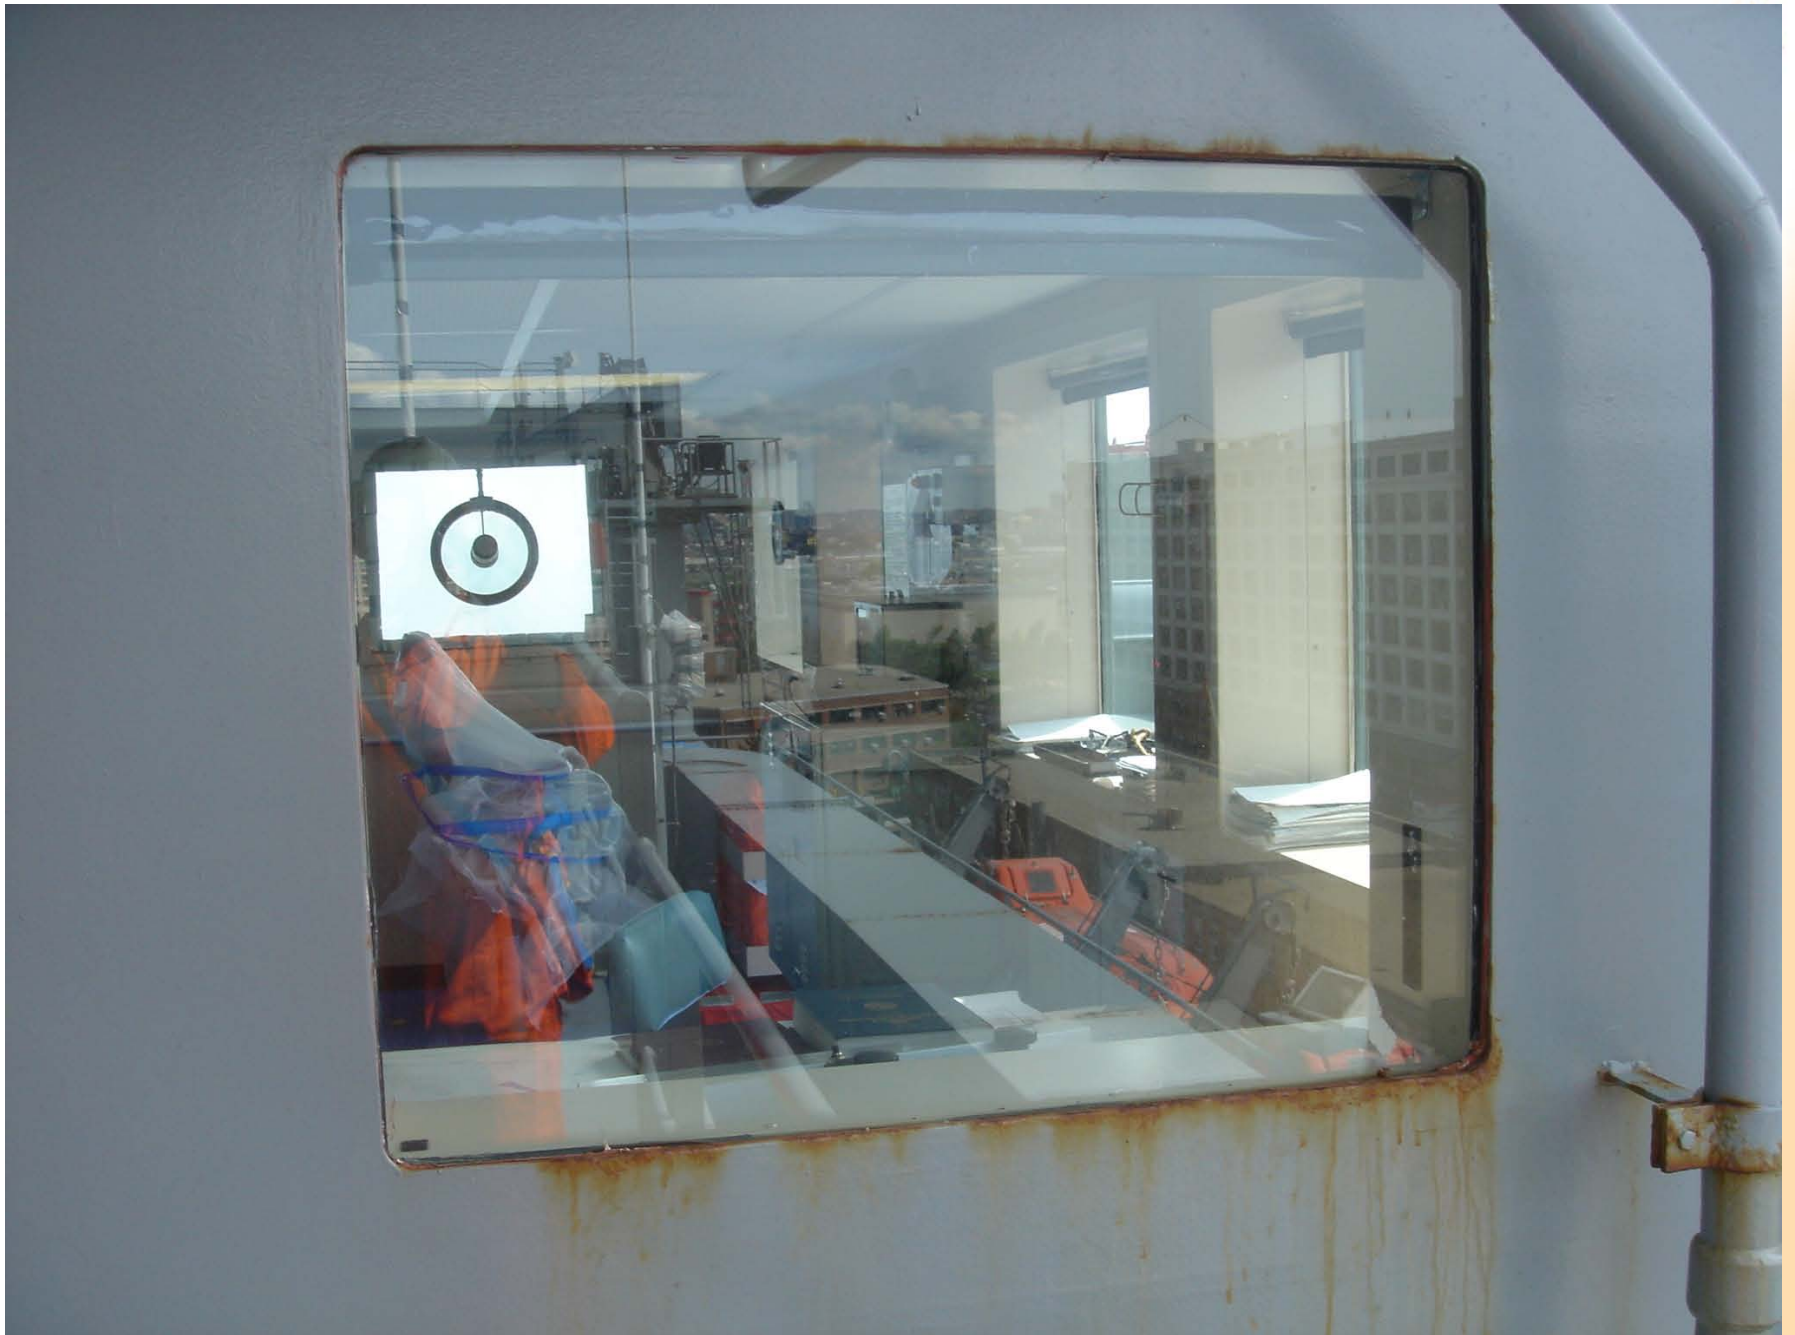
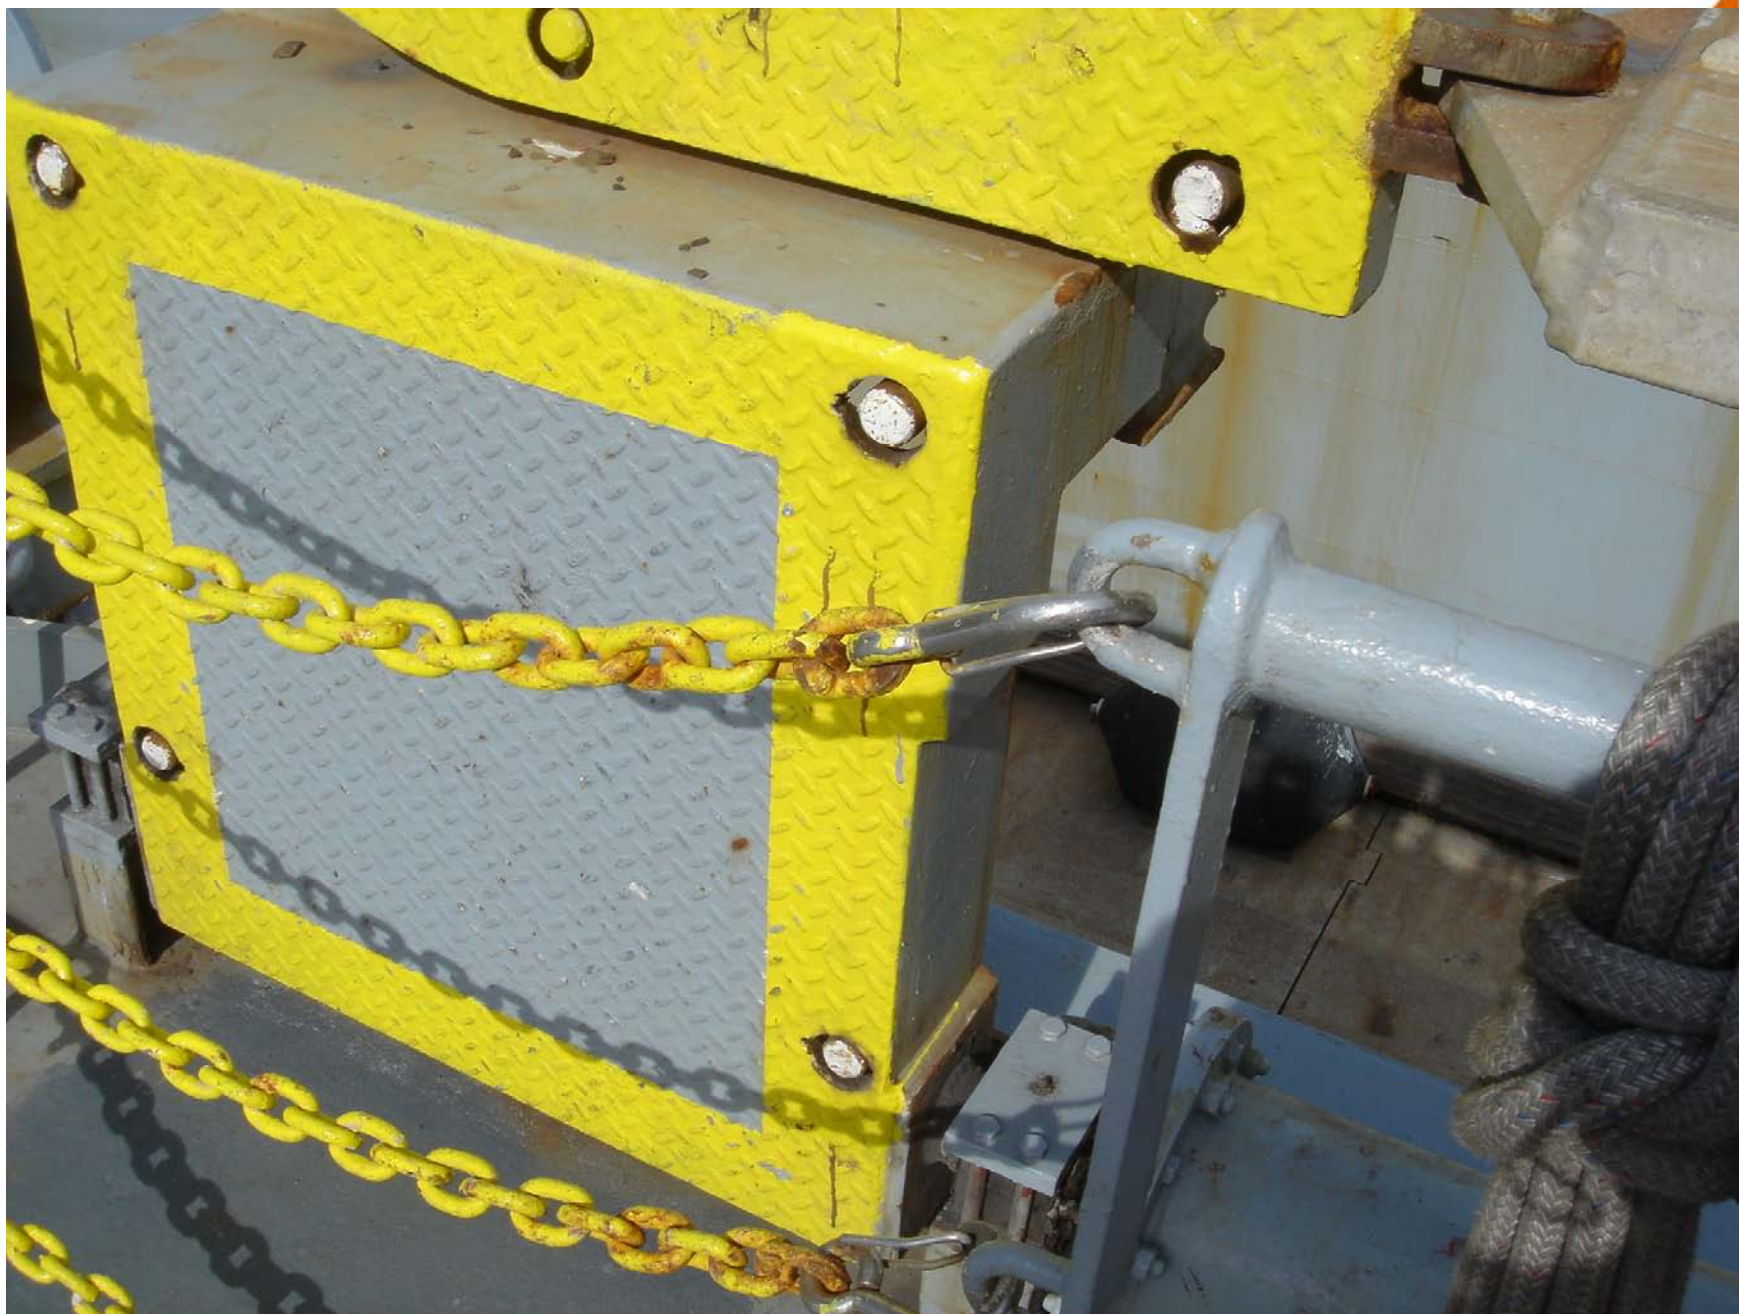
Design Examples

- ▶ Clover leaf
- ▶ D-rings
- ▶ Window edge problems
- ▶ Dissimilar metals and rust tears
- ▶ Pipe fittings
- ▶ Poor use of alternative materials

- ◆ Coating of stainless steel fittings
- ◆ Build up coats to required DFT in way of touch up /repairs
- ◆ Review design detail for windows and dissimilar metals, labels
- ◆ Use of anti-stain paints
- ◆ Review paint spec for hull and decks and gloss retention and life time
- ◆ Waste disposal policy to be agreed with paint companies
- ◆ Rounding of edges on weather decks
- ◆ Weld surface preparation

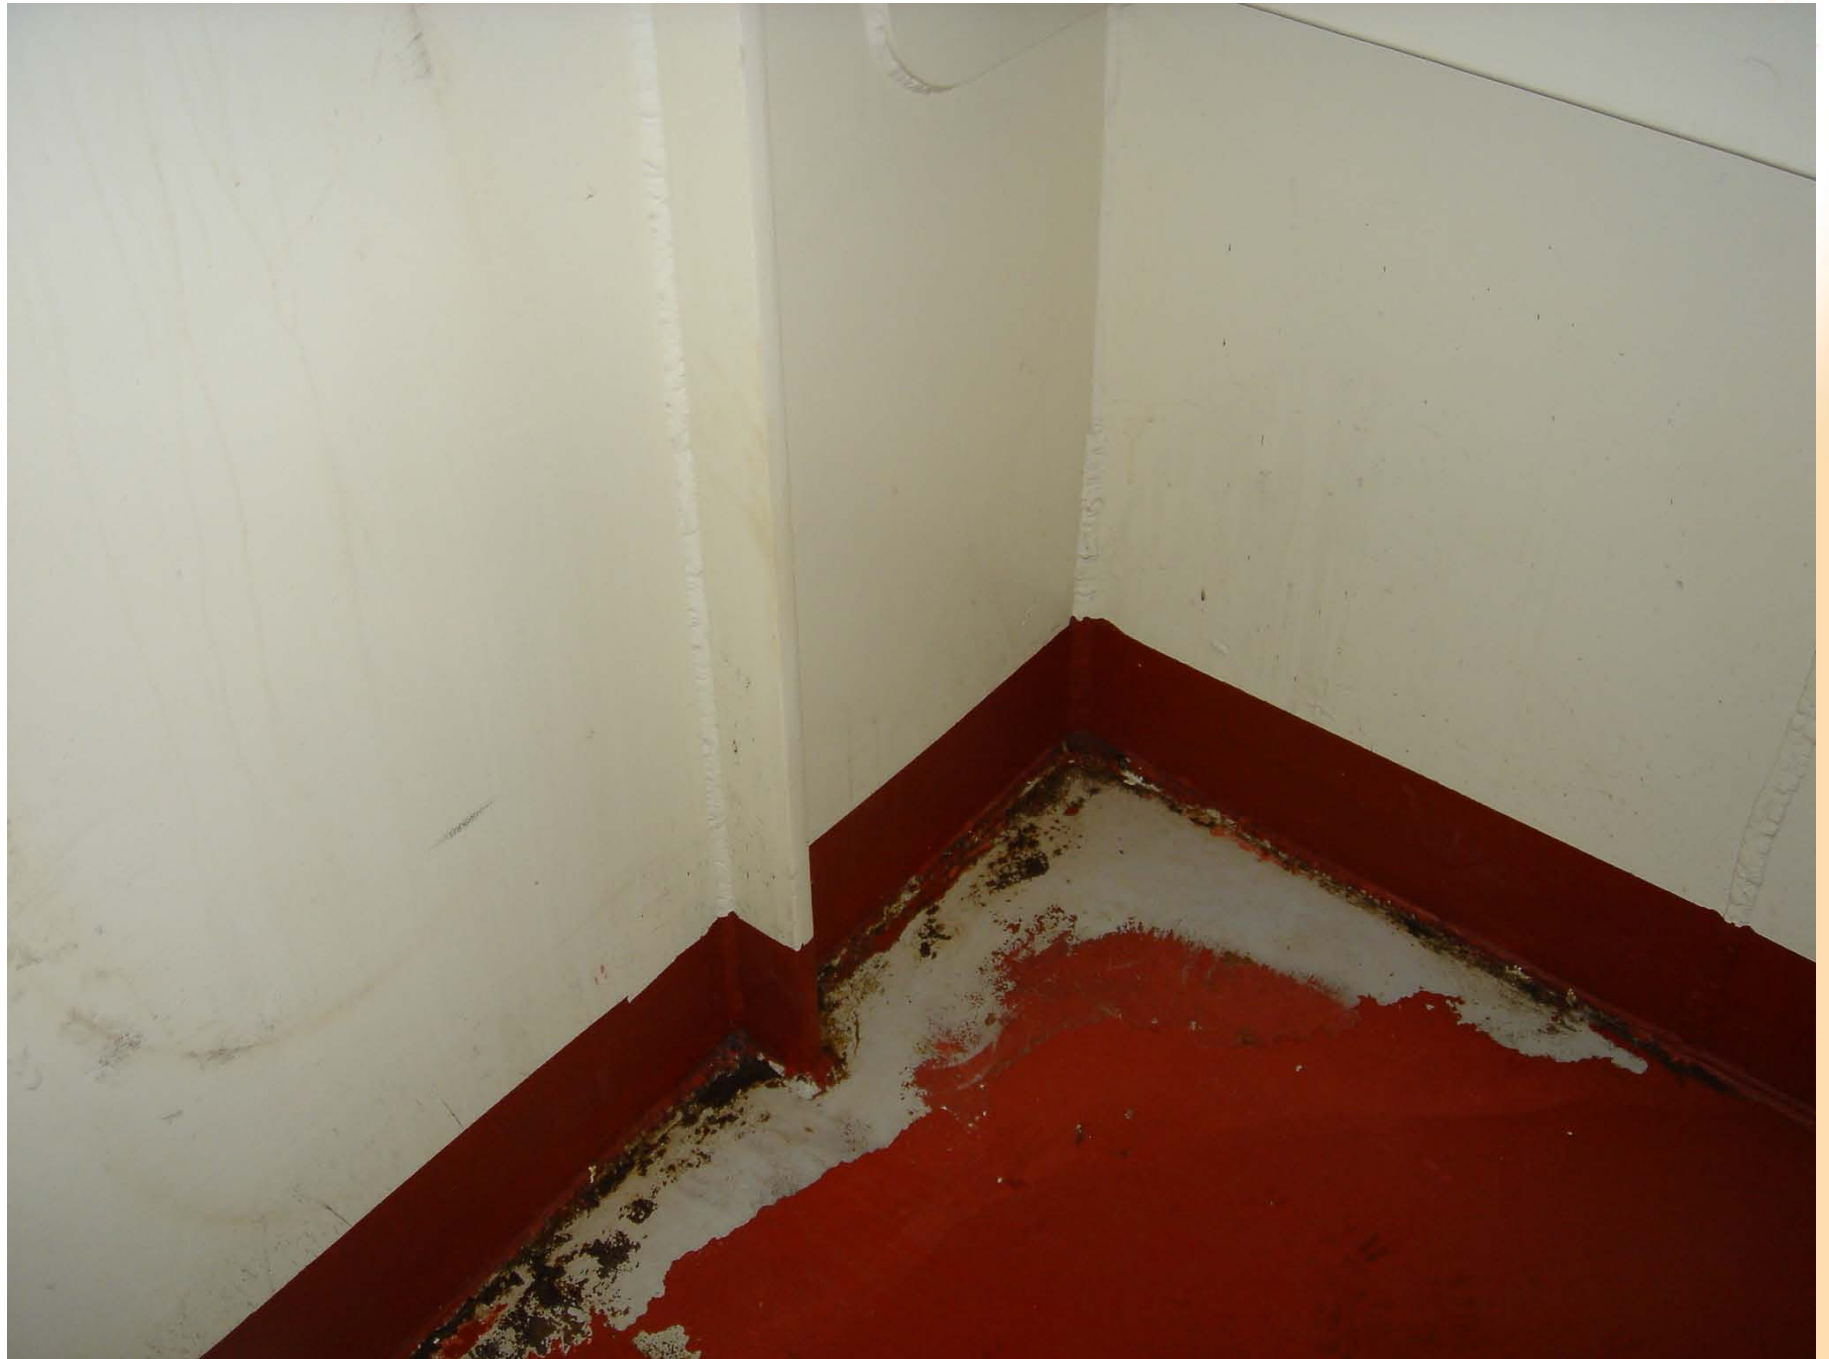
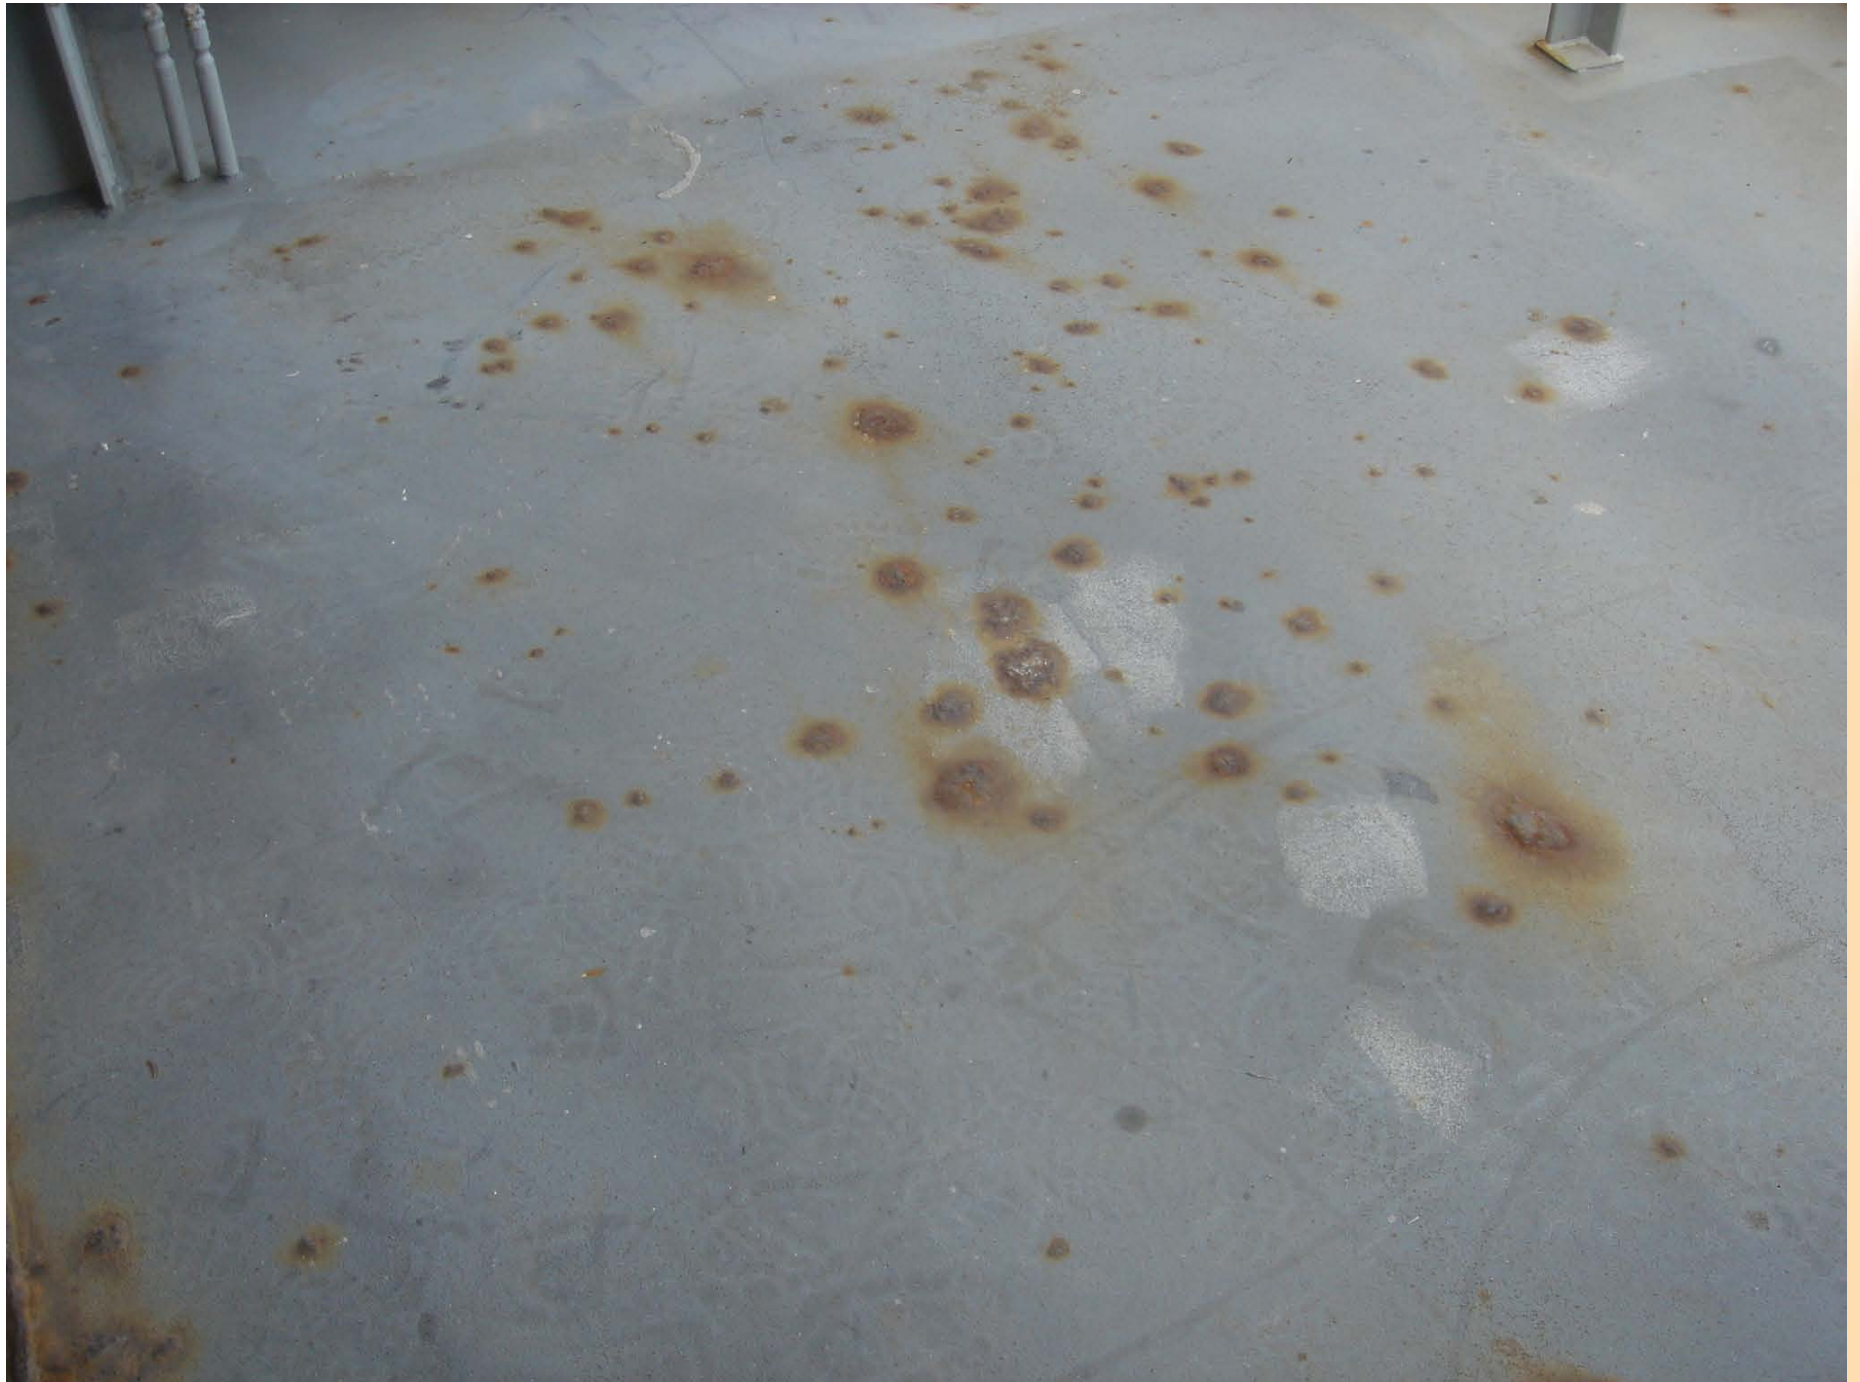
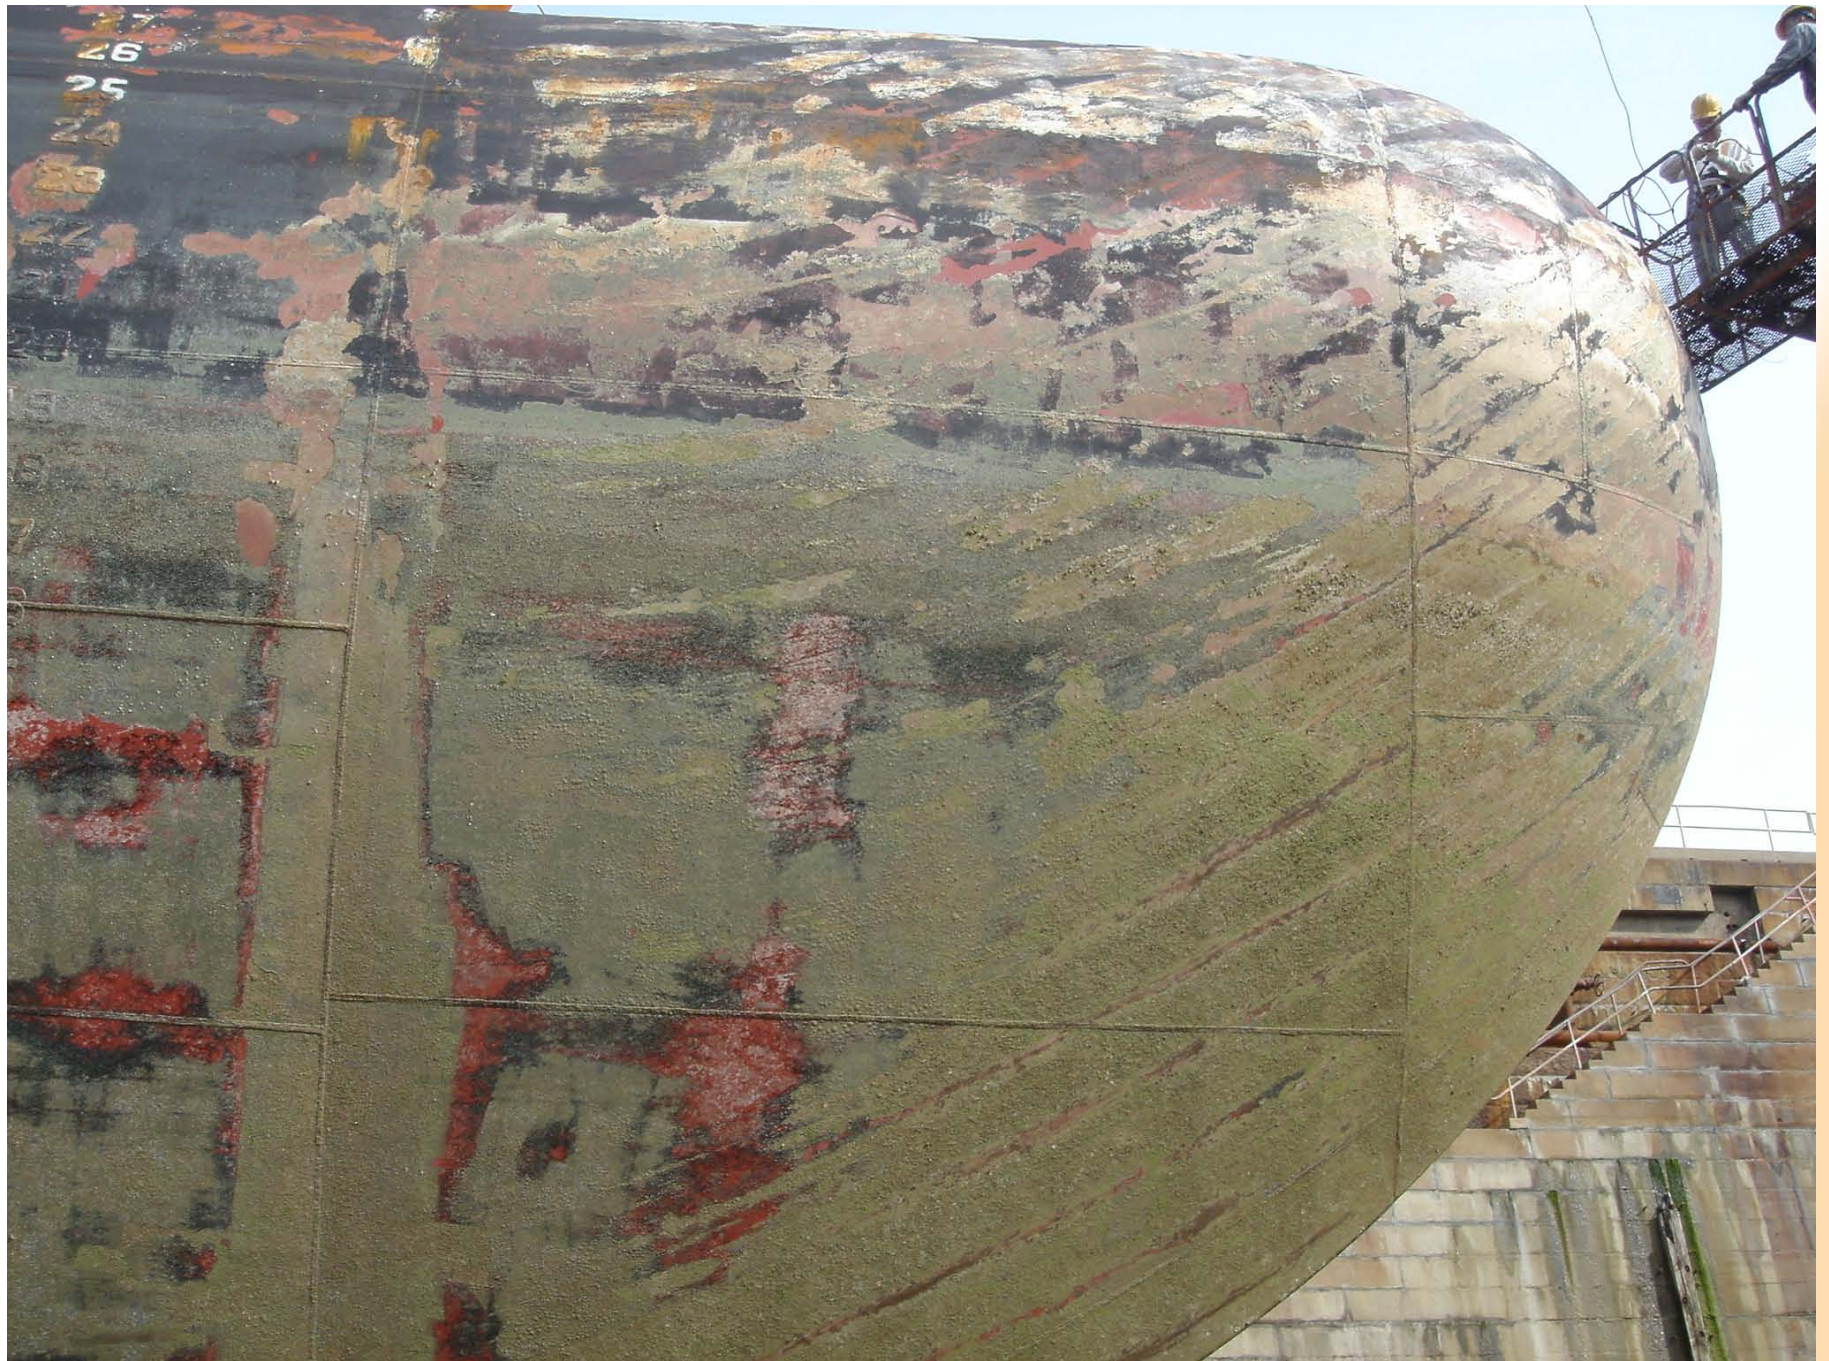
Example Paint Specification

- ✦ Not taking into account the build process and timing
- ✦ Weld seams breakdown
- ✦ Performance on rudders
- ✦ Clover leaf cups/buttons
- ✦ Bow abrasion problems
- ✦ Soot problems
- ✦ Hydraulic oils

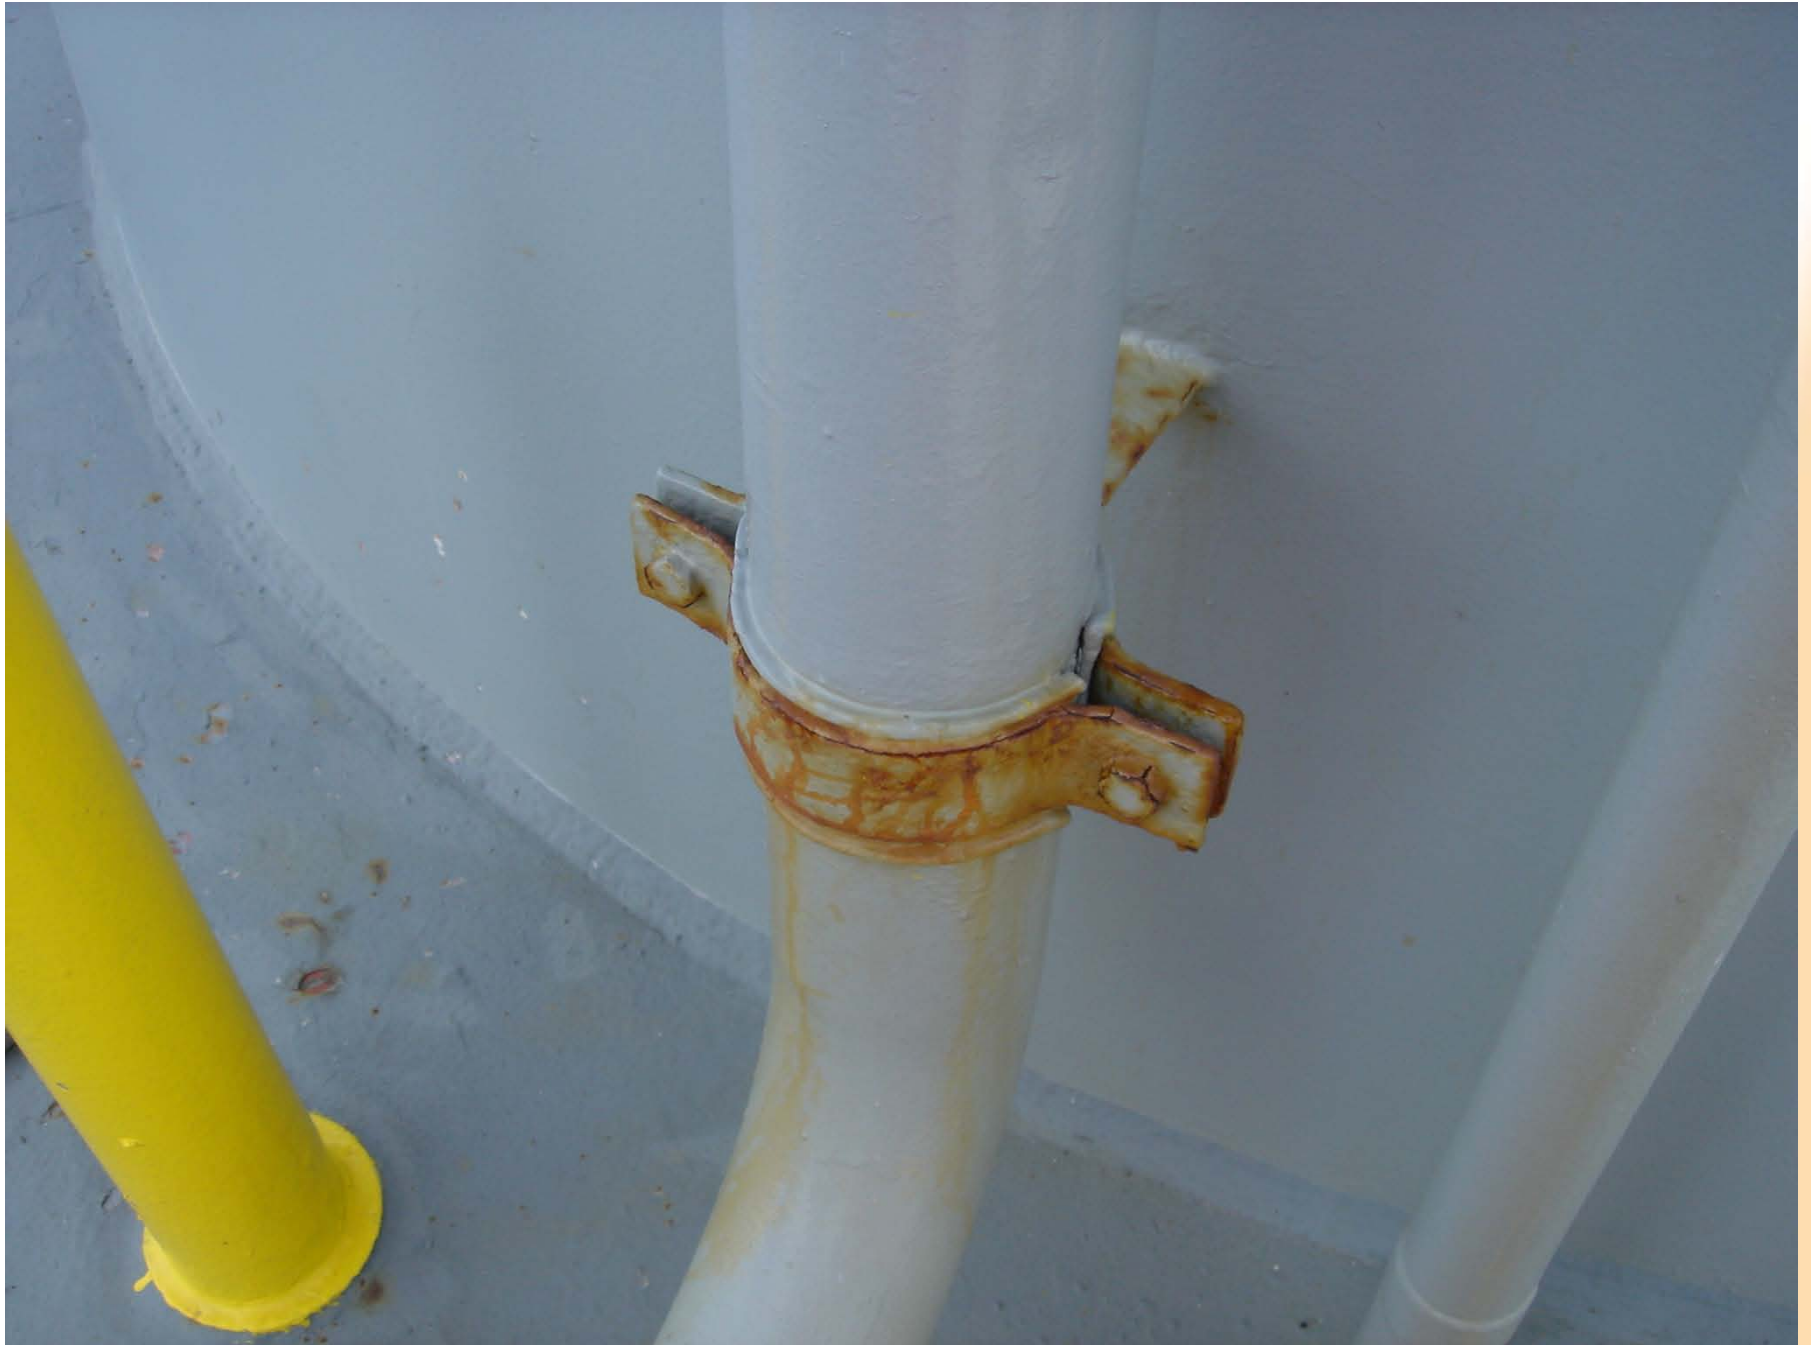
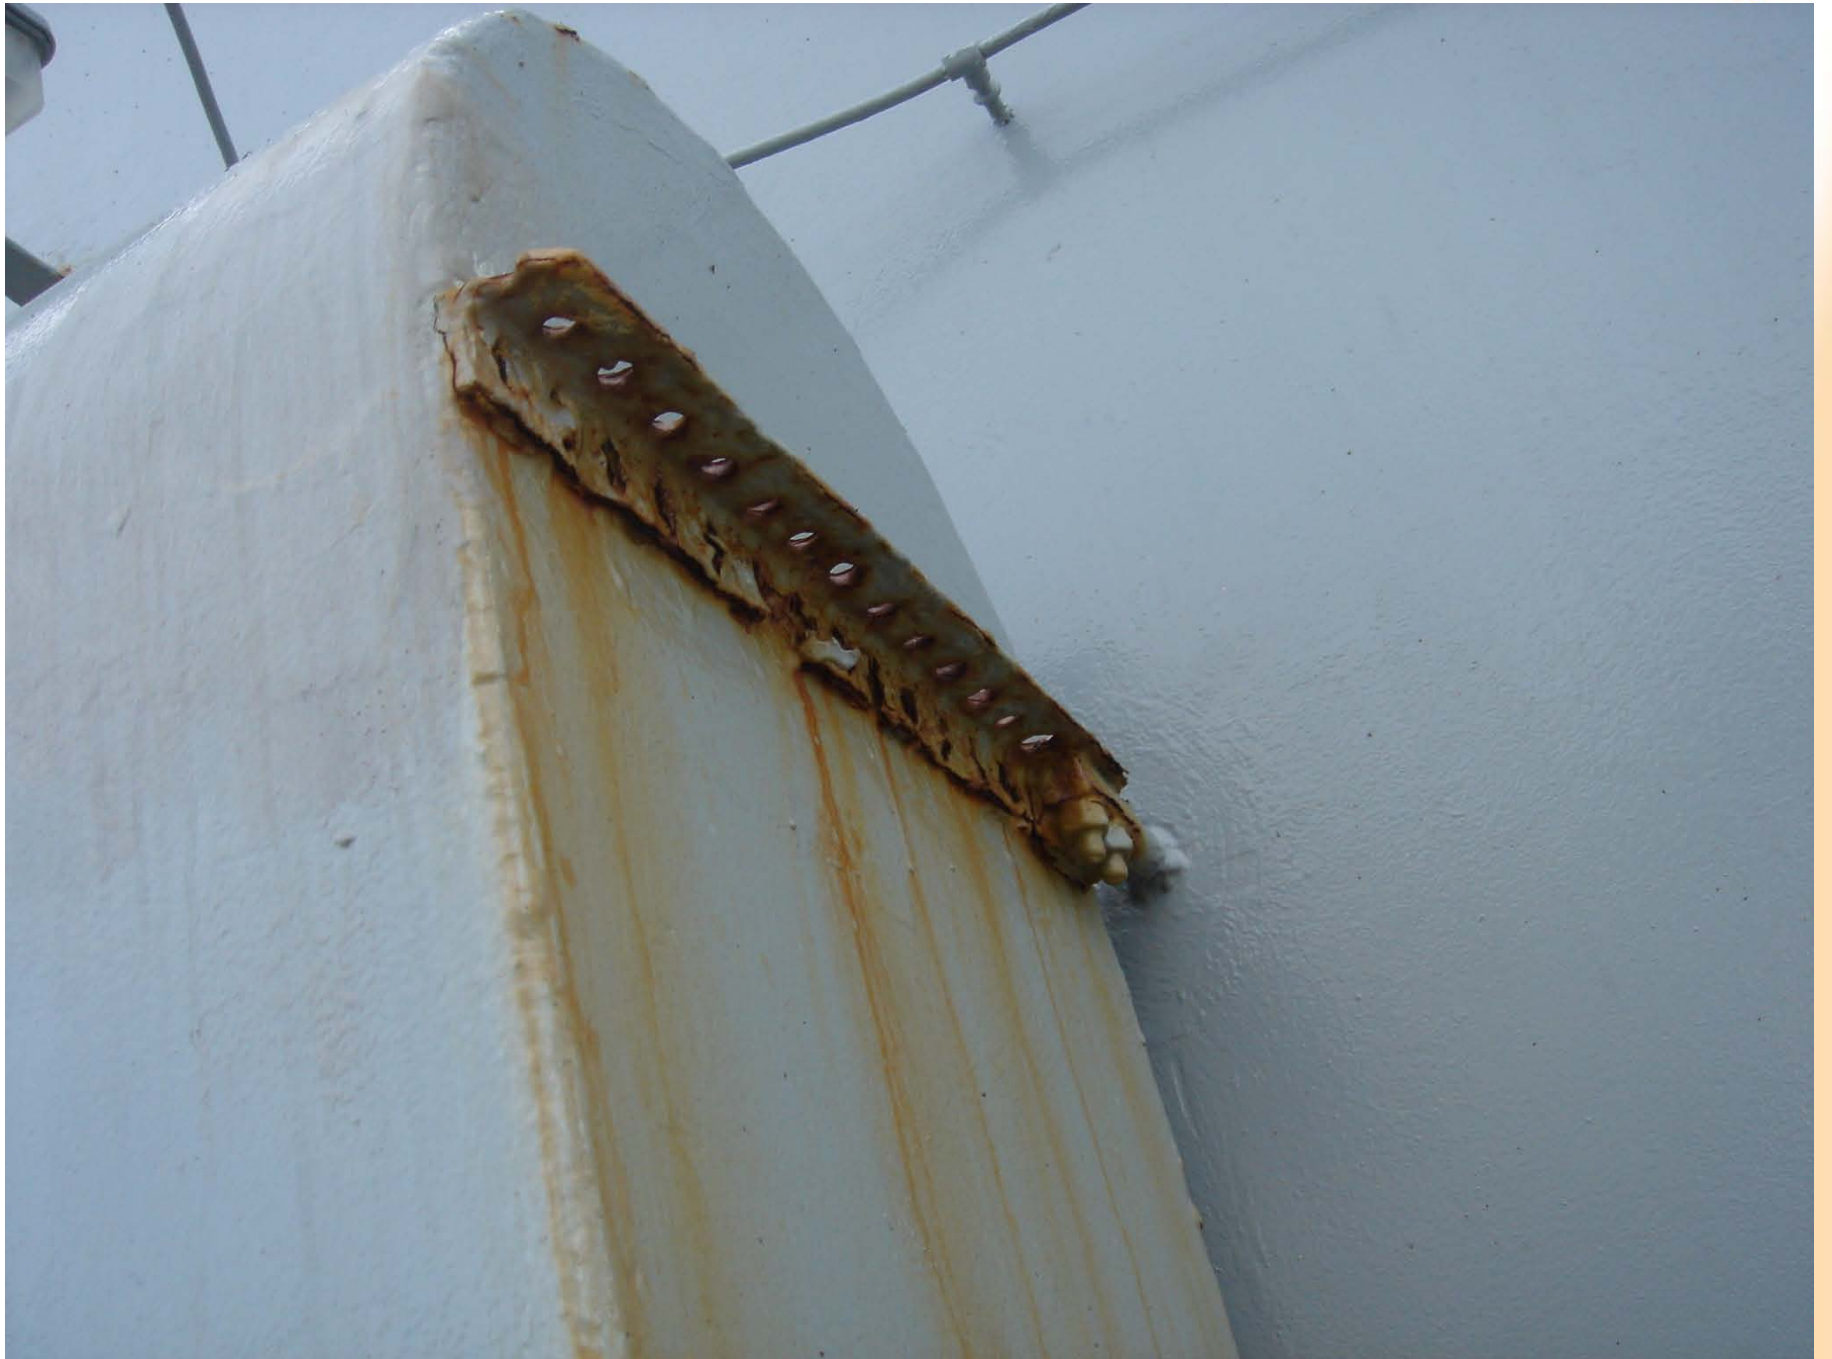
Shipyard process examples

- ✦ Control of DFT
- ✦ Poor integration of coating process into yard activities and schedule control
- ✦ Schedule/programme delays/changes
- ✦ Work sequencing problems
- ✦ As delivered report on coatings, what was put on and where and its status
- ✦ Initial planned maintenance requirements

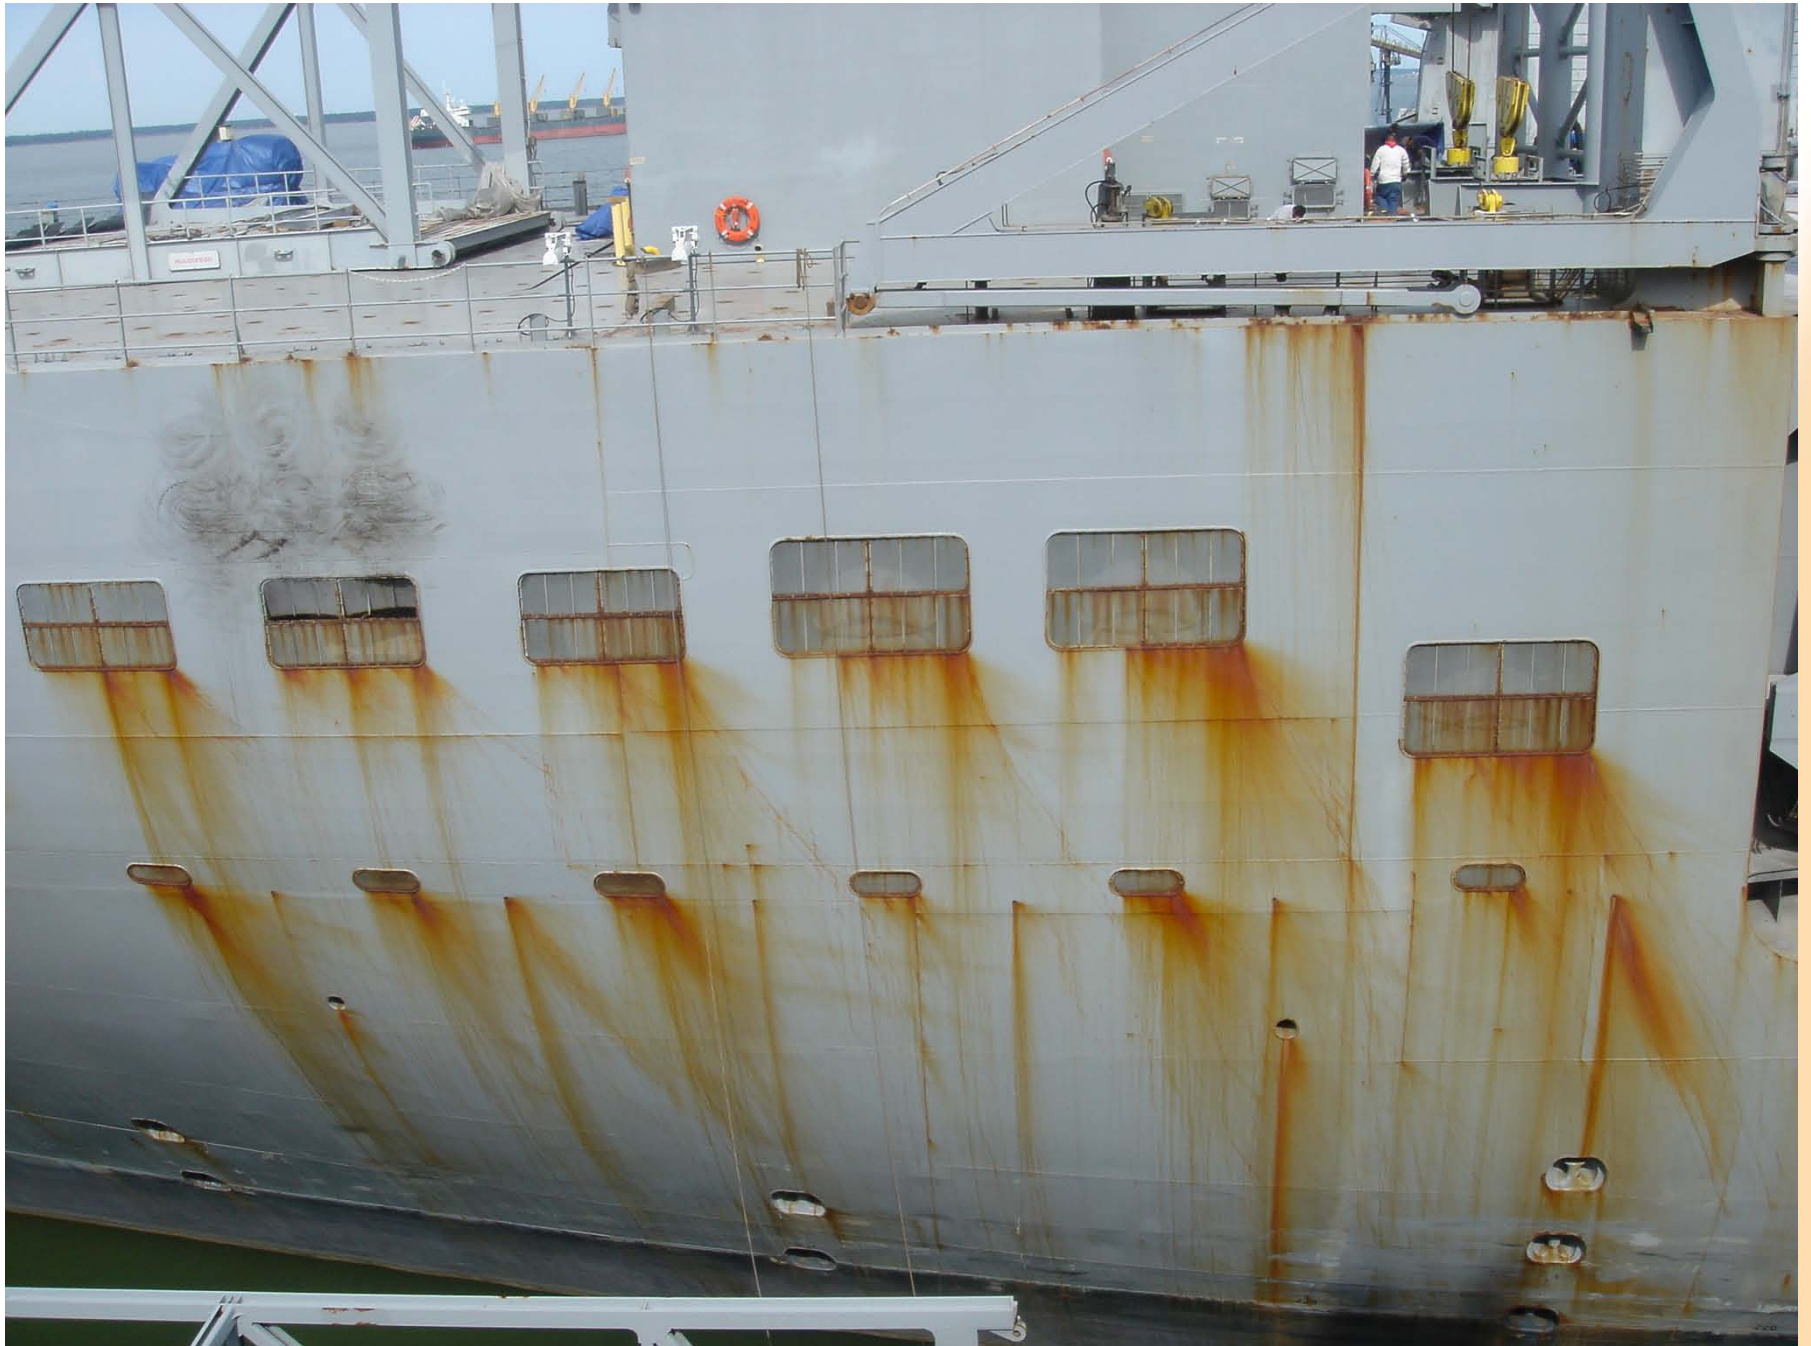
- ✦ GDNASSCO had already applied some lessons learned based on feedback.
- ✦ Other lessons that could have been learned were not available in any systematic format to allow the vessel to be influenced at the design stage.
- ✦ Some lessons learned were not applied for a variety of reasons
 - Edge rounding
 - Source of paint problems on welds
