# Compatibility of “Single Coat” Tank Coatings with Retained Pre- construction Primer

NSRP Surface Preparation and  
Coatings Panel Project Report  
March, 2014

Elzly Technology Corporation

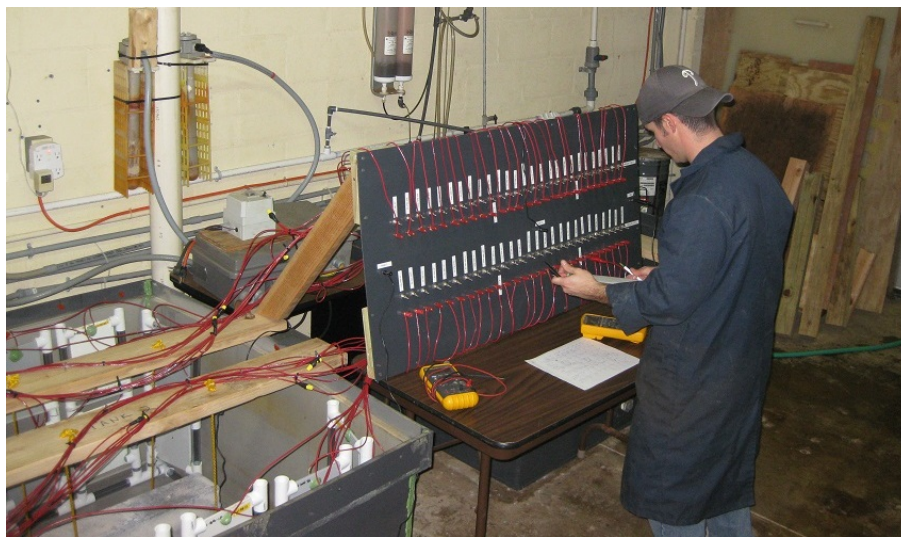
Figure 2. Cathodic disbondment test arrangement.

Figure 2 shows the general arrangement of the testing. Testing was performed in tanks containing continuously refreshed natural seawater. Galvanic current and potential data as well as water chemistry was monitored throughout the test.

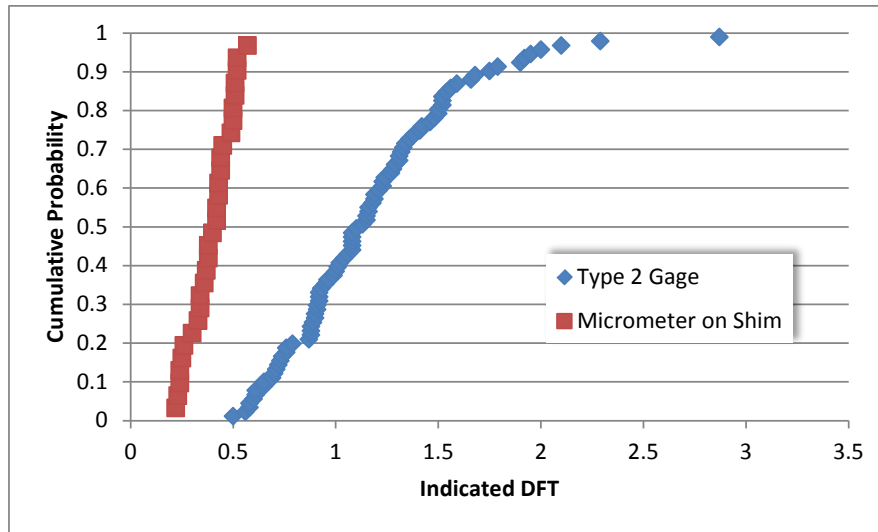
Figure 3. Cumulative probability representation of all PCP DFT measurements.

Pre-construction primer was hand applied to the test tanks using conventional air equipment. The first application resulted in excessive PCP thickness. The PCP was removed by abrasive blasting to SP-10, near white metal blast with steel grit. The average surface profile for each tank (measured with replica tape) was between 2.75 and 3.5 mils. The PCP dry film thickness (DFT) was measured using two methods. Fifteen gage readings were taken in each compartment using a Type 2 electronic gage. The average PCP DFT in each compartment was between 1.02 and 1.24 mils. Because the target thickness is low compared to the surface profile, these readings are likely to be higher than the actual film build. In anticipation of this problem, the PCP DFT was also measured on a transparent film shim, which was placed in each of the tanks. These readings for each tank (made using a micrometer) indicated an average DFT between 0.24 and 0.5 mils. Figure 3 shows all of the PCP measurements in a cumulative probability format.

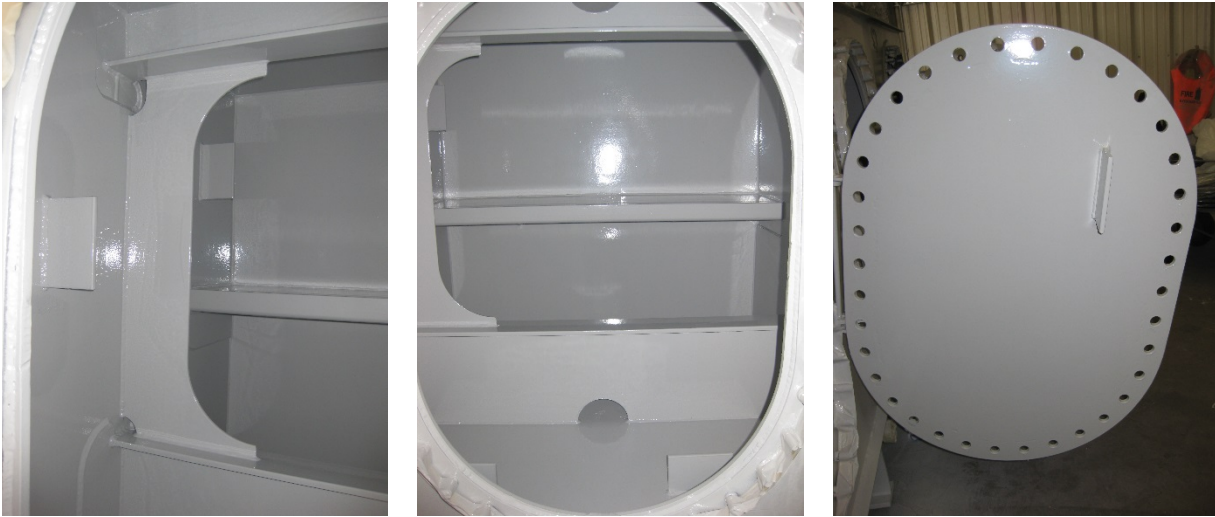
Figure 5. Representative surfaces of simulated ballast tanks with single coat tank coating.

Figure 2 shows representative surfaces of the simulated ballast tanks after the single coat system was applied. Table 8 shows the surface conductivity and profile for each tank after secondary surface preparation. Table 9 shows the average DFT readings after the primary coating was applied to each compartment. After final DFTs were performed, the inspector marked low areas for touch-up. Varying degrees of brush/roller touch was required in each of the tanks. Only two panels required touch-up (along bottom edge).

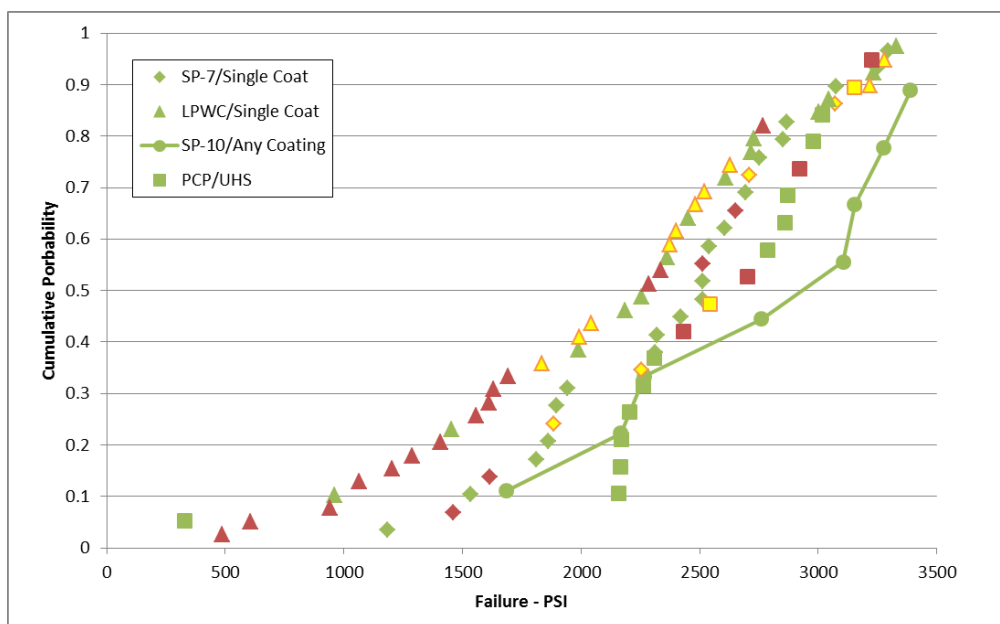
Figure 6. Cumulative probability of as applied pull-off adhesion.

Adhesion tests were performed on unexposed coated test panels after a minimum of 14 days cure. Figure 6 is a cumulative probability plot of the data. Cumulative probability plots express the likelihood in which an observation will be less than or equal to a given value. As an example, the right-most SP-10 data point would conclude that there is approximately an 89% likelihood that the next data point collected will be less than approximately 3400 psi.

The graph shows the distribution of adhesion failure loads for various populations as indicated in the legend. Each shape represents the data set indicated in the legend while the color indicated the plane of failure. For these tests the “interface of interest” is one which involved the pre-construction primer (e.g., substrate-PCP, within the PCP or PCP-primary coating system). Within each population, the red data points predominately failed at this interface of interest (i.e., more than 50% of the failed surface area). The yellow data points had some indication of failure at the interface of interest and the green data points had no failure at the interface of interest. Data sets which result in a line toward the lower right of the graph are indicative of “better” adhesion. Adhesion above 1000 psi is generally considered good for these types of coatings. The data suggest that all of the coatings have good adhesion but there is slightly better adhesion for (1) control coatings over retained PCP (PCP/UHS) and (2) for coatings over a near-white metal blasted surface. For single coat products over retained PCP, brush blasting results in better adhesion than pressure washing.

*Note: within each population of similarly shaped data points, the red data points predominately failed at the PCP-primary coating interface. The yellow data points had some indication of failure at the PCP-primary coating interface and the green data points had no failure at the PCP-primary coating interface.*

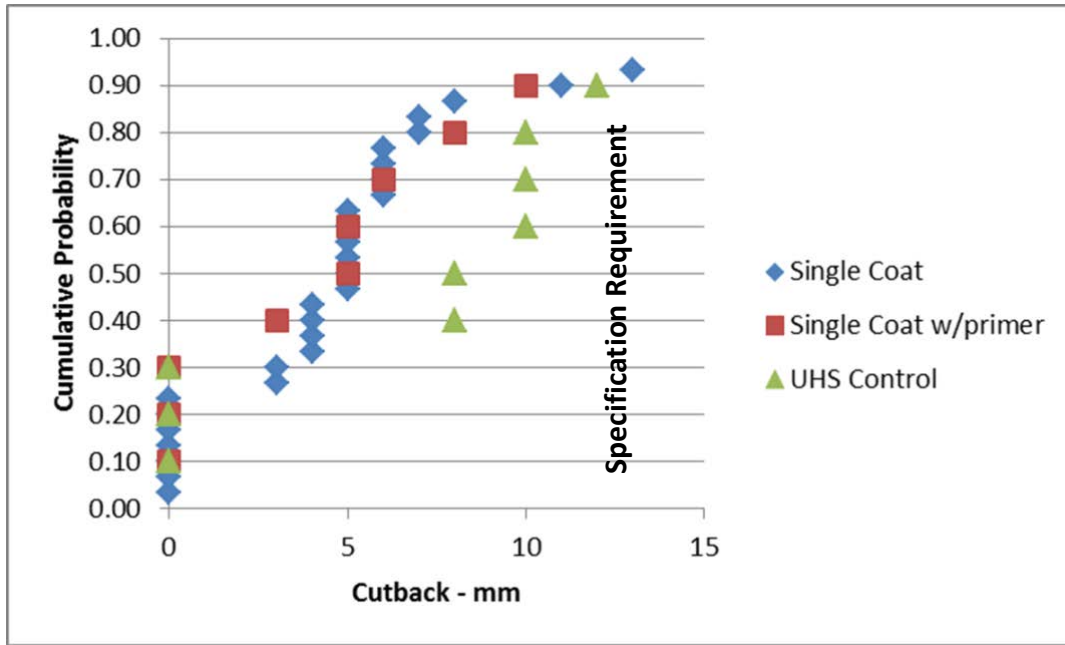
Figure 7. Cumulative probability of cathodic disbondment test results grouped by primary coating system.

Figure 7 presents the cathodic disbondment test results grouped by primary coating system. The data do not suggest any significant difference in performance between the control systems and those with single coat. Figure 8 presents the cathodic disbondment data test results grouped by surface preparation. As mentioned above, it is interesting that the only system to not meet the specification requirement had an SP-10, near white metal blast preparation. However, the remaining systems over an SP-10 surface had minimal undercutting. The system which failed was applied by the coating manufacturer several weeks after the initial surface preparation and it is not known if surface cleanliness was maintained before the coating application.

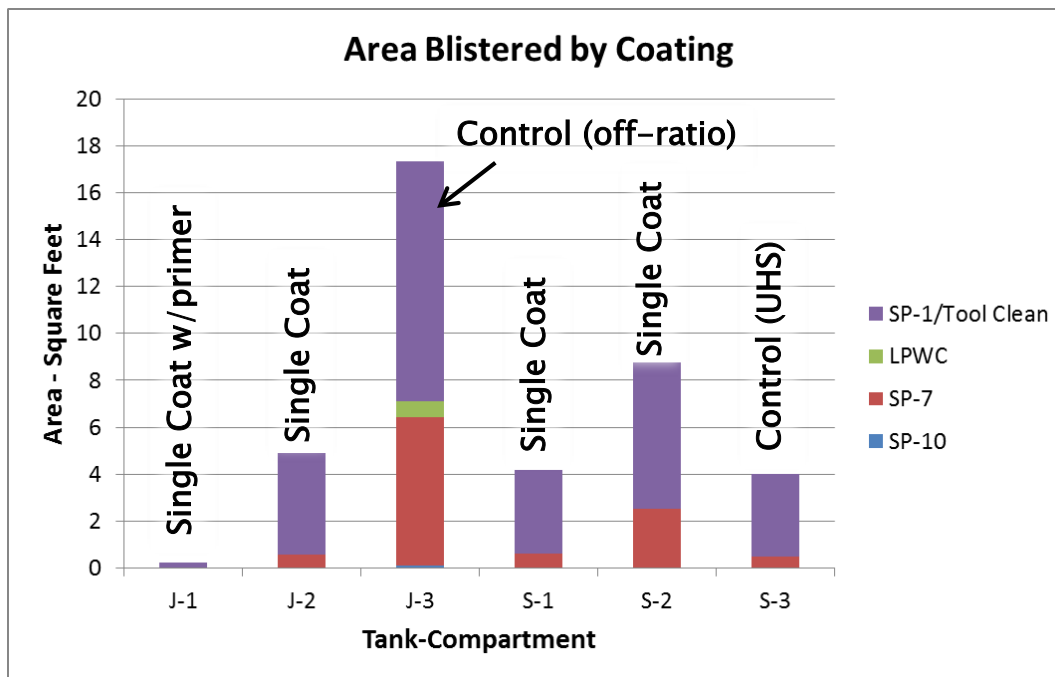
Figure 12. Square footage of blistering observed in simulated ballast tanks after 6 months

Figure 12 graphically shows the square footage of blistering observed by surface preparation and primary coating system. The data show that most of the blistering was observed on the SP-1/power tool cleaned surfaces. The brush blasted surfaces had the next highest level of blistering. Negligible blistering was observed on the pressure washed or near white metal blasted surfaces. The single coat systems had

similar or slightly more blistering than the properly applied control coating (the other control system was suspected to have an off-ratio primer). The single coat system with primer had negligible blistering.

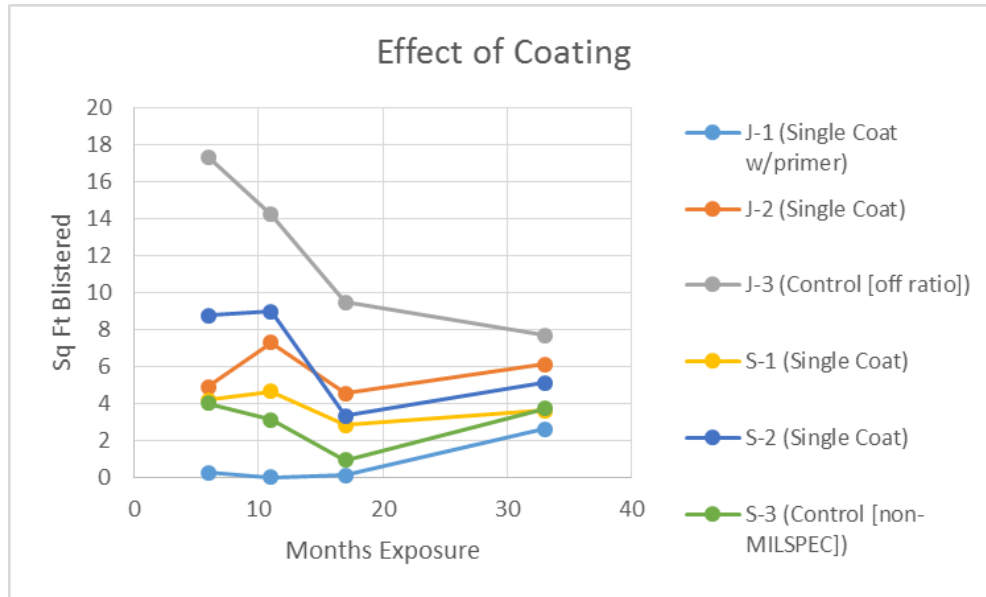
Figure 13. Estimated blistered surface area in each simulated ballast tank over time.

Figure 13 shows the trend of blistered area in each tank over the test period. Note that the drop in blistered area between 12 and 17 months is primarily the result of the repairs that were performed. Also note that it was difficult to accurately measure the area blistered in tank S-3 until the final inspection when the panel rack was removed. The data suggest a comparable extent of blistering for the single coat products and the non-MILSPEC control. The control coating which was inadvertently applied off-ratio had slightly more blistering than the other coatings.

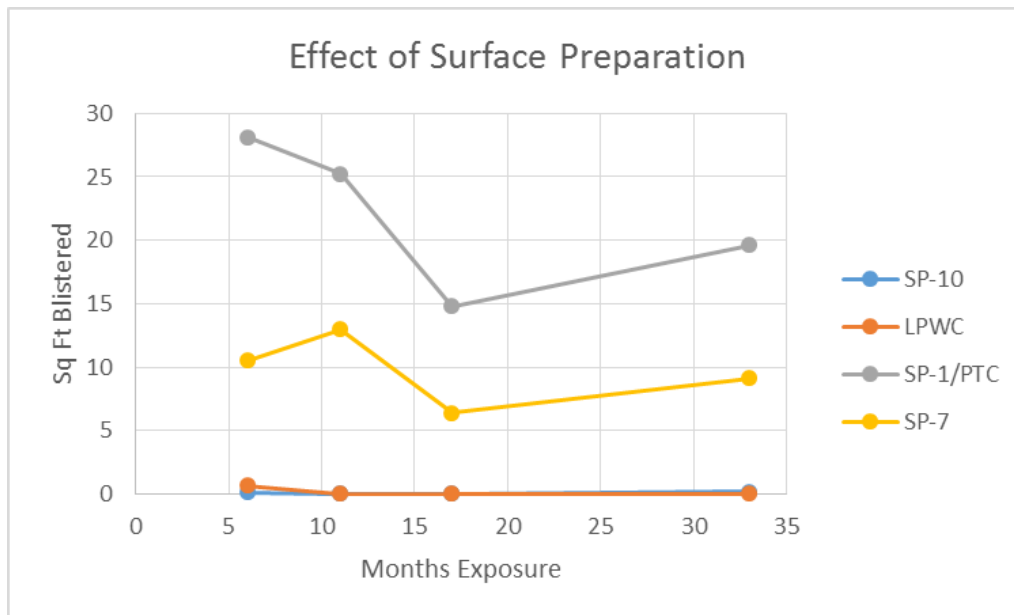
Figure 14. Estimated blistered surface area as a function of secondary surface preparation over time.

Figure 14 shows the trends in blistering as a function of surface preparation. The low-pressure water cleaned surfaces and SP-10 surfaces had negligible blistering. Note that these surface preparation methods were used on smaller areas and did not include horizontal surfaces. The SP-7 surfaces had more blistering and the SP-1/power tool cleaned surfaces had the most extensive blistered area. The changes in blistered area are suspected to simply reflect variation in surface area estimates, though it was noted that some of the repaired area did begin to exhibit blisters. As noted above, no cracked blisters were observed at any of the inspections.

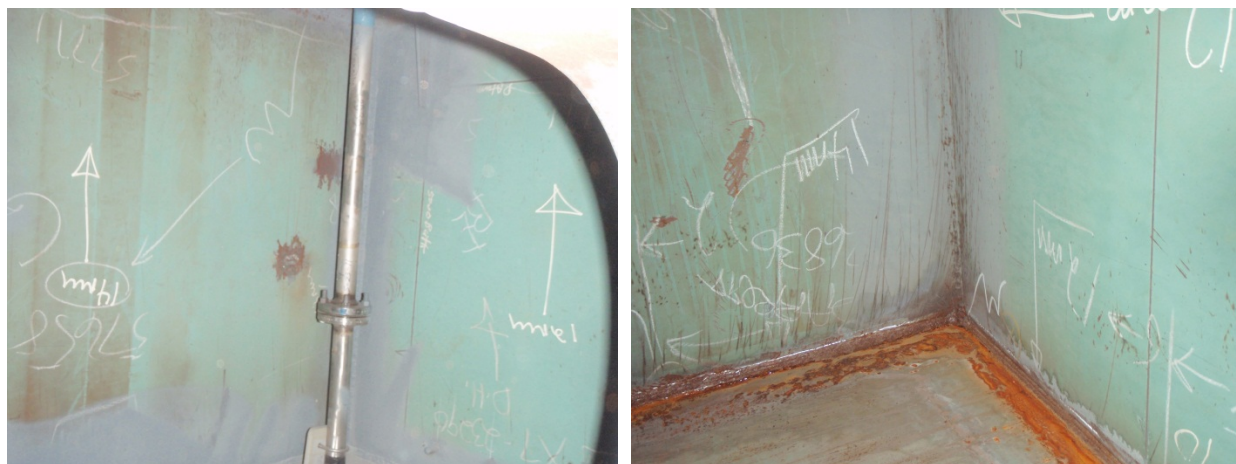
Figure 20. Representative surfaces of 8-85-2-W prior to surface preparation.

condensation occurred. Tank 8-68-1-W also had some corrosion on the floor near the ladder. The steel for these tanks was initially primed with Interplate 997 approximately 18 months prior to this coating application. Figure 20 shows representative tank surfaces prior to blasting.
