Fiber Optic Tester with Go-No-Go Acceptance Criteria – Final Report

Place of Performance: KITCO Fiber Optics
5369 Cleveland Street
Virginia Beach, VA 23462

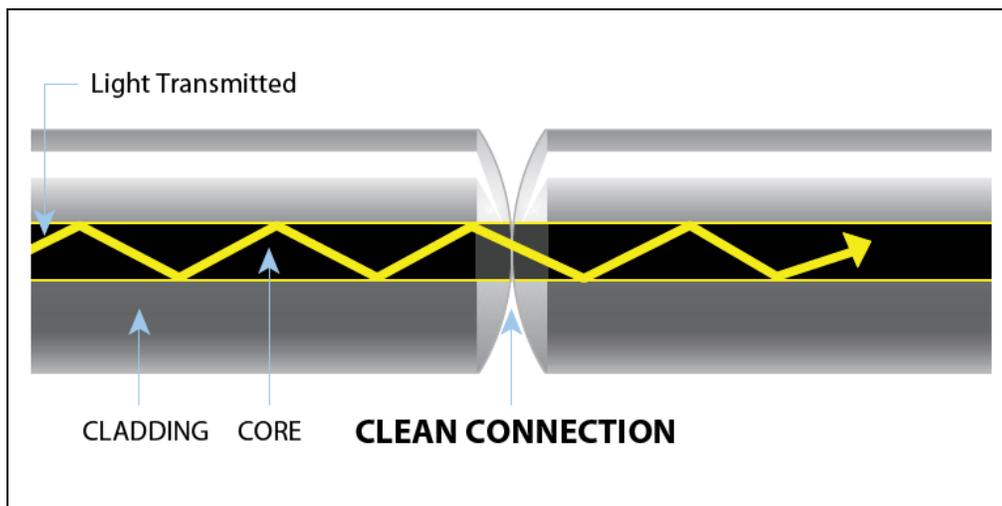
Figure 3 – Proper Fiber Connection

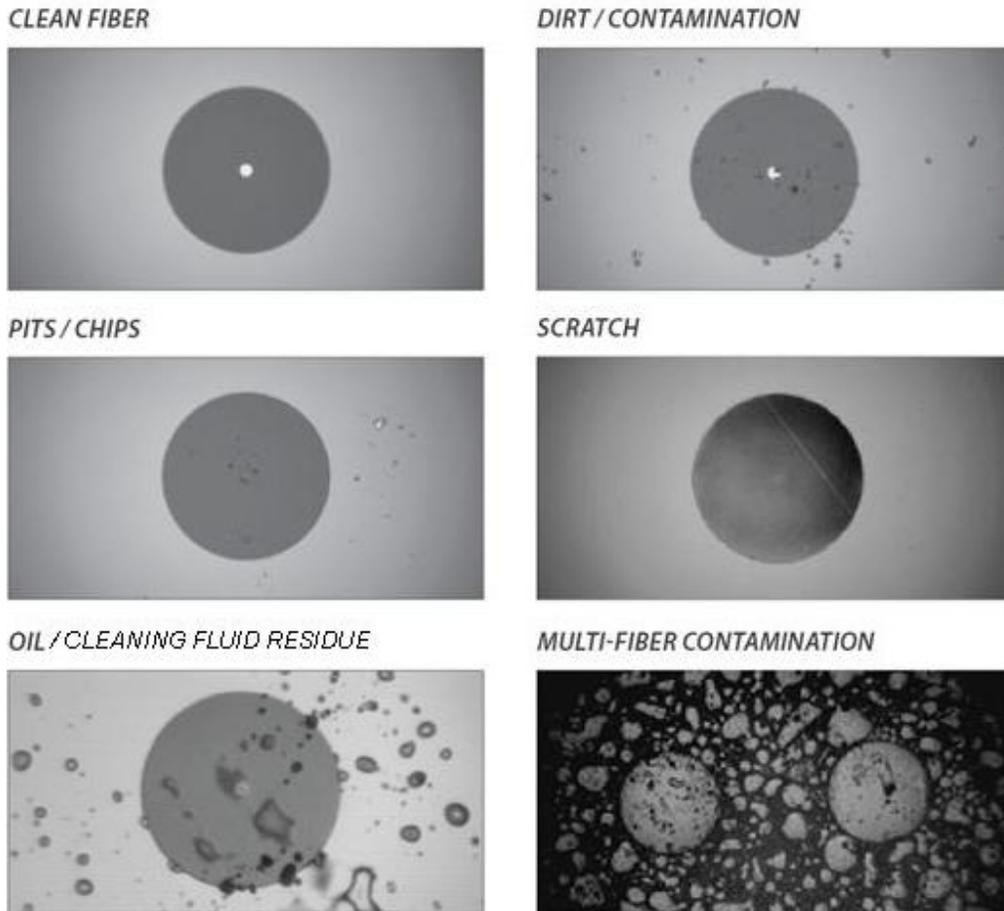
Figure 6 – Fiber Connection and Various Connector Endface Views

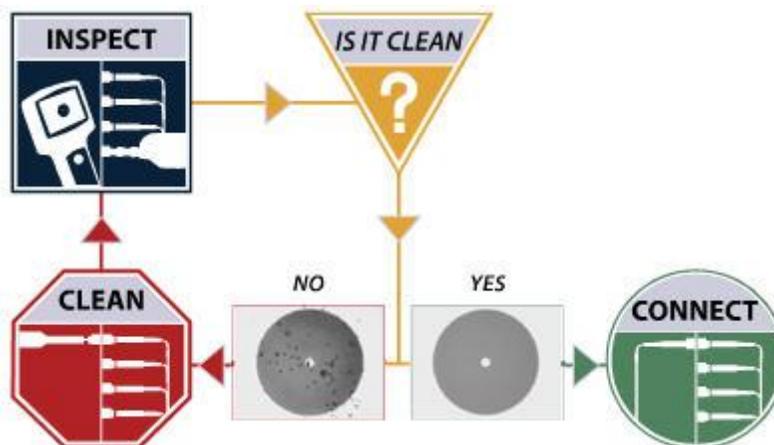
Figure 9 – Optical Connector Inspect/Clean/Connect Process

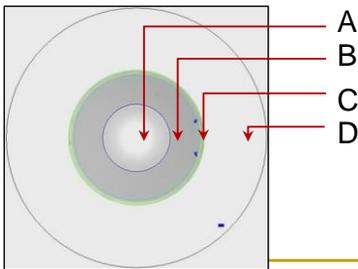
ZONE NAME	SCRATCHES	DEFECTS
A. CORE (0–66 μ m)	No limit \leq 3 μ m 0 > 3 μ m	No Limit \leq 2 μ m 10 \leq 5 μ m None > 5 μ m
B. CLADDING (66–110 μ m)	No limit \leq 3 μ m 0 > 3 μ m	No limit < 10 μ m None > 10 μ m
C. ADHESIVE (110–135 μ m)	No limit	No limit
D. CONTACT (135–250 μ m)	No limit	None \Rightarrow 20 μ m

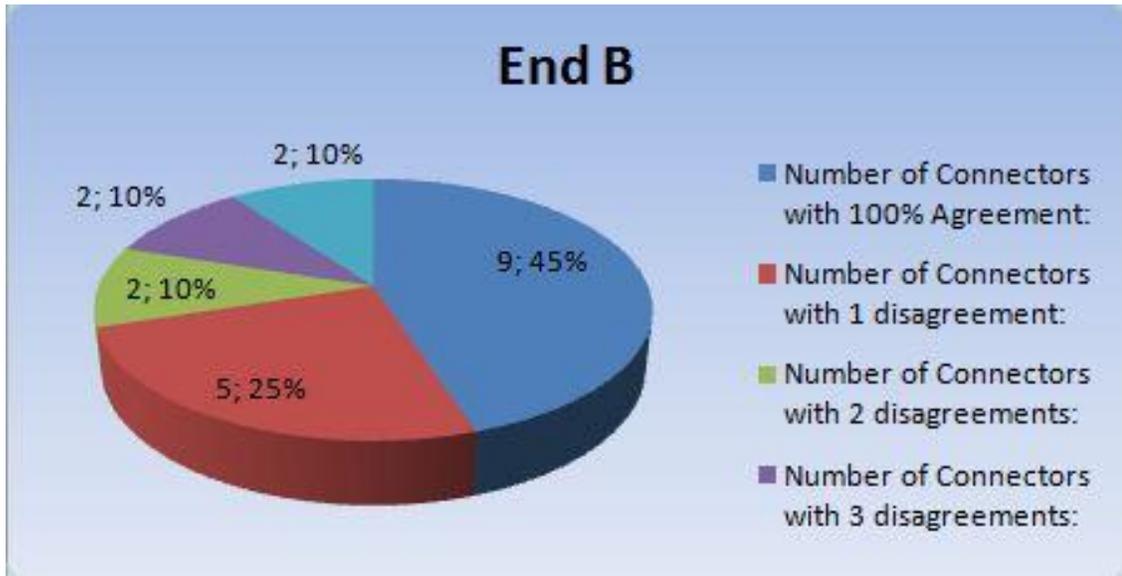
Figure 18 - End B Test Summary

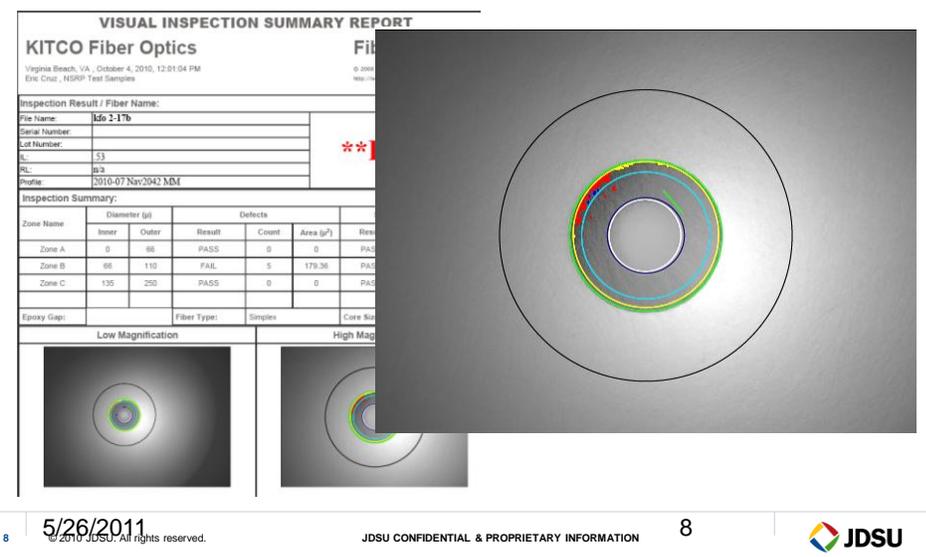
Figure 20 – KFO 2-17B Test Image

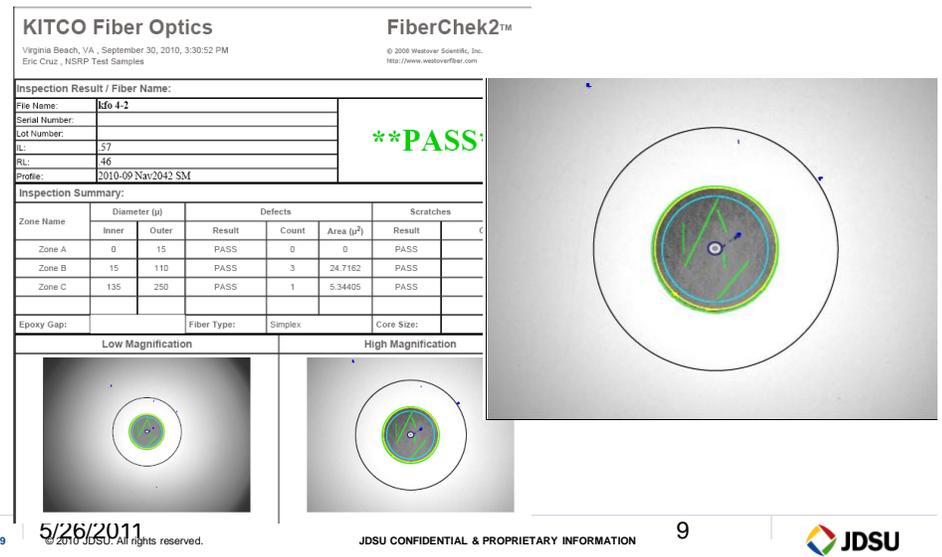
Figure 21 - KFO 4-2A Test Image

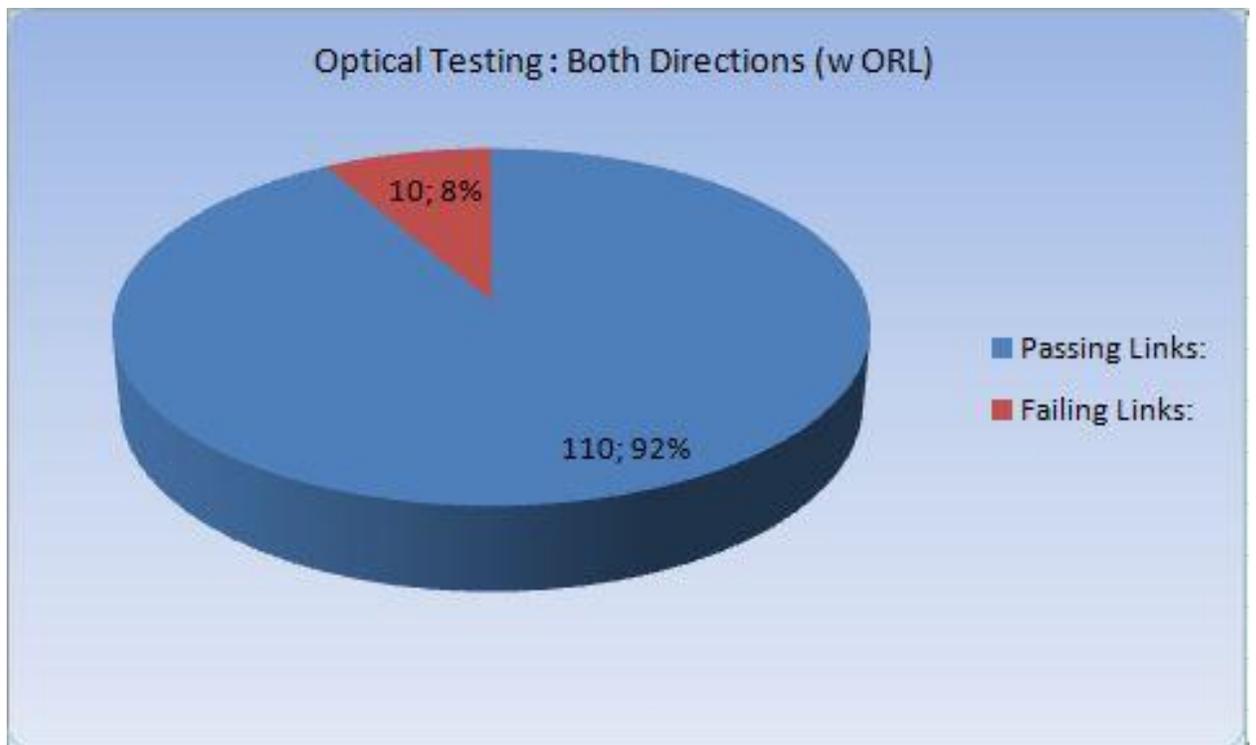
Figure 22 - Combined Optical Testing Results

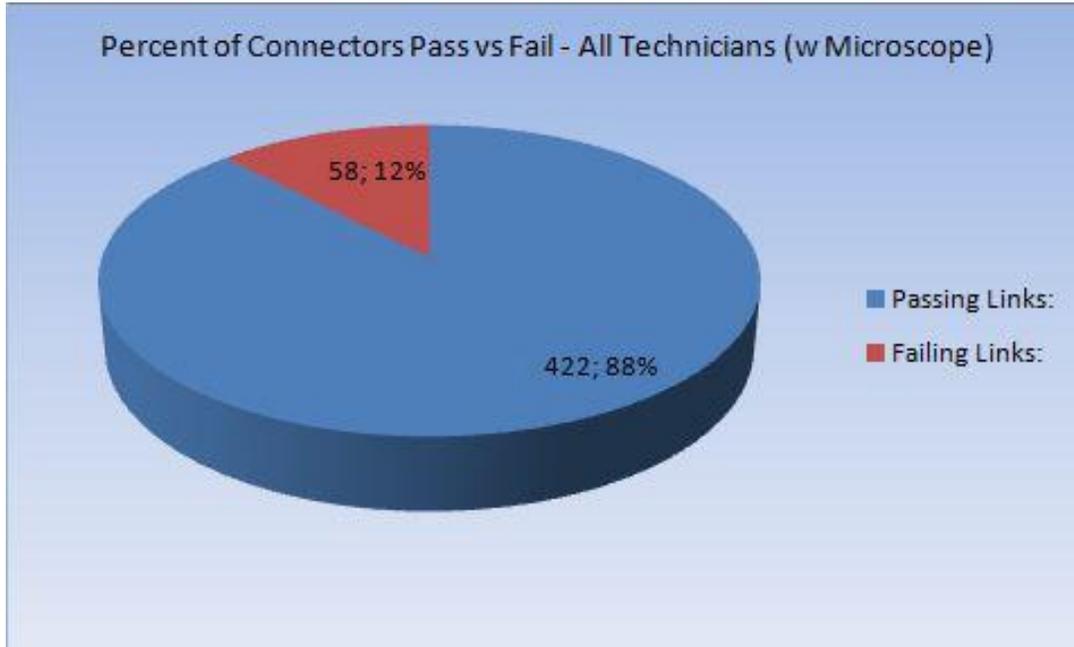
Figure 23 - Combined Visual Inspection Results (w Microscope)

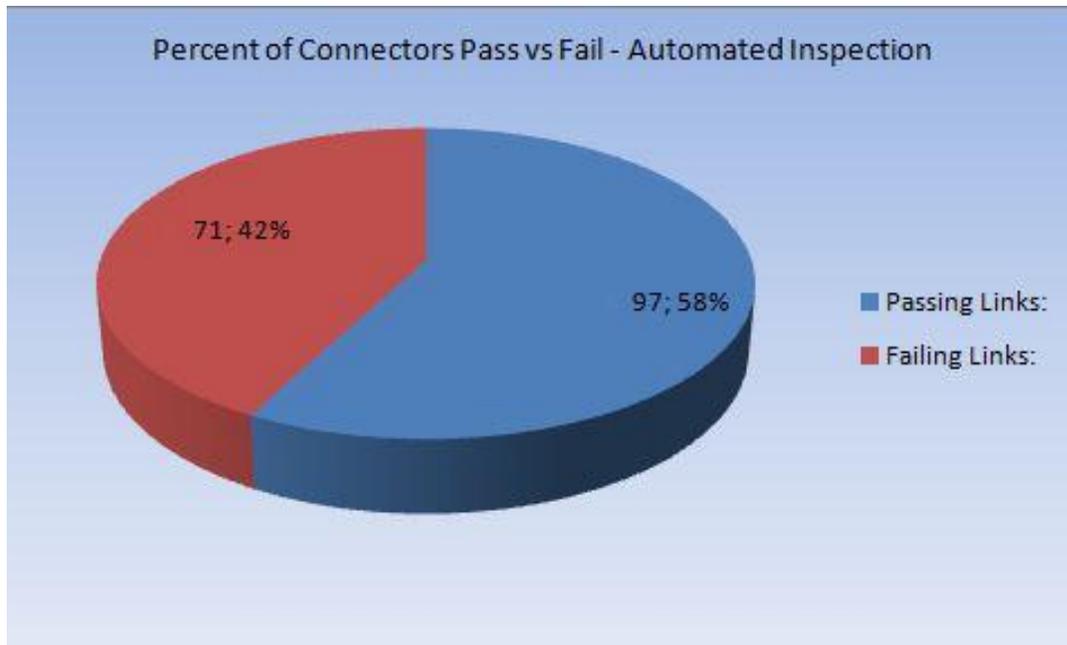
Figure 24 - Combined Visual Inspection Results - (Automated Inspection)
