# Retention of MIL-PRF-23236 Type VI Epoxy under UHS Epoxy

Subcontract Agreement 2017-417

## Final Report

Rev A – April 15, 2019

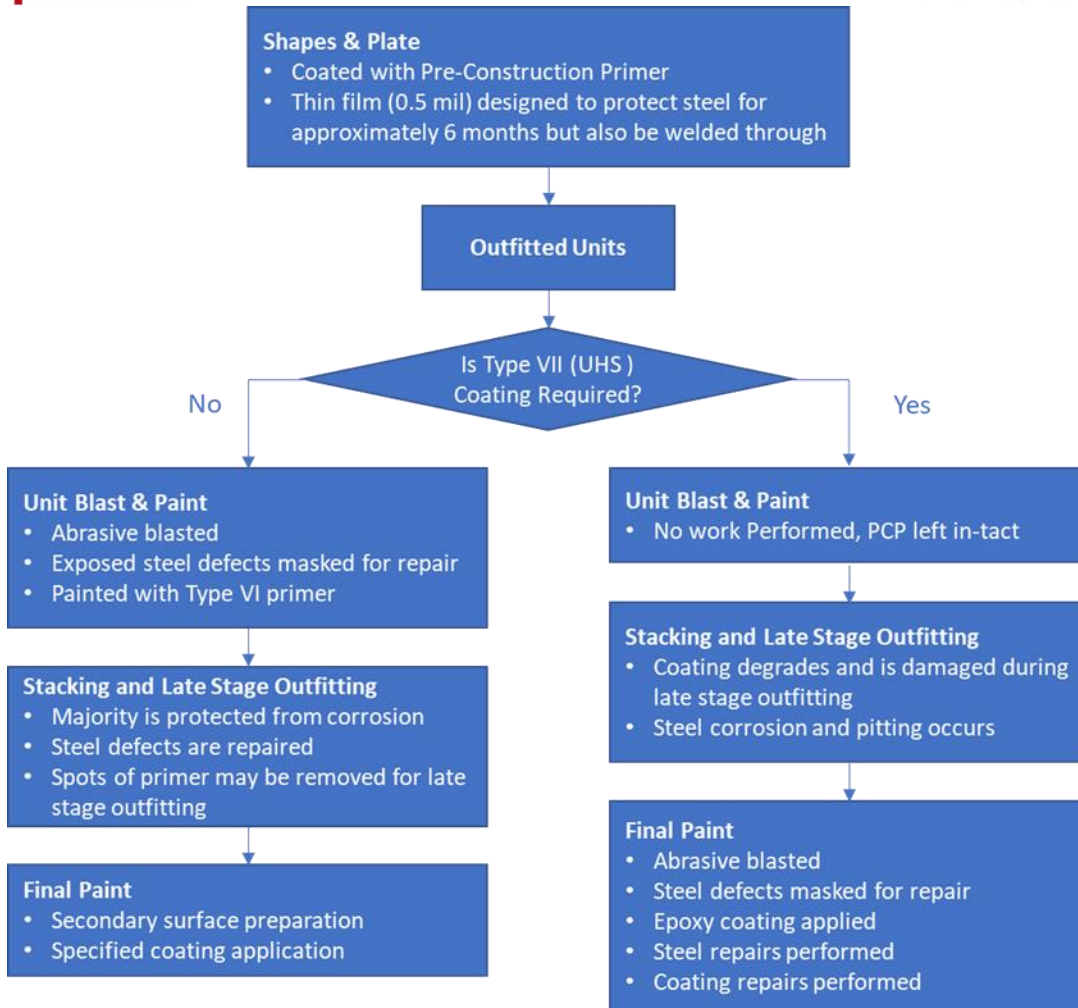
**Figure 1. Coating Application Sequencing During Shipbuilding**

Figure 1 schematically illustrates how protective coatings are integrated into the shipbuilding process. The detailed procedure at any particular shipyard may vary, but in general the process begins with steel plate and shapes protected by a thin (0.5-mil) PCP. The plate and shapes are welded together to form panels and the panels are welded together to form units. These units are then outfitted to the greatest possible extent before proceeding to a blast and paint facility. The PCP is damaged during fabrication and outfitting up to the unit stage, but corrosion is minimal in part due to the relatively quick progression of work and the ability to perform most of the work in a somewhat sheltered location.

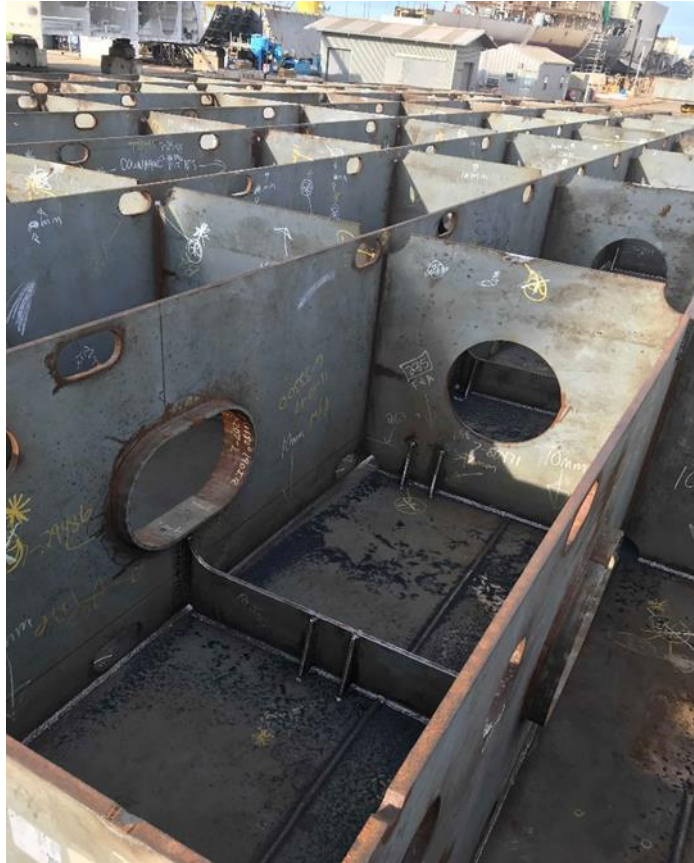
**Figure 2. Degradation of PCP coated surfaces during unit construction.**

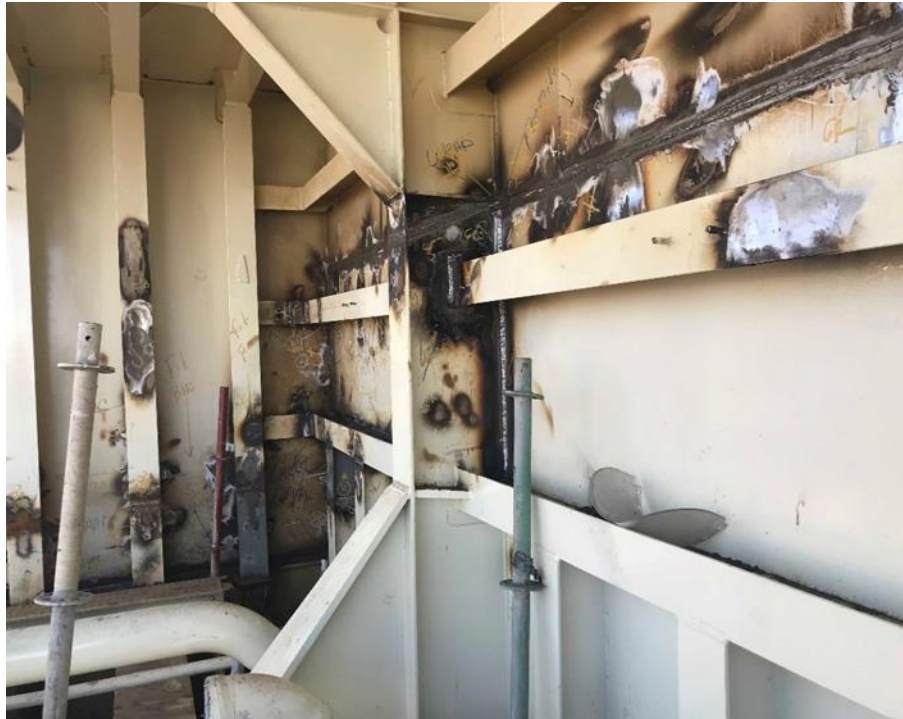
MIL-PRF-23236 Type VII (UHS) primers are *not* well suited to application at the unit stage. These coatings have a shorter pot life and high viscosity which make them more difficult to apply. They generally end up being applied at dry film thicknesses up to 10 mils, making them difficult to remove if required for subsequent outfitting or hot work. Construction damage to UHS coatings from unplanned work, such as heat straightening, increases rework costs. Figure 3 illustrates the type of damage which occurs to UHS coatings. Repairs at this point produce patchwork coating systems and decrease delivered quality. In addition, the coatings tend to char more extensively than Type VI coatings, increasing the amount of coating damage during hot work. Because of the challenges, spaces requiring UHS coatings are commonly left coated with PCP until late stage outfitting is completed. This results in more steel corrosion as the PCP breaks down and emergent hot work identified during abrasive blasting late in the build cycle.

**Figure 3. Hot Work Damage to Type VII (UHS) Epoxy.**

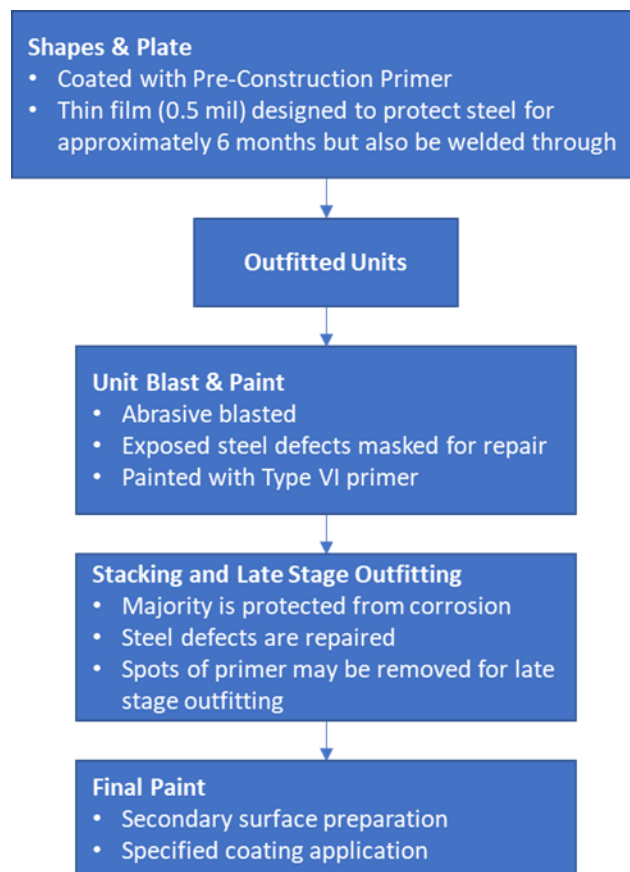
**Figure 4. Desired Future Integration of Coating Work Into the Shipbuilding Process.**

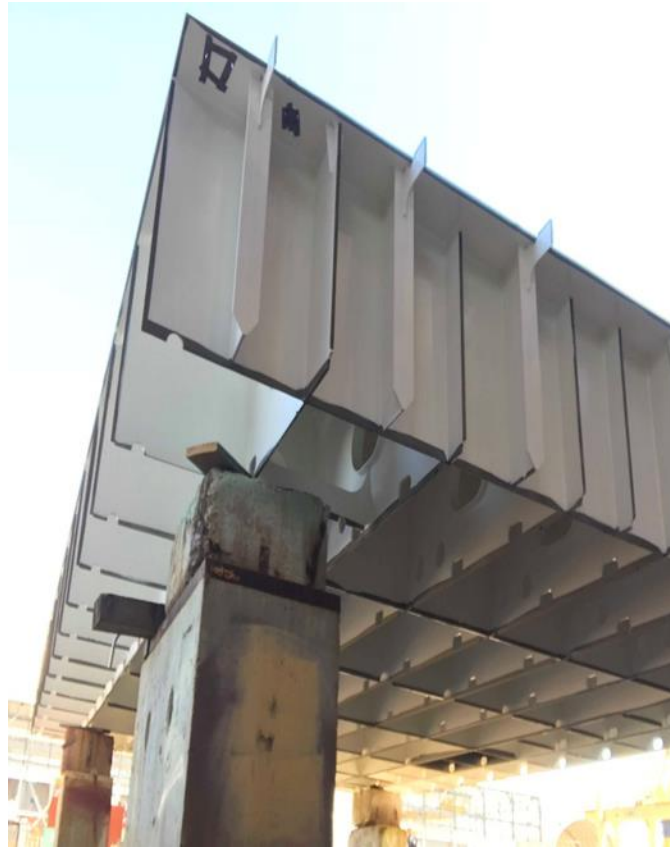
Figure 5. Unit After Coating with Type VI Primer in Blast and Paint Hall.

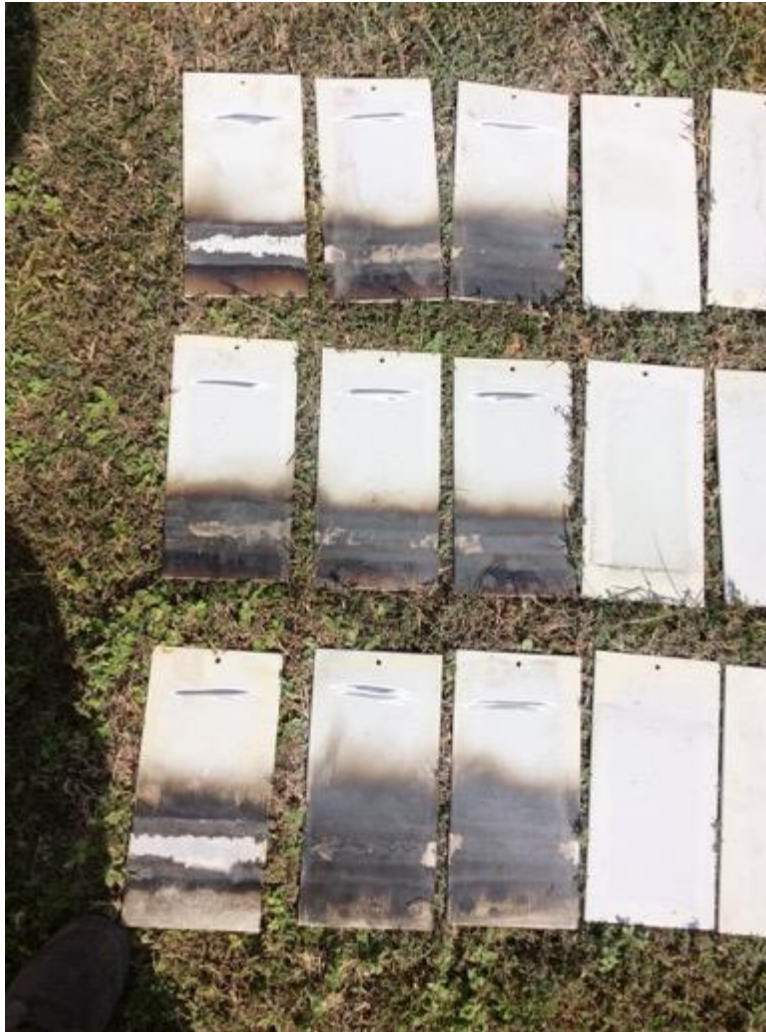
Figure 3. Panels Weathering

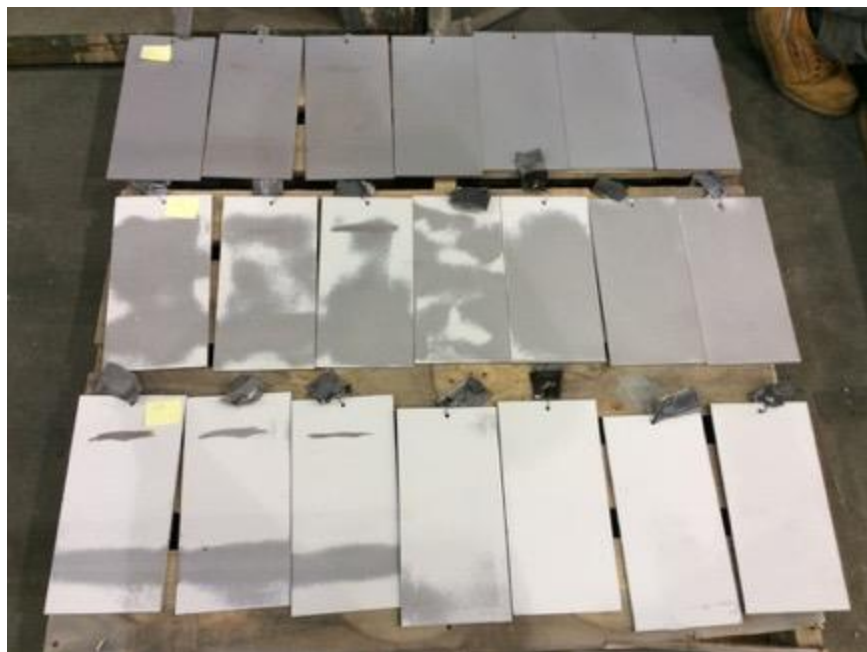
The test panels were visually inspected after surface preparation for conformance with the specified degrees of cleanliness. Special attention was taken to ensure all edges were properly feathered and surfaces were properly abraded to the desired standard. Figure 5 shows panels after the surface preparation during application at Ingalls.

**Figure 5. Panels after Surface Preparation**

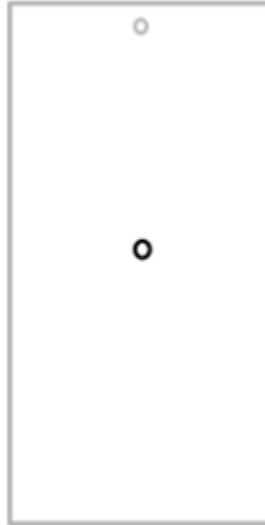
This test was performed in general accordance with section 4.5.16 of MIL-PRF-23236D. Duplicate test panels for each condition in the test matrix were electrically connected to a commercial magnesium anode conforming to ASTM G8<sup>3</sup> and had a 0.25-inch (nominal) hole drilled through the coating to the metal at the center of the test panel. Figure 10 shows a representative photo for this test.

**Figure 10. Representative Photo of CP Test Panels**

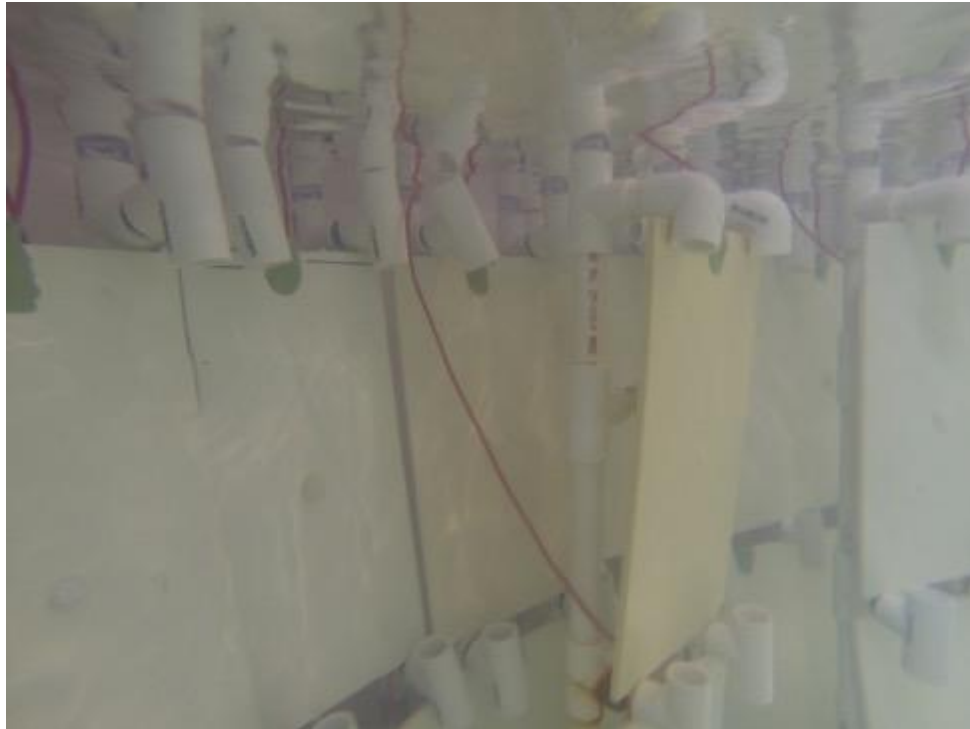
At the completion of the testing, each panel was photographed and inspected for peeling, flaking, blistering, dissolving, or other failures. Lifting, peeling, or undercutting around the drilled hole was measured and recorded. Section 3.5 of MIL-PRF-23236D states that undercutting or peeling shall not exceed 4 percent of the area of the test panel and that all undercutting and peeling shall be located within ½-inch of the holiday. However, for the purposes of this test the relative performance of the various coating systems was used to determine suitability of alternative coating scenarios.

Figure 11. Panels in CD Testing

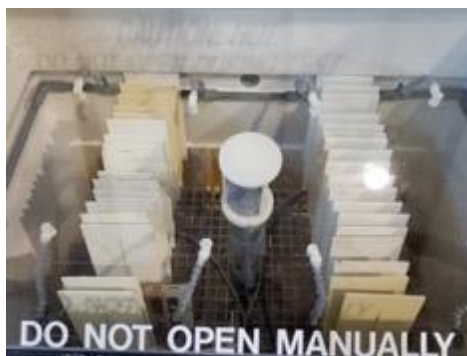
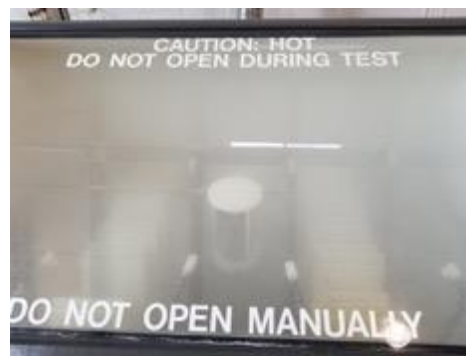
Prohesion cycle testing was performed in accordance with ASTM G85<sup>4</sup> Annex A5 on duplicate test panels for each condition in the test matrix. Figure 12 shows panels in testing.

Figure 12. Panels in Prohesion Testing

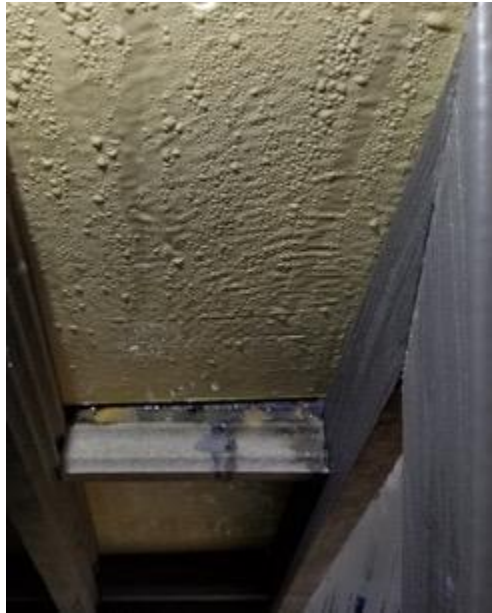
Duplicate panels for each condition in the test matrix were placed in a condensing cabinet as specified in ASTM D4585<sup>7</sup> for 1,300 hours at 38 °C (100 °F) (Figure 14). The temperature of the water in each tank was monitored periodically throughout each day with the temperatures being recorded daily to ensure that the water was maintained at the designated 38 °C (100 °F). Inspections were performed every 500 hours for blistering, surface imperfections, and signs of edge rusting. The requirement specified in 3.17 of MIL-PRF-23236 states there shall be no pinhole rusting or blistering rated in excess of ASTM D714, blister size number “4 few,” after 2,000 hours of exposure. For the purposes of this test the relative performance of the various coating systems was used to determine suitability of alternative coating scenarios.

**Figure 14. Panel in Condensing Test**

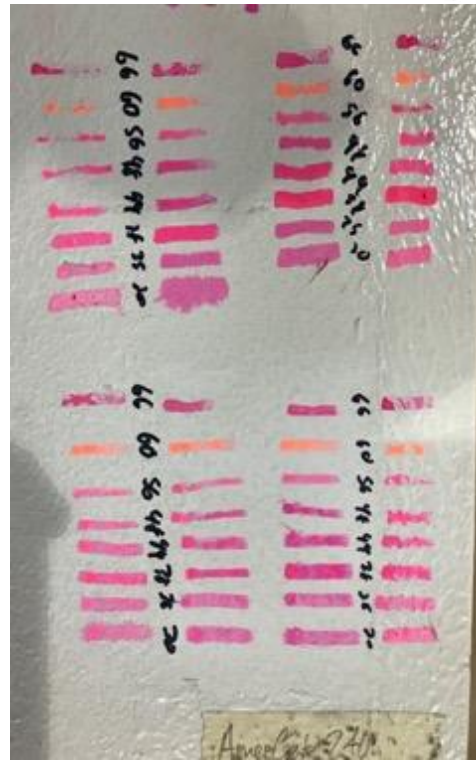
An exploratory technique for evaluating the remaining epoxy surface, Dyne marker pens were used to determine the surface tension of the remaining epoxy coating. Surface tension measurements were performed on a representative sample of panels within 2 to 3 weeks of coating application. Figure 15 shows SeaGuard 5000 HS and Amercoat 240 after testing with Dyne pens. Both had similar tensions of 56-48. After the panels were scuff sanded, a higher surface tension was indicated on both panels.

Figure 15. Dyne Pens on Test Panels

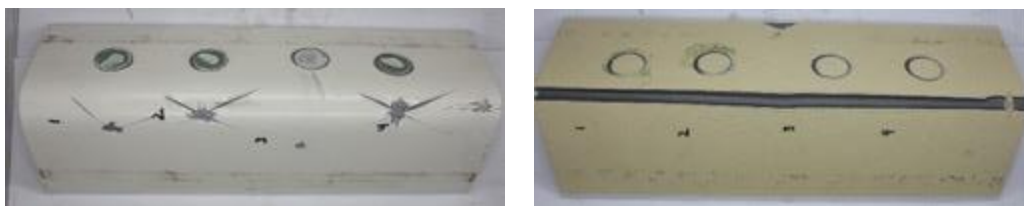
At each bending angle, the coating was photographed and inspected for cracking, flaking, and delamination. Appendix B shows a photo of each panel after each angle of deformation. Note that in some cases the X-cut adhesion test (performed prior to the bend) had a localized impact on the bend test performance. The impact can be neglected without impacting the overall observations. Figure 17 shows a representative panel from systems 10 and 5 after being bent 110 degrees. System 10 exhibited excellent adhesion despite the impact of the X-cut test near the bend. Systems 5 and 6 exhibited complete delamination at the bend. Also note that on some systems, there was a noticeable difference in bend test performance on areas cleaned to bare metal versus areas where intact primer was overcoated. Figure 18 illustrates this behavior on panel 3 $\beta$ A1. The damaged portions that were repaired (marked by the blue arrows) are more flexible than the areas that were not damaged. This may be influenced by surface preparation, overall coating thickness, or aging of the retained epoxy primer.

**Figure 17. Panels 10YA1 (left) and 5A1 (right) after bend at 110 degrees**

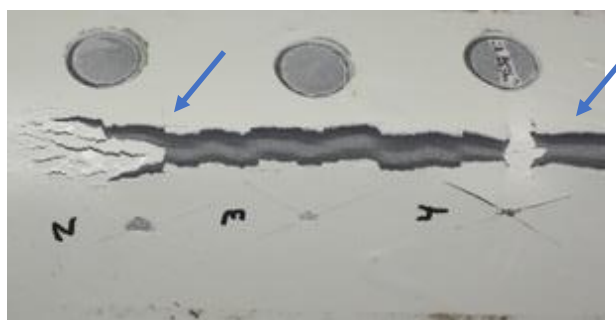
**Figure 18. Damaged areas displayed less delamination.**

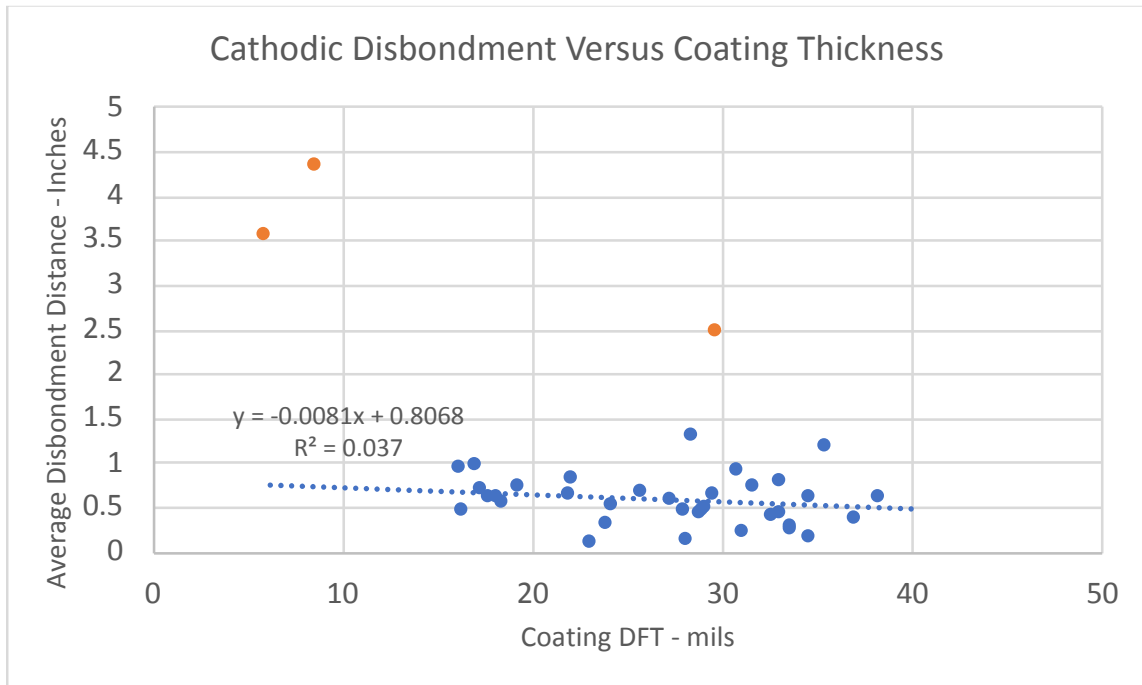
**Figure 19. Impact of coating thickness on average disbondment distance.**

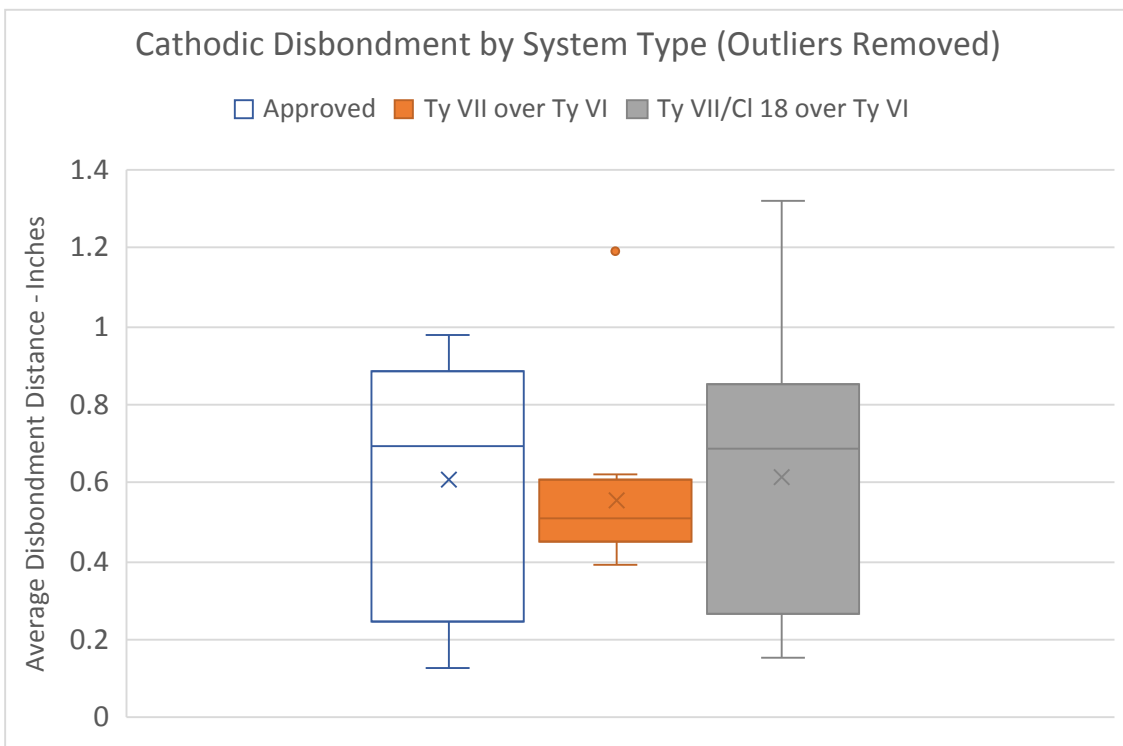
**Figure 21. Data from Figure 20 with “outliers” removed.**

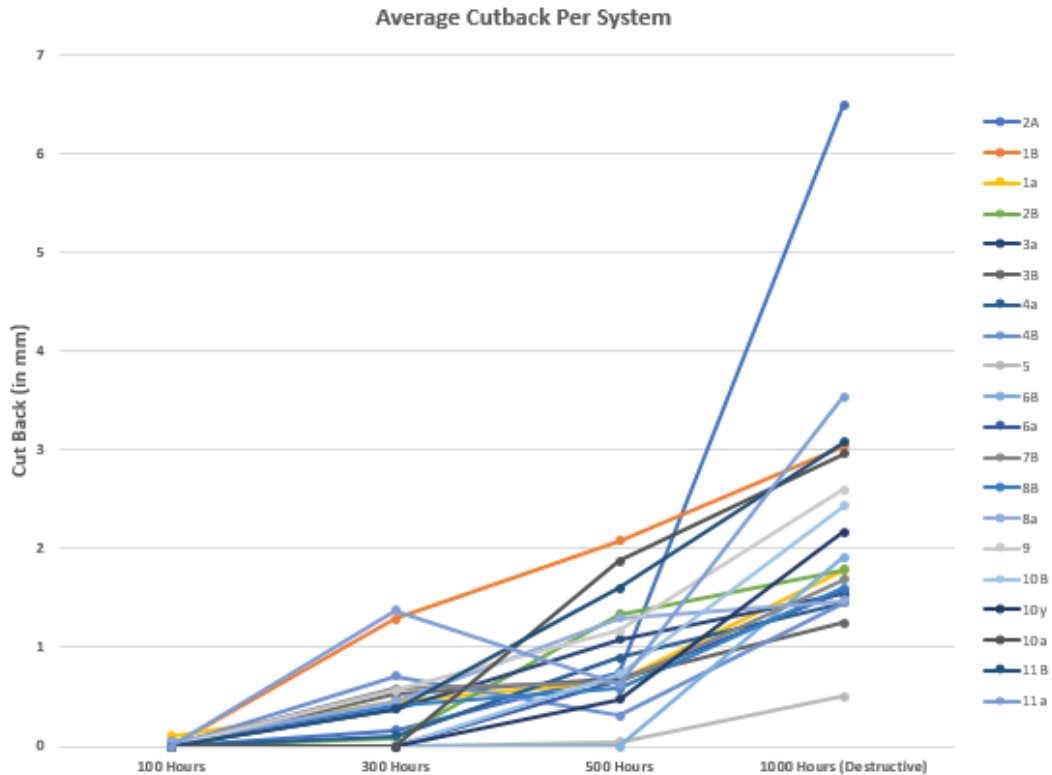
**Figure 23. Prohesion Cutback Ratings**

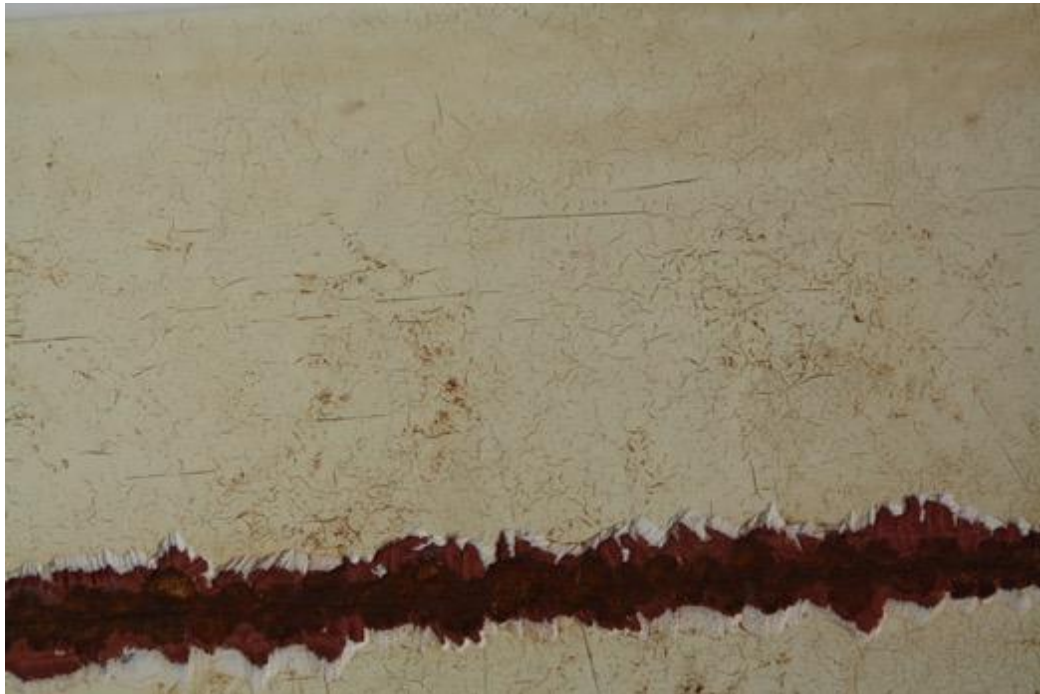
Checking was observed during the 1,000-hour inspection on the coating systems with Interbond 988 final coat (systems 1 $\alpha$  through 4 $\beta$ ). Figure 24 and Figure 25 illustrate the range of checking observed during the inspections. There were not any noteworthy concerns during the coating application that could have resulted in checking. Since the checking occurred independent of the primer or surface preparation process, it is not of any concern to the objectives of the test program.

**Figure 24. Checking on Interbond 998 Topcoat**

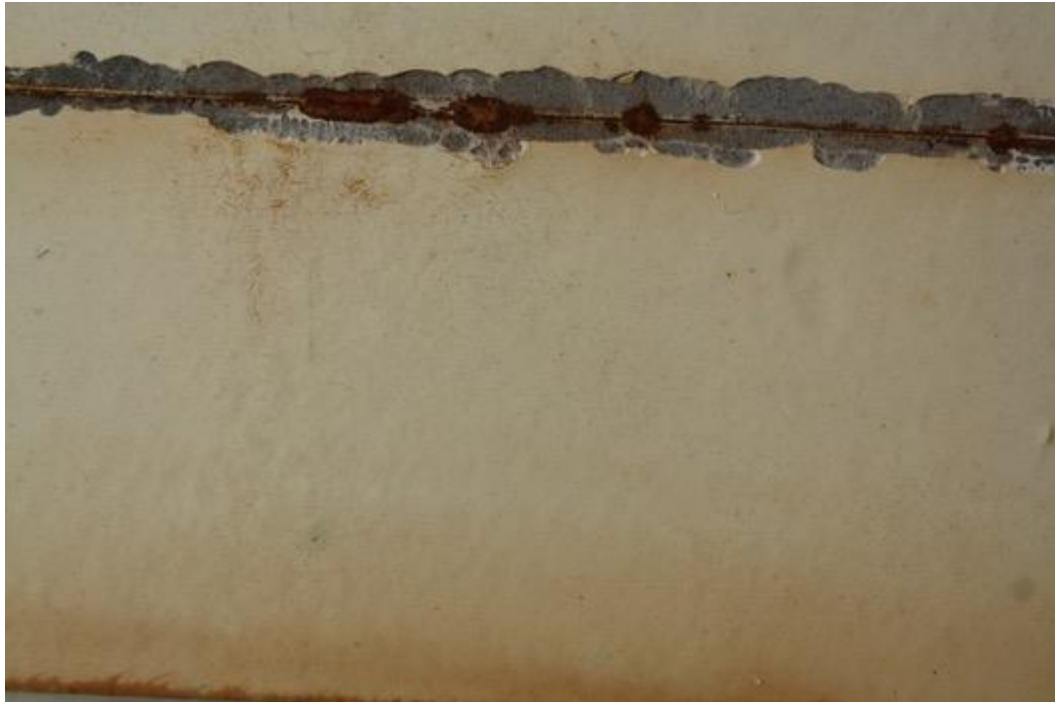
Figure 25. Least amount of Checking Displayed on Interbond 998

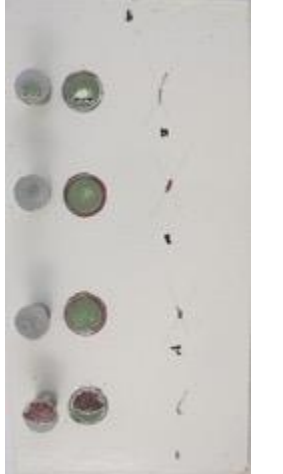
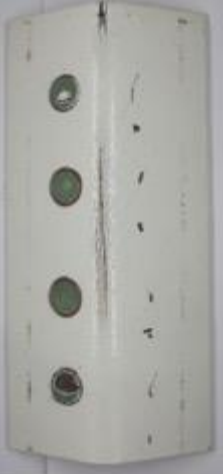
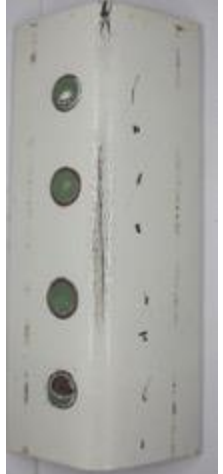
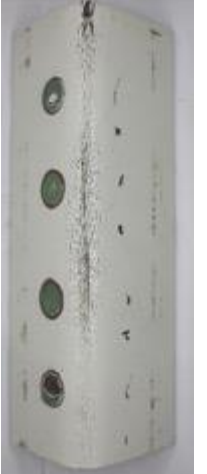
Scenario	Adhesion Test Results	Bend 1 (50°)	Bend 2 (80°)	Bend 3 (110°)
<p><b>1αA1</b> 1<sup>st</sup> - PCP/Interbond 998 Prep - SP-3/SP-11 2<sup>nd</sup> - Interbond 998 3<sup>rd</sup> - N/A</p>

Panel #	1st Coat	Prep/Repair	Finish coat(s)	1 (50°)	2 (80°)	3 (110°)
1aA1	PCP/Interbond 998	SP-3/SP-11	Interbond 998	4	4	4
1BA1	PCP/Interbond 998	SP-7/SP-10	Interbond 998	4	4	4
2B1	PCP	SP-7/SP-10	Interbond 998	4	4	4
3aA1	PCP/Intergard 264	SP-3/SP-11	Interbond 998 (+2 mils)	4	3	3
3BA1	PCP/Intergard 264	SP-7/SP-10	Interbond 998 (+2 mils)	2	1	1
4aA1	PCP/Intergard 264	SP-3/SP-11	Interbond 998/Interbond 998	3	3	2
4BB1	PCP/Intergard 264	SP-7/SP-10	Interbond 998/Interbond 998	3	3	3
5A1	PCP	SP-14/SP-10	Interline 783	0	0	0
6aA1	PCP/Intergard 264	SP-7/SP-10	Interline 783	0	0	0
6BA1	PCP/Intergard 264	SP-14/SP-10	Interline 783	2	1	0
7A1	PCP	SP-7/SP-10	Amercoat 240	3	2	2
8aA1	PCP/Amercoat 240	SP-3/SP-11	Amercoat 240	4	3	3
8BA1	PCP/Amercoat 240	SP-7/SP-10	Amercoat 240	4	3	2
9A1	PCP	SP-14/SP-10	Fast Clad ER	5	4	2
10aA1	PCP/SeaGuard 5000 HS	SP-3/SP-11	Fast Clad ER	4	4	4
10BA1	PCP/SeaGuard 5000 HS	SP-7/SP-10	Fast Clad ER	5	5	5

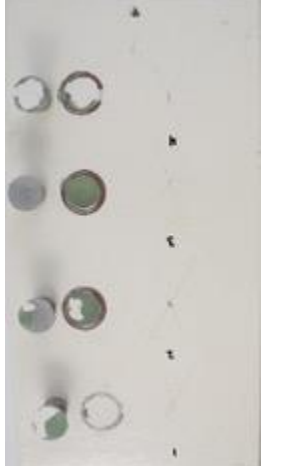
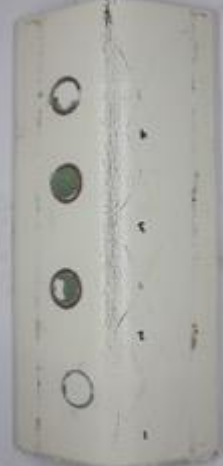
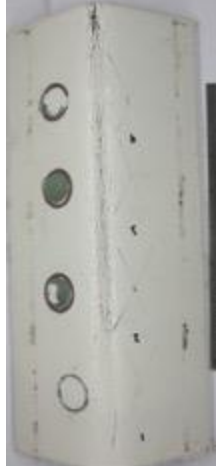
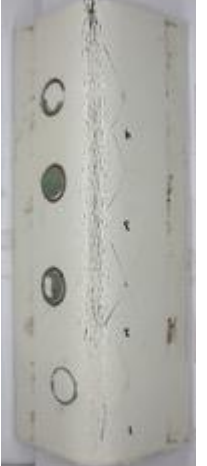
<p><b>1BA1</b> 1<sup>st</sup> - PCP/Interbond 998 Prep - SP-7/SP-10 2<sup>nd</sup> - Interbond 998 3<sup>rd</sup> - N/A</p>

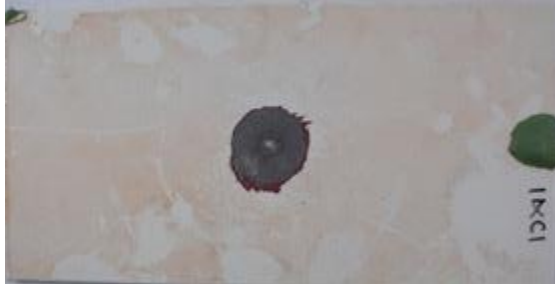
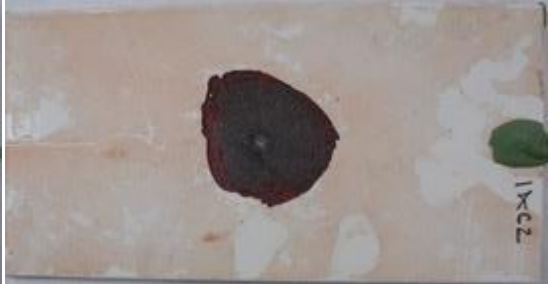
<p><b><u>1<math>\alpha</math></u></b>            1<sup>st</sup> - PCP/Interbond 998            Prep - SP-3            2<sup>nd</sup> - Interbond 998            3<sup>rd</sup> - N/A</p>

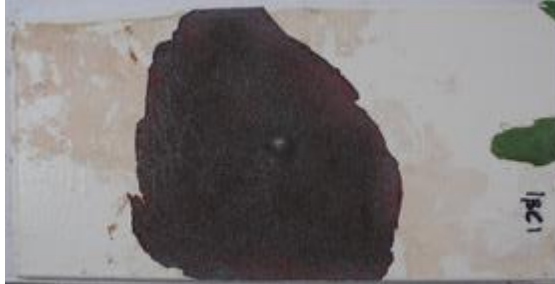
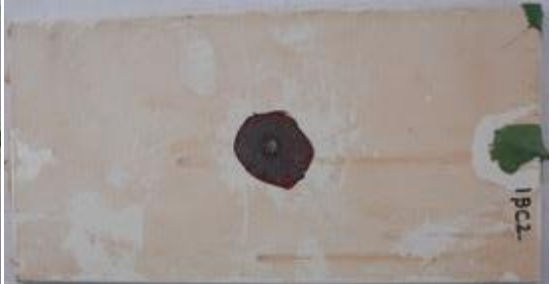
<p><b><u>1<math>\beta</math></u></b>            1<sup>st</sup> - PCP/Interbond 998            Prep - SP-7            2<sup>nd</sup> - Interbond 998            3<sup>rd</sup> - N/A</p>

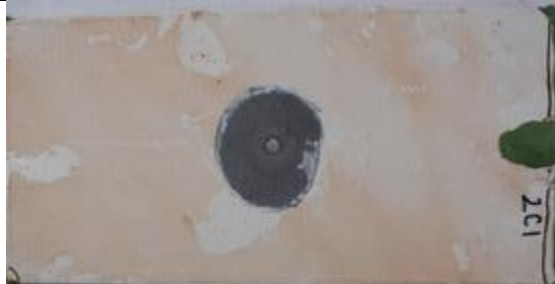
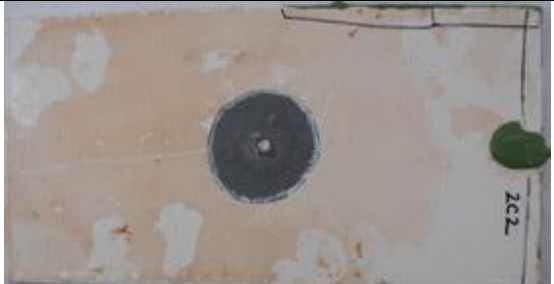
<p><b><u>2</u></b>            1<sup>st</sup> - PCP            Prep - SP-7            2<sup>nd</sup> - Interbond 998            3<sup>rd</sup> - Interbond 998</p>

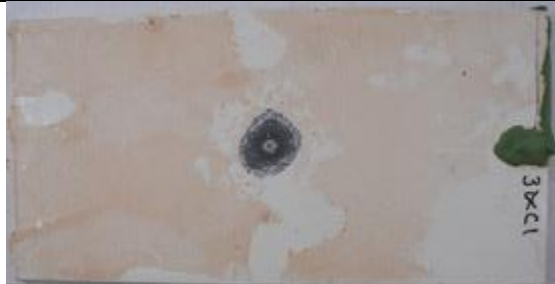
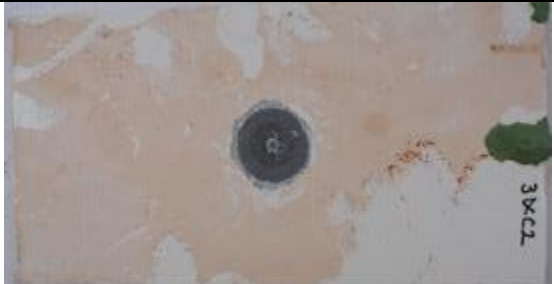
<p><b><u>3<math>\alpha</math></u></b>            1<sup>st</sup> - PCP/Intergard 264            Prep - SP-3            2<sup>nd</sup> - Interbond 998 (+2mils)            3<sup>rd</sup> - N/A</p>

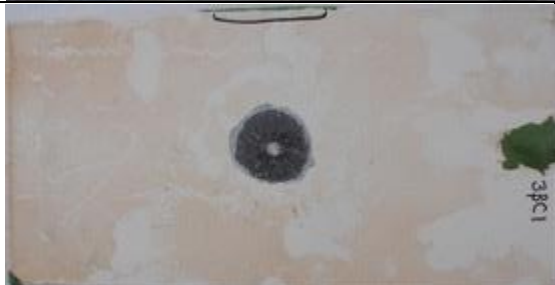
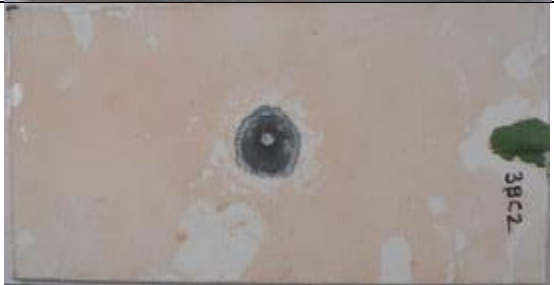
<p><b><u>3<math>\beta</math></u></b>            1<sup>st</sup> - PCP/Intergard 264            Prep - SP-7            2<sup>nd</sup> - Interbond 998 (+2mils)            3<sup>rd</sup> - N/A</p>

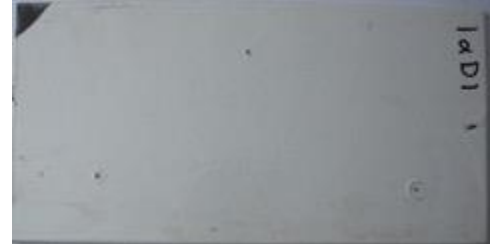
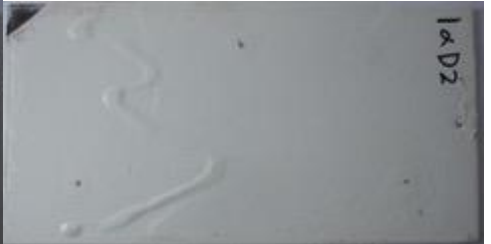
<p><b><u>1aD</u></b> 1<sup>st</sup> - PCP/Interbond 998 Prep - SP-3 2<sup>nd</sup> - Interbond 998 3<sup>rd</sup> - N/A</p>

After the inspection, the exposed face of each test panels was subjected to three impact tests as described in 4.5.6. Appendix E includes photographs of the test panels after condensing humidity and impact testing. Table 12 presents the results of the impact testing as the percent of impact sites exhibiting a coating holiday. The data show that systems 5, 8, and 9 are more susceptible to impact damage than the remaining systems. Interestingly, systems 5 and 9 (Type VII/Class 18 materials) were less susceptible to impact damage when applied over a Type VI primer (systems 6 and 10).

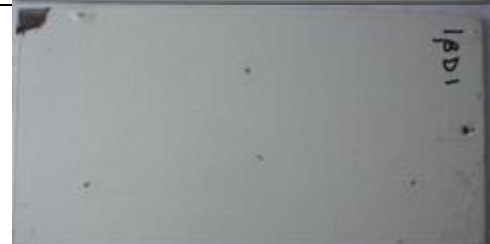
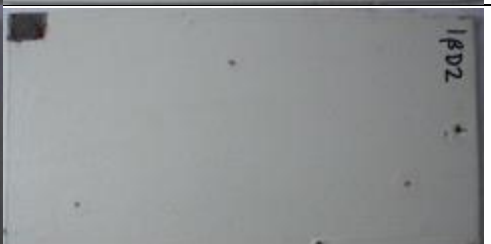
<p><b><u>1bD</u></b> 1<sup>st</sup> - PCP/Interbond 998 Prep - SP-7 2<sup>nd</sup> - Interbond 998 3<sup>rd</sup> - N/A</p>

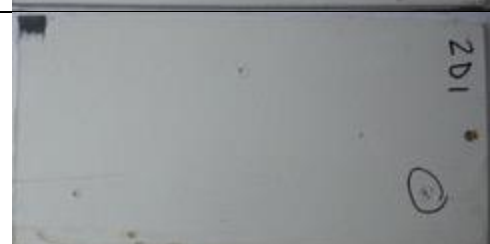
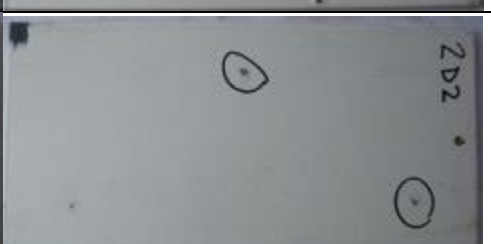
<p><b><u>2D</u></b> 1<sup>st</sup> - PCP Prep - SP-7 2<sup>nd</sup> - Interbond 998 3<sup>rd</sup> - Interbond 998</p>

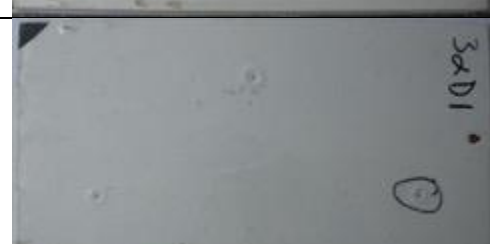
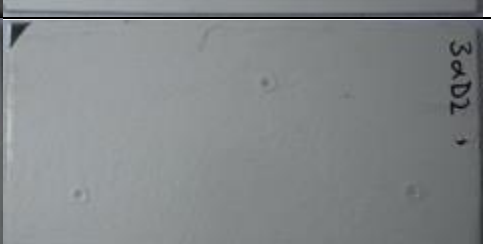
<p><b><u>3aD</u></b> 1<sup>st</sup> - PCP/Intergard 264 Prep - SP-3 2<sup>nd</sup> - Interbond 998 (+2mils) 3<sup>rd</sup> - N/A</p>

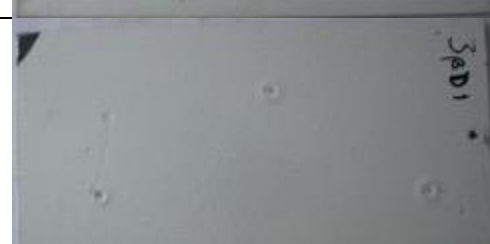
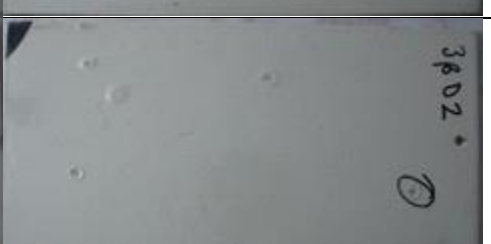
<p><b><u>3bD</u></b> 1<sup>st</sup> - PCP/Intergard 264 Prep - SP-7 2<sup>nd</sup> - Interbond 998 (+2mils) 3<sup>rd</sup> - N/A</p>
