Zinc-Rich Coatings Over High Strength Steel

July 2024

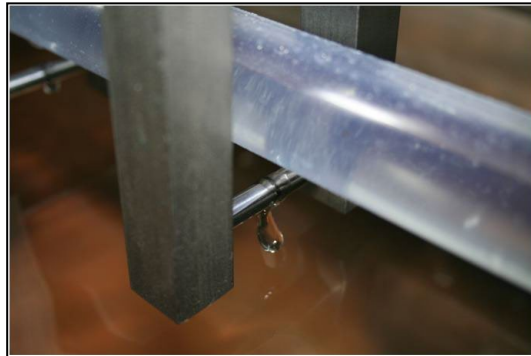
- *ASTM F519 - Mechanical Hydrogen Embrittlement Evaluation of Plating/Coating Processes and Service Environments*
 - Describes mechanical test methods and defines acceptance criteria for coating and plating processes that could potentially cause hydrogen embrittlement in steels
 - Stressed notched bars exposed for 200 hours
 - Time to failure recorded; run-outs incrementally stressed to failure

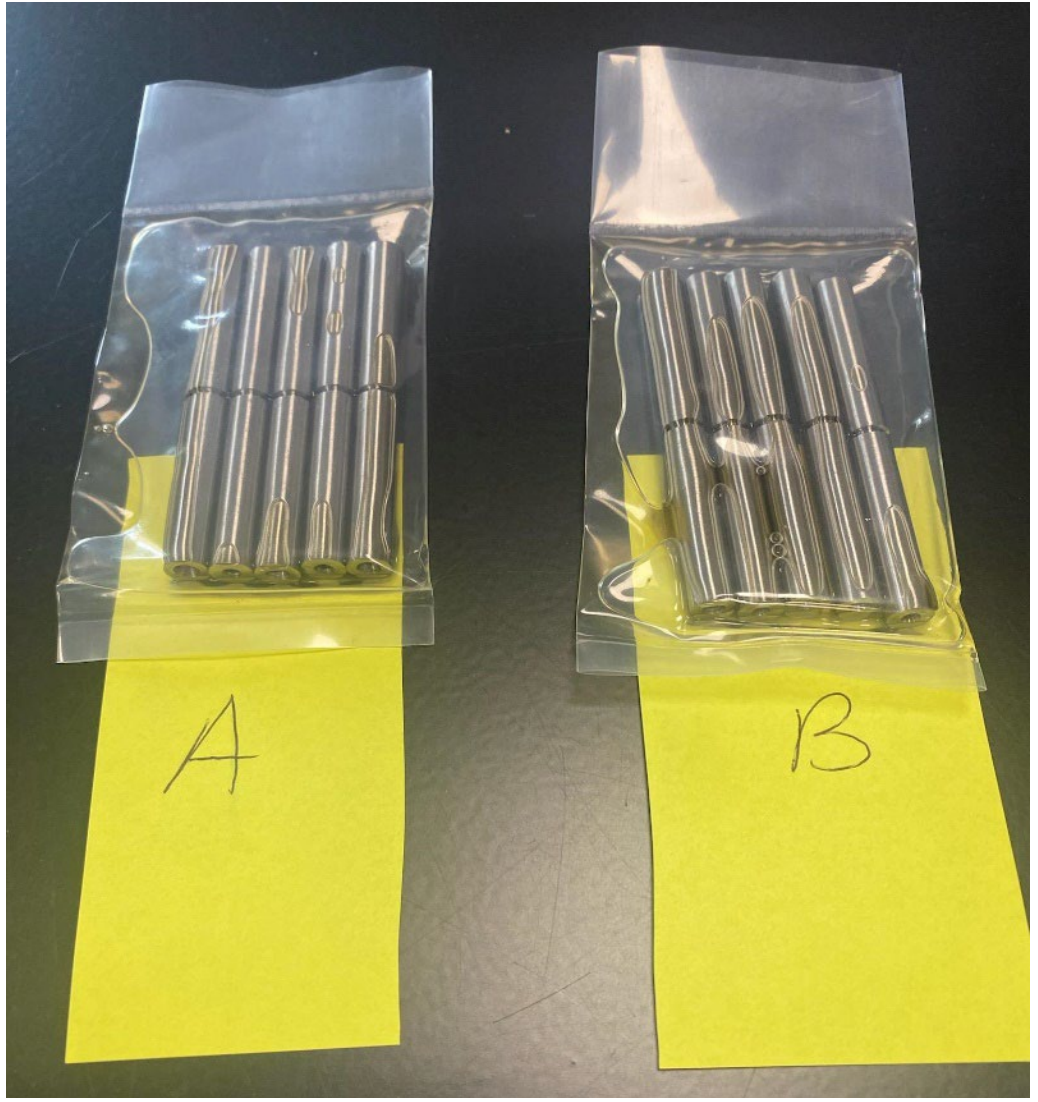
ID	Coating	Substrate	QTY. Dry	QTY. "Wet"
A-00	None	4340	4	0
A-0	None		4	4
A-1	IOZ PCP #1		4	4
A-2	IOZ PCP #2		4	4
A-3	IOZ		4	4
A-4	TT-P-664		4	4
B-00	None	HY-100	4	0
B-0	None		4	4
B-1	IOZ PCP #1		4	4
B-2	IOZ PCP #2		4	4
B-3	IOZ		4	4
B-4	TT-P-664		4	4
C-00	None	HSLA-100 Composition 3	4	0
C-0	None		4	4
C-1	IOZ PCP #1		4	4
C-2	IOZ PCP #2		4	4
C-3	IOZ		4	4
C-4	TT-P-664		4	4

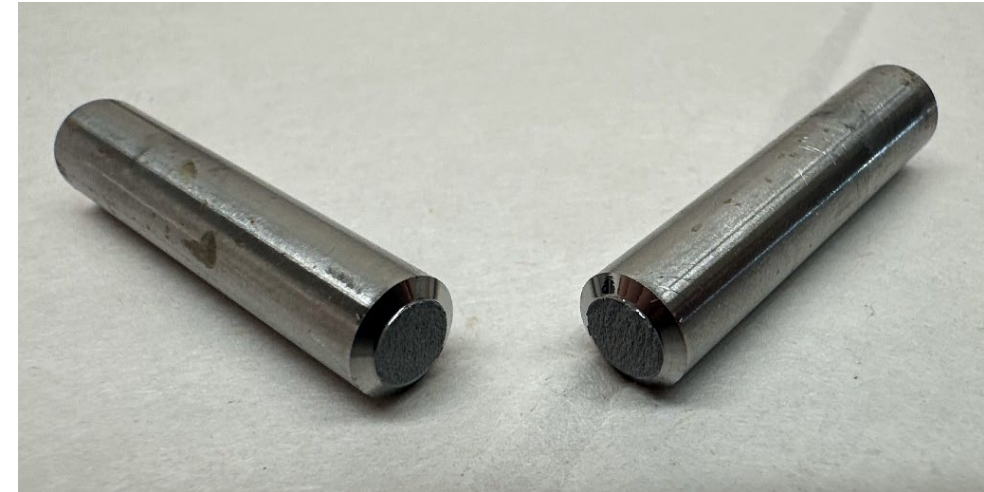
- ASTM F519 – *Mechanical Hydrogen Embrittlement Evaluation of Plating / Coating Processes and Service Environments*
- 7) Monitor samples to determine time to failure, up to at least 200 hrs.
 - 8) For samples that do not break at 200+ hrs.
 - Increase load by 5% RtF every 2 hours until failure
 - 9) Examine fracture surfaces and unbroken specimens (if any)

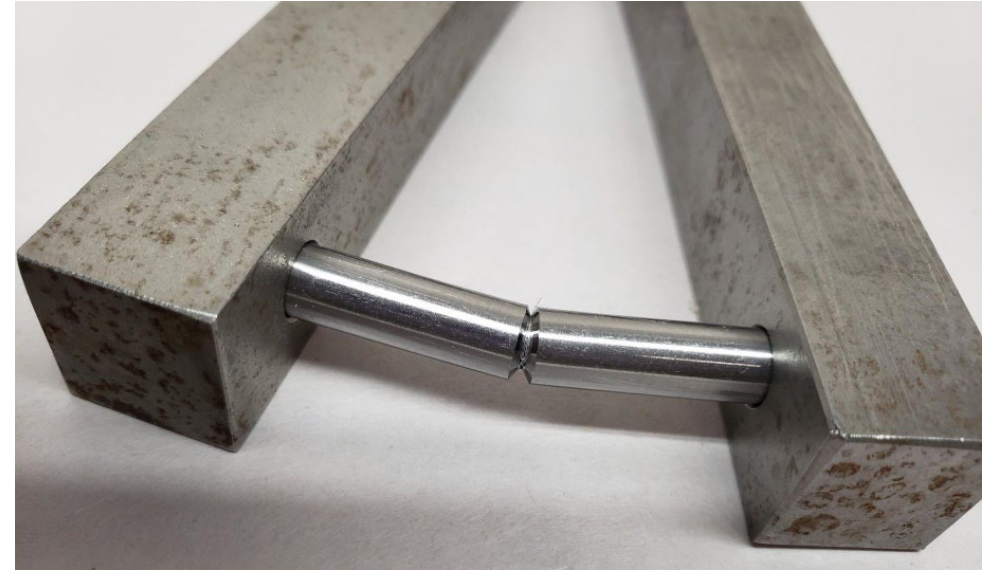
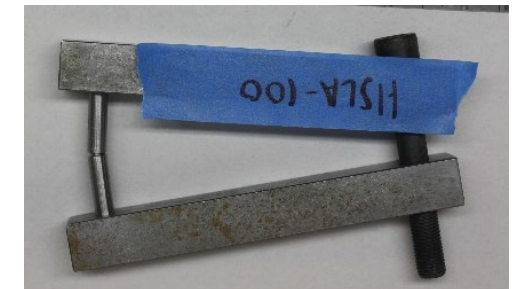
- What if no baseline RtF can be determined at room temperature?
- HY-100 and HSLA-100 C3 baseline samples did not fully fracture at room temperature
- Bending occurred without complete fracture until the fixture strain range was at its maximum (30 revolutions)
- 4340 steel broke and a RtF was established for uncoated, room temperature specimens (RtF = 14)

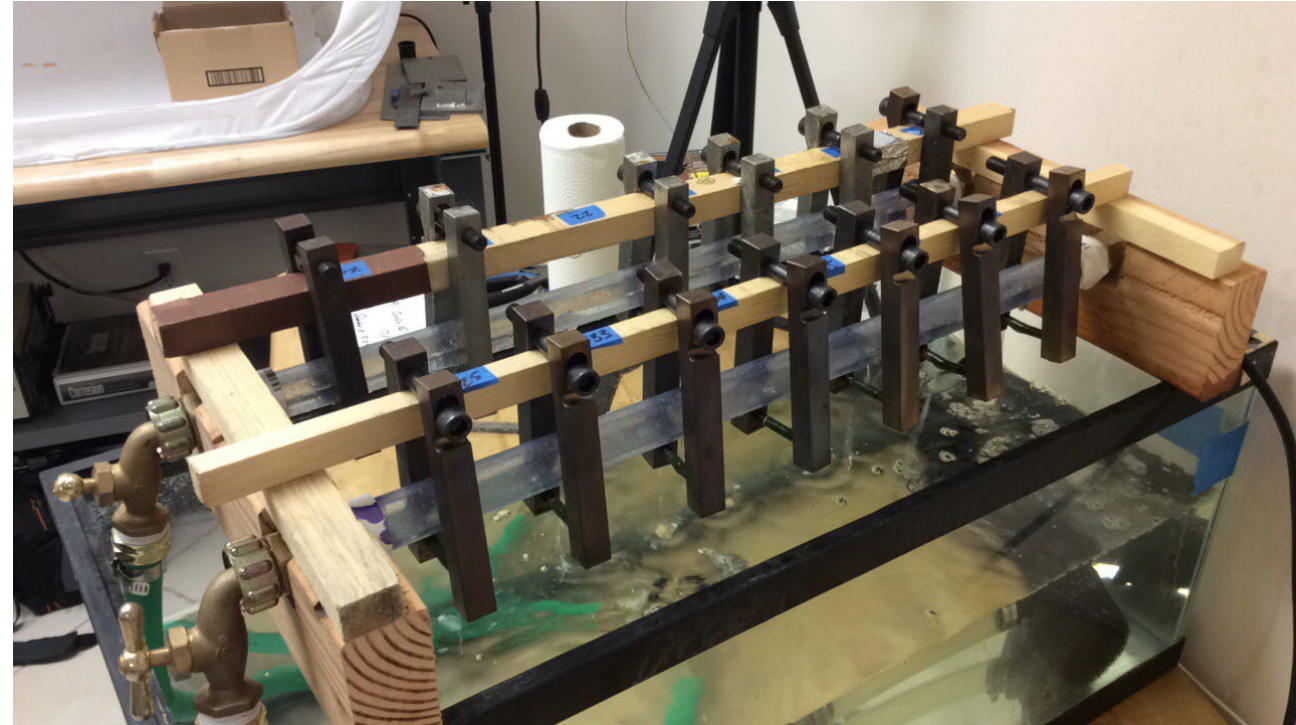
- The “Wet” Environment
 - Wetting occurs only after loading
 - Constant drip
 - Drop location is directly over notch
 - Drop rate approximately 15 – 30 drops per minute
 - Laboratory Temperature / RH

- The Dry Environment
 - Laboratory Temperature / RH
