# Zinc-Rich Coatings Over High Strength Steel

September 2024

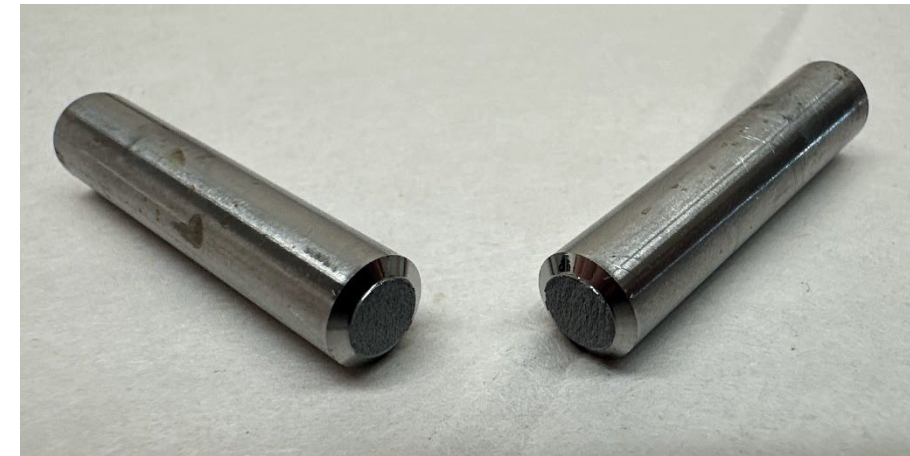
- ASTM F519 – *Mechanical Hydrogen Embrittlement Evaluation of Plating / Coating Processes and Service Environments*
- 7) Monitor samples to determine time to failure, up to at least 200 hrs.
  - 8) For samples that do not break at 200+ hrs.
    - Increase load by 5% RtF every 2 hours until failure
  - 9) Examine fracture surfaces and unbroken specimens (if any)

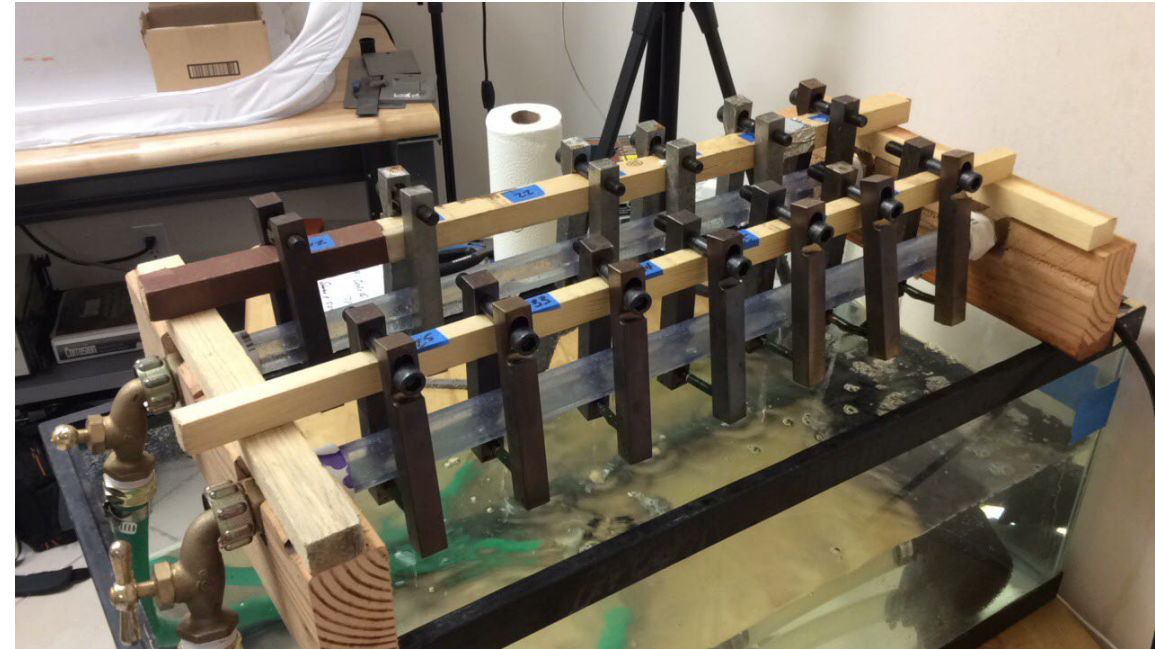
- The “Wet” Environment
  - Wetting occurs only after loading
  - Under constant drip
    - Drip location is on the notch.
    - Approximately 15~30 drops per minute
  - Laboratory conditions
- The “Dry” Environment
  - Laboratory conditions

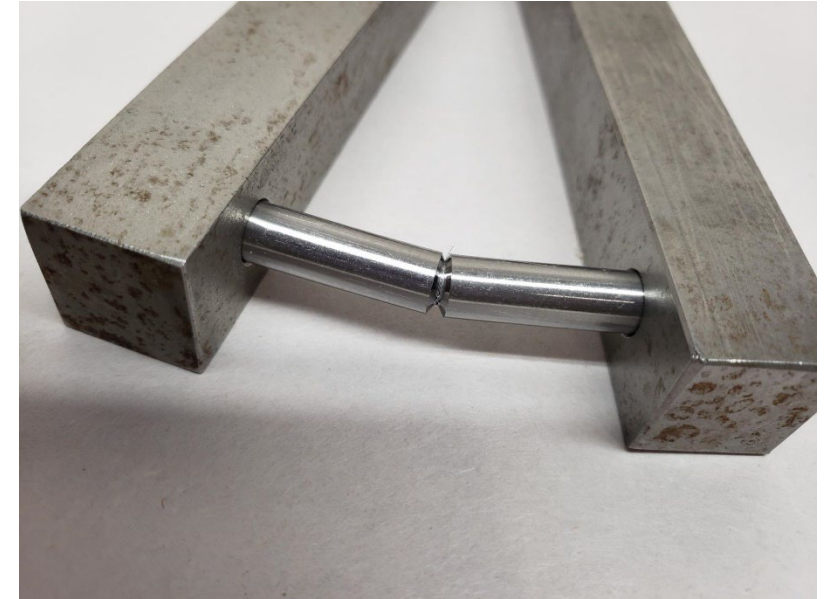
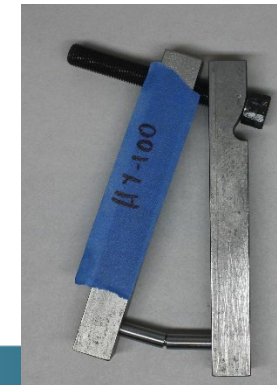
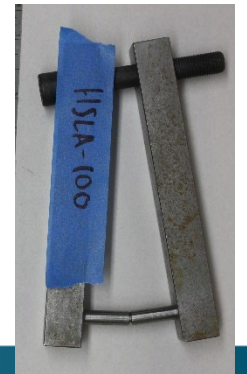
- What if no baseline RtF can be determined at room temperature?
- HY-100 and HSLA-100 C3 baseline samples did not fracture at room temperature
- Bending occurred without fracture until the fixture strain range was at its maximum (30 revolutions) – **Determined 20 was failure and loaded samples to 15 turns**
- 4340 steel broke and a RtF was established for uncoated, room temperature specimens (RtF = **14**)

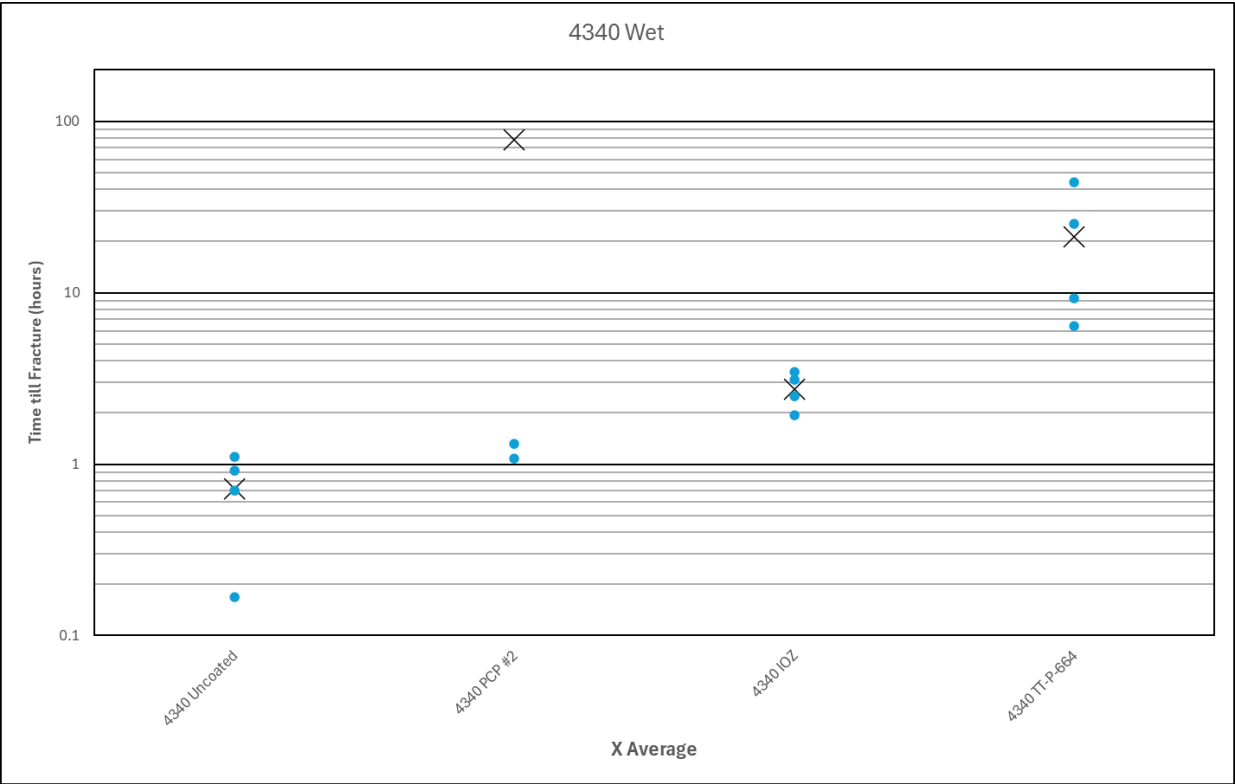
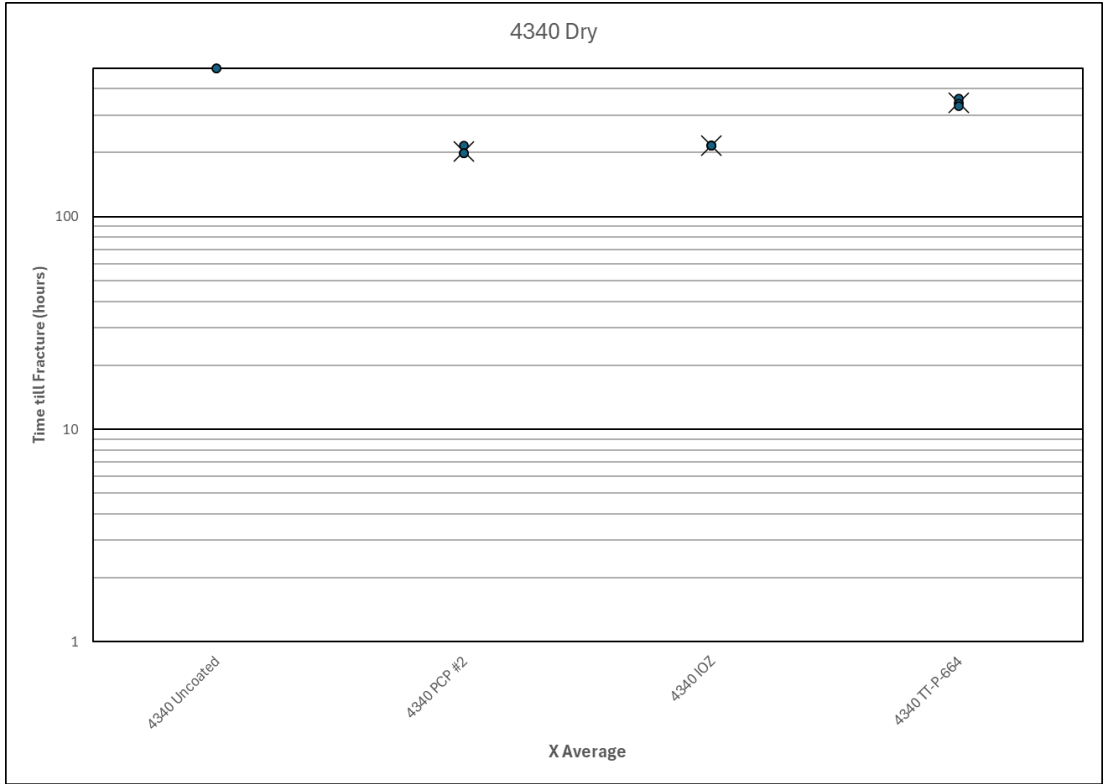
# Task 3 (Ongoing) – 4340 test results

- The “Wet” Environment shows that the zinc coatings protect uncoated steel from early fatigue
- *Dry samples so no differences in terms of failure differences.*

- Share data with Navy Technical Community
- Continue testing and collect data
- Finalize report for distribution
- Make recommendations on additional testing or tests to better determine if Hydrogen embrittlement is an issue with any of these coatings.
  - Early 4340 data from this program suggests it might not be an issue

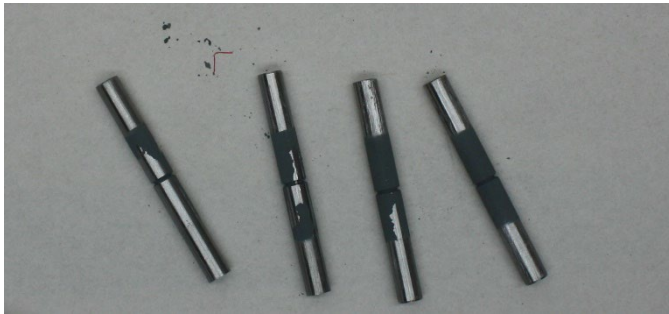
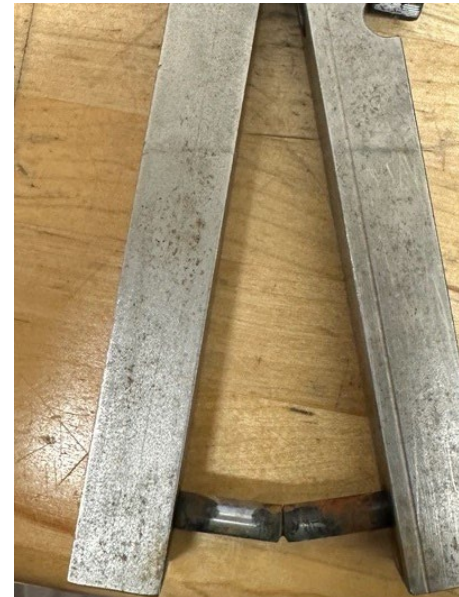
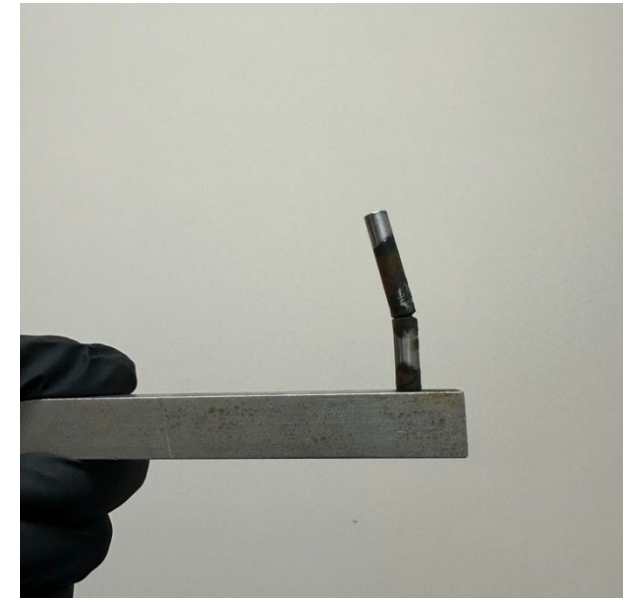
## Task 3 (Ongoing) – HY and HSLA test results

- No differences seen in either Wet or Dry environments during testing.
- No breaking of either material has to the witnessed.
- Two systems in current testing.
- PCP Coating Chipped off all Systems
