S2944: Thermal Insulating Coatings

NSRP All Panel Meeting 2025

Huntington Ingalls – Newport News Shipbuilding

February 2025

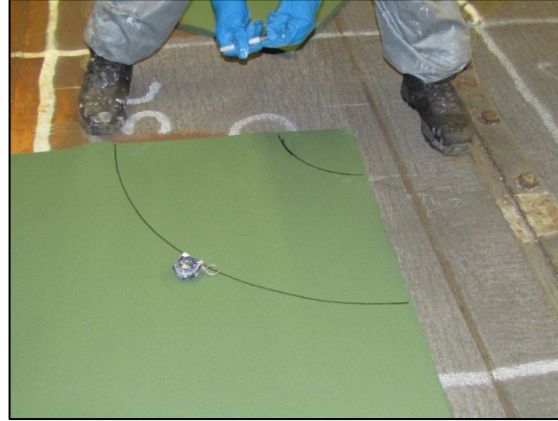
Laying out shapes

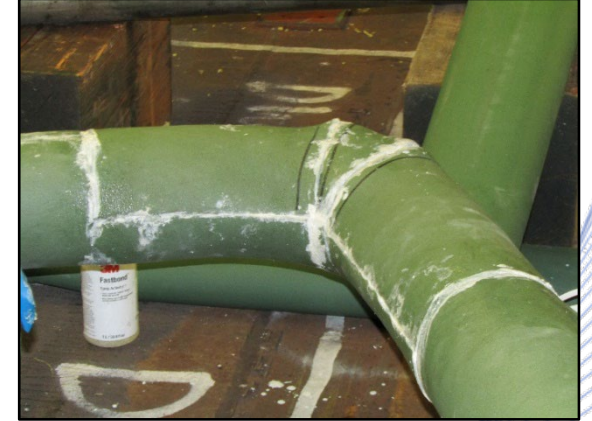
Gluing pipe seams

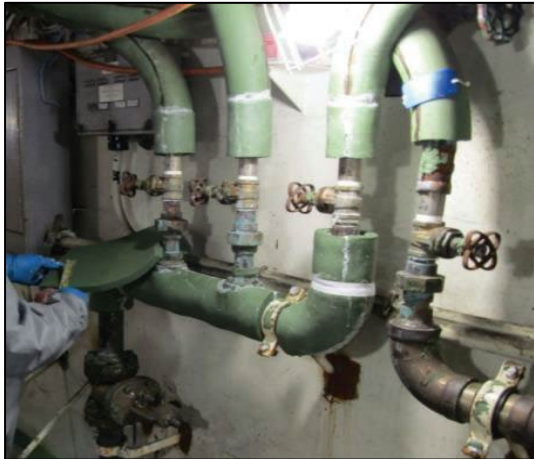
Pipe manifold

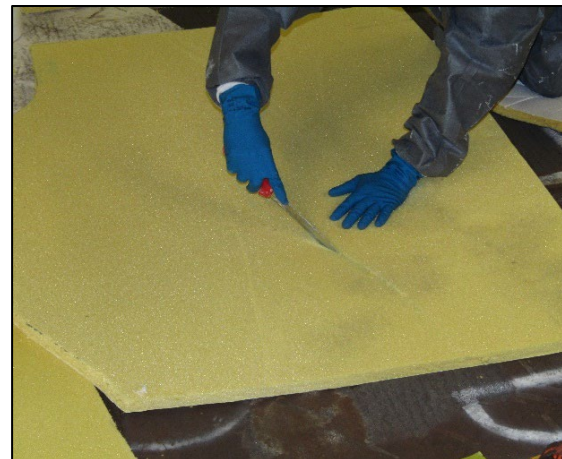
Cutting to shape

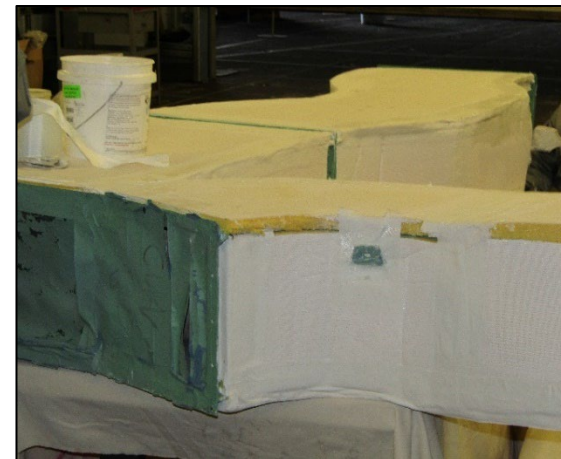
Vent duct fitting, gluing, and taping

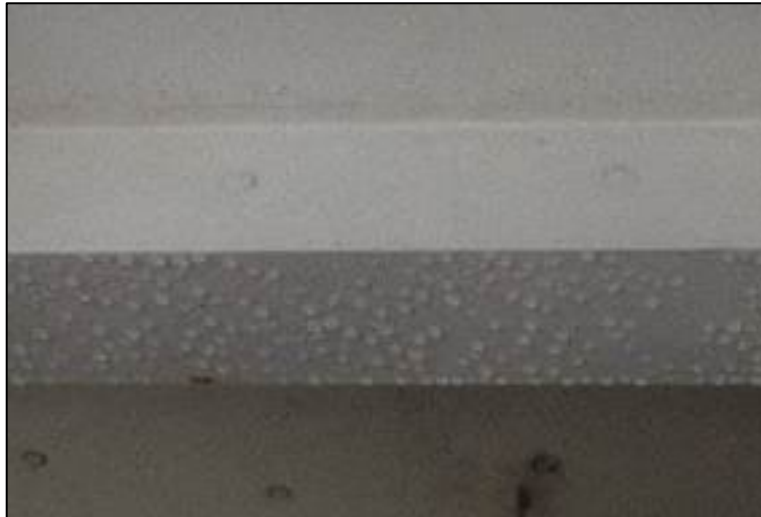
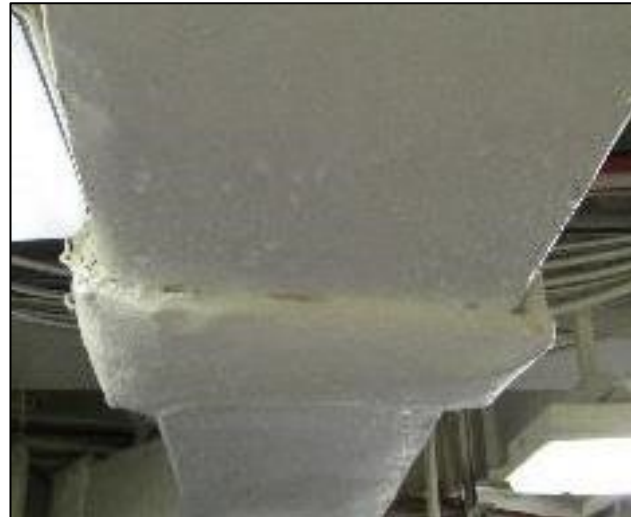
Condensation

- Improve Insulation Performance in Target Areas
 - Exposure to high humidity conditions beyond the design conditions, even for short cyclic periods, introduces surface and substrate condensation as the insulation surface temperature falls below the dew point.
 - Moisture erodes the thermal conductivity performance of the insulation exacerbating the situation.
 - Increased A/C demand is broadening the issue.

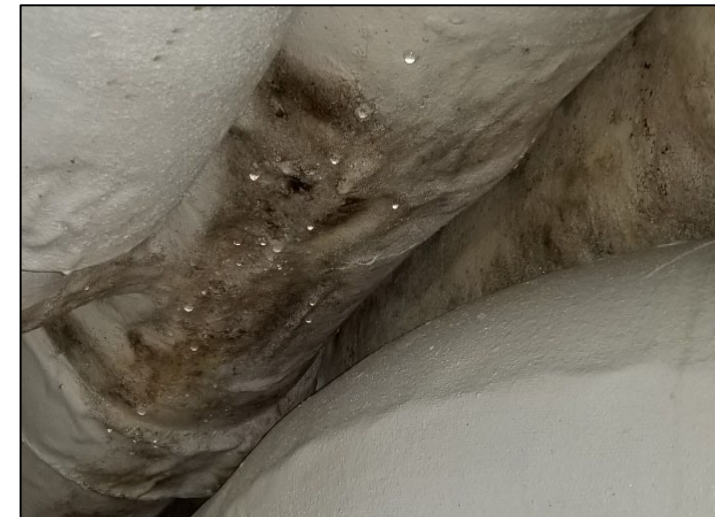
Condensation with mold
growth

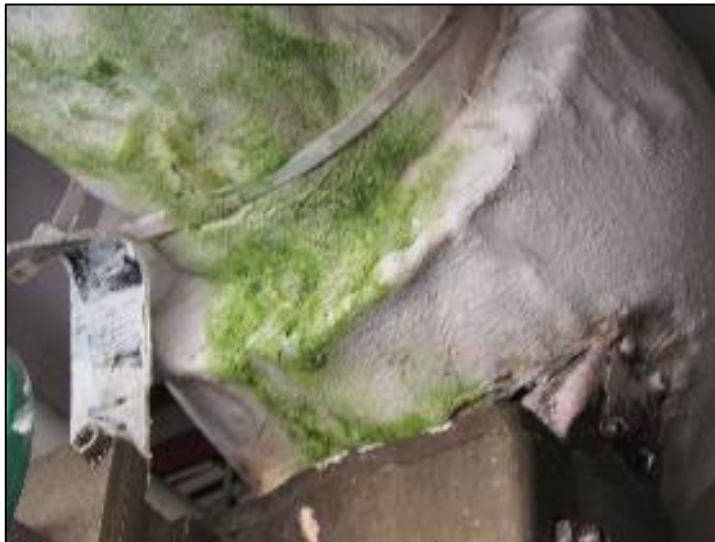
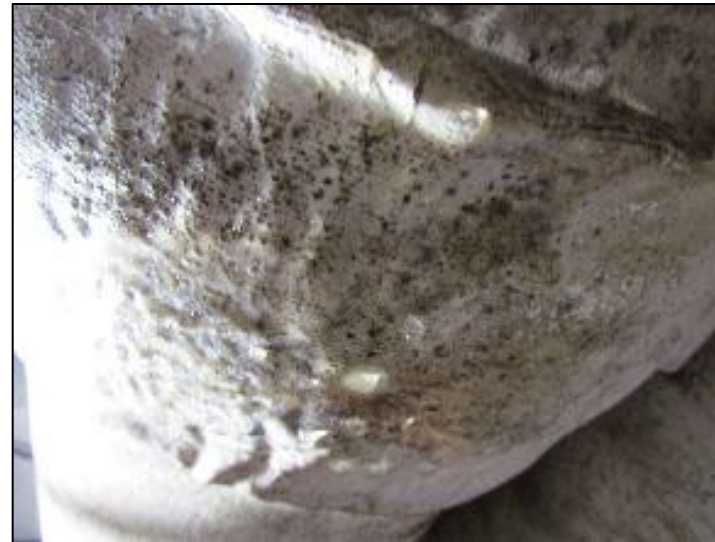
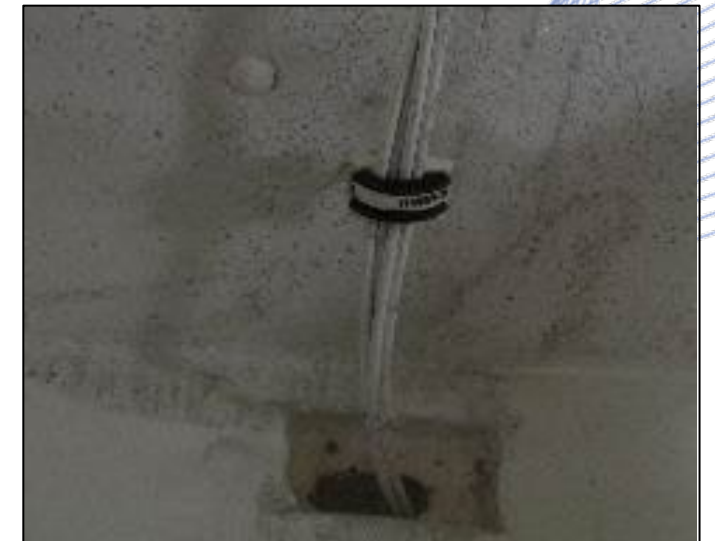
Mold growth

- Reduce Long Term Maintenance (Mold and Condensation Damage)
 - Cold vent and pipes and uninsulated A/C boundaries are exposed to consistently high humidity environments, moisture condenses and promotes mold growth.
 - TICs eliminate need to replace saturated and mold laden insulation.
 - NAVSEA study revealed that mold is a widespread issue throughout the fleet.
 - Any condensation that does form on TIC surface does not infiltrate the material allowing evaporation from the surface.
 - Wetted TIC retains its original properties.
 - TICs offer an economical insulating option for areas outside specification driven insulation requirements – eliminates cleaning / repainting of moldy bulkheads.

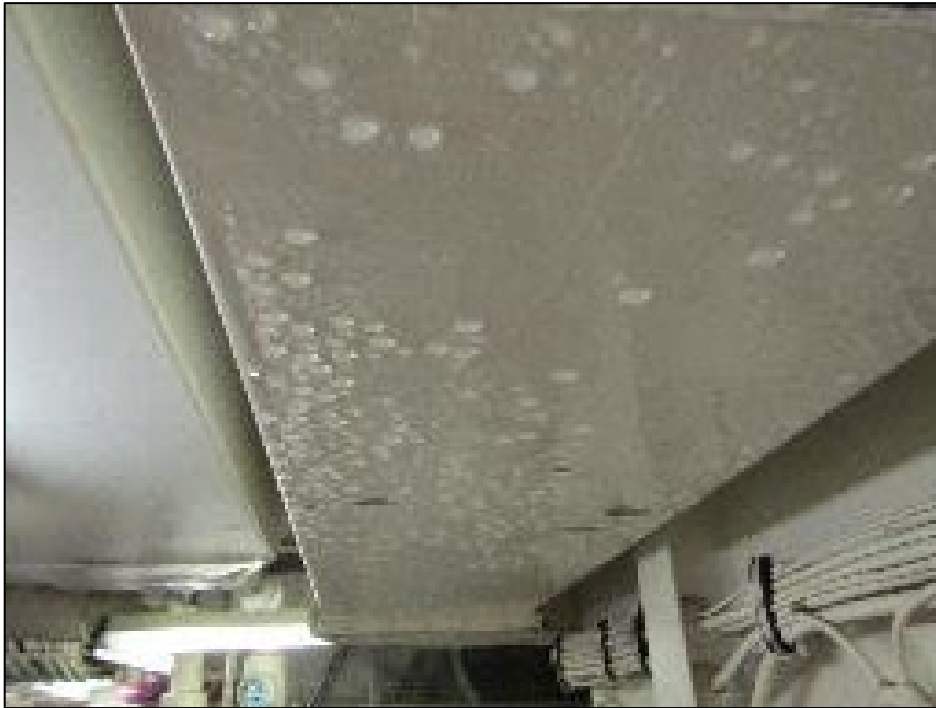
Condensation

- Ship Habitability, Performance, and Safety
 - Dripping condensation provides slip hazards, damage to equipment, and erosion of flooring materials.
 - Extreme condensation can impact cooling systems performance and impede ship operations.
 - Condensation can impact ship habitability exposing the crew to an uncomfortable environment.

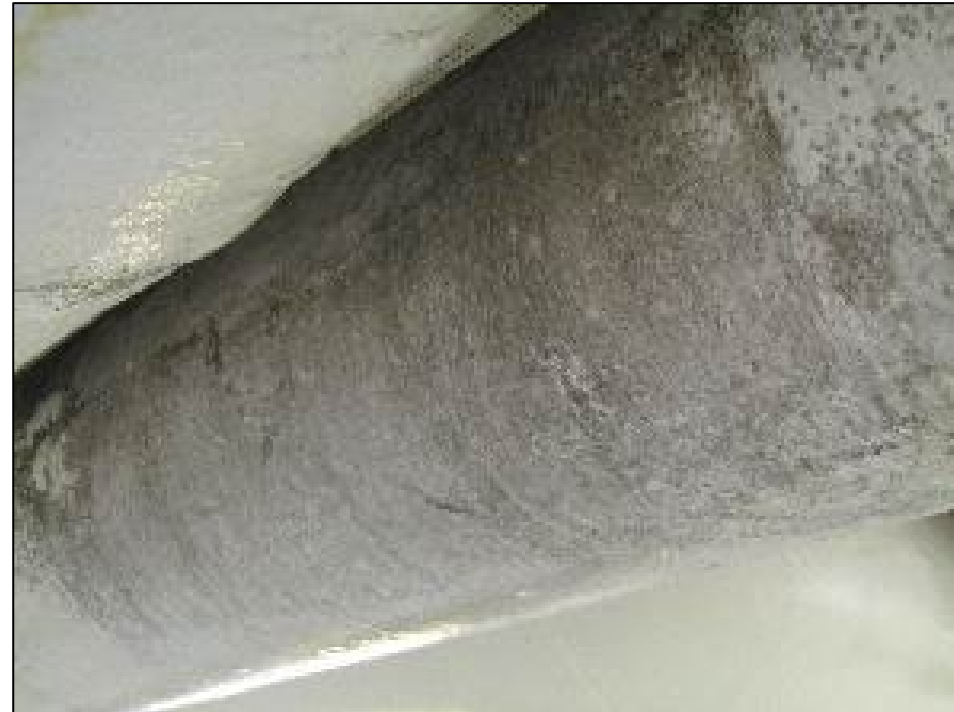
Mold Growth

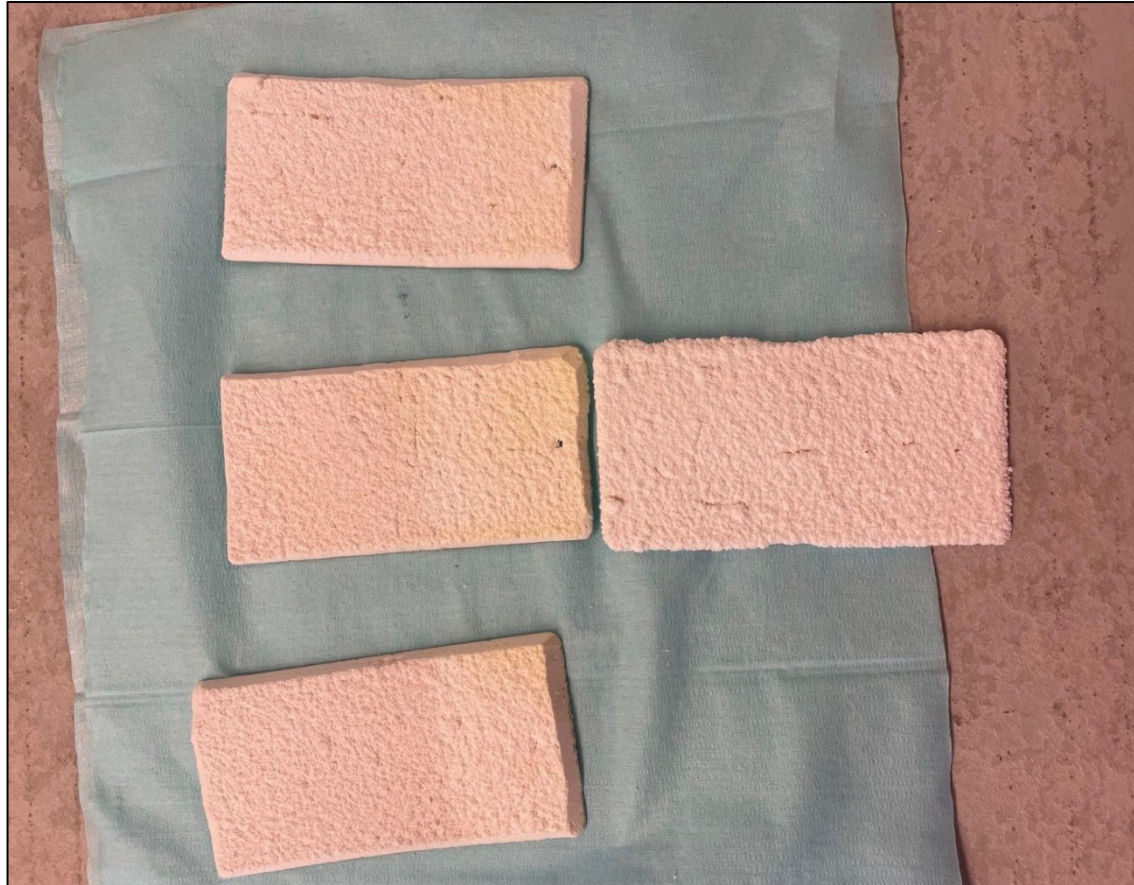
Supplier B

Water Resistance of Coatings Using Water Immersion

Three samples sprayed to configuration thickness on primed aluminum panels were immersed to 3/4 depth in jars full of DI water. The jars were then placed into a heated water bath and were left for a period of time.

Immediate observations after removal: No blisters or cracks were observed after immersion. Slight discoloration was observed.

All three panels weighed more immediately after being removed from their jars due to water uptake during immersion.

24 hours drying observations: *Panels returned to their original pre-immersion weight within 24 hours of removal from their jars. No changes to coating observed (color, cracks, blisters, etc.)*

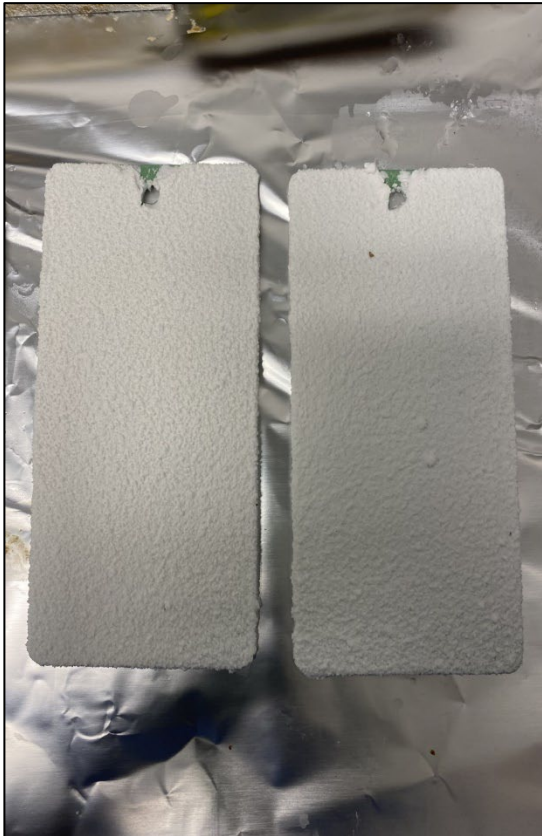
Supplier B

Resistance to Growth of Mold on the Surface of Interior Coatings in an Environmental Chamber
 Determining the Resistance of Paint Films and Related Coatings to Fungal Defacement by accelerated Four-Week Agar Plate Assay

The samples were exposed for a period of time in the mildew cabinets and rated according to the specification.

Substrate/Base	Period 1	Period 2	Period 3	Period 4
Aluminum	10	10	10	10
Aluminum	10	10	10	10
Aluminum	10	10	10	10
Aluminum	10	10	10	10
Free film	10	10	10	10

- 3.3 HVAC Design Trade-off Study
 - Complete – identified ~200K SQFT where boundary conditions support use of new materials at less than equivalent thickness
- 3.4 & 3.5 Physical Damage & Splash Zone Impact Testing
 - Manufacturers have submitted ASTM test recommendations
 - Current results:
 - Water Absorption - samples were placed into a heated water bath and left for a period of time
 - Slight discoloration
 - All weighed more immediately upon removal from water bath
 - Returned to original weight within 24 hours of removal
 - Fungal Resistance – samples were exposed for a period of time in mildew cabinets and rated in accordance with standard test method
 - No defacement occurred

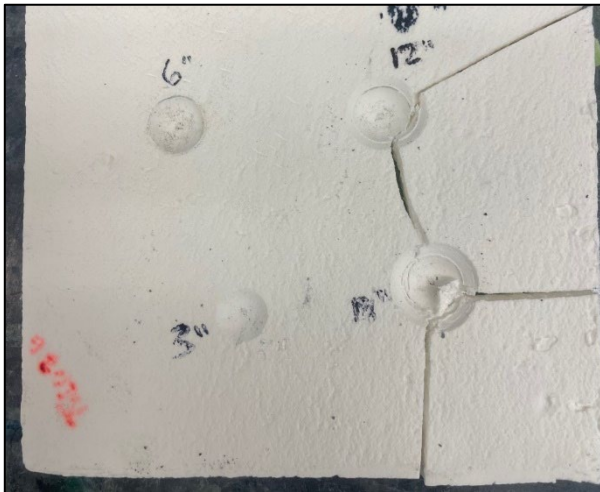
Supplier B

Impact Resistance of Pipeline Coatings (Falling Weight Test)

Free film: Film thickness at configuration thickness. Impacts at various heights dented the surface but did not deform the back of the sample, indicating that the weight did not push through the entirety of the sample. At greater heights the sample cracked, as seen in the image. Impact of a sample supported on steel may improve the result at greater drop heights.

- 3.4 & 3.5 Physical Damage & Splash Zone Impact Testing
 - Current results (cont.):
 - Impact– samples were subjected to falling weights
 - Free film: Film thickness at anticipated configuration
 - Impacts at various heights dented the surface but did not penetrate through sample.
 - At greater heights, the sample cracked, as seen in the image. Impact of a sample supported on steel may improve the result at the greater height.
 - Steel Panel: Film thickness at anticipated configuration
 - Impacts from various heights deformed the surface but did not penetrate to the primer.
 - Impact from greatest drop height did expose primer in a small spot in the middle of the impact area.
 - Coating failure/deformation was localized to the impact point for all drop heights.

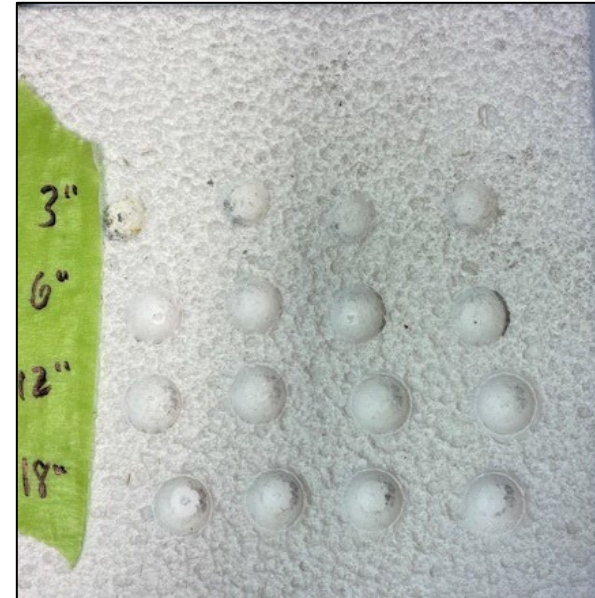
Supplier B

Steel Panel: Film thickness at configuration thickness. Impacts from various heights deformed the surface but did not make it through to the primer. Impact from greater drop height did expose primer in a small spot in the middle of the impact area. Coating failure/deformation was localized to the impact point for all drop heights.
