# FINAL PANEL PROJECT REPORT

## SIMPLIFIED PRECISION WELDING TECHNIQUE

### AGREEMENT # 2019-375-013

*March 7, 2025*

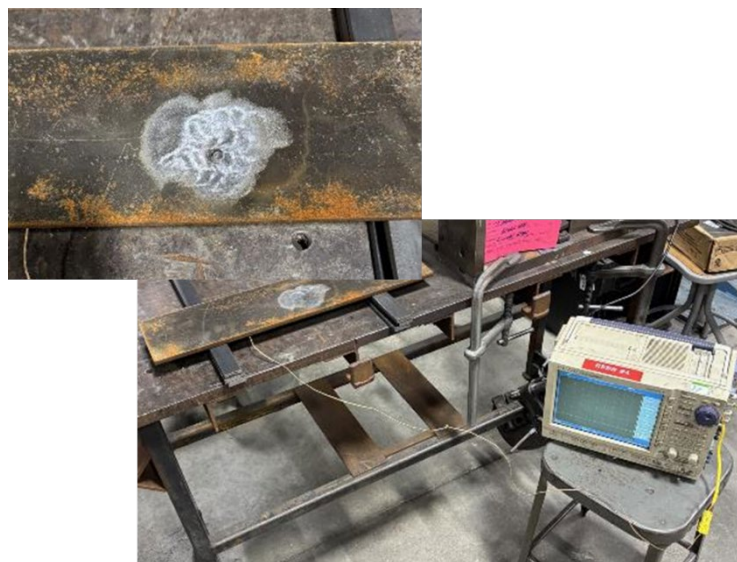
A heat study was done during flat position repair parameter development, whereby EWI attached thermocouples to the backside of a pitted plate to assess the ability to complete repairs near insulation or painted surfaces without creating a fire hazard. This study yielded a backside temperature maximum of 80.6°F. A photograph of the heat study setup is shown in Figure 4.

**Figure 4. Heat Study during Parameter Development**

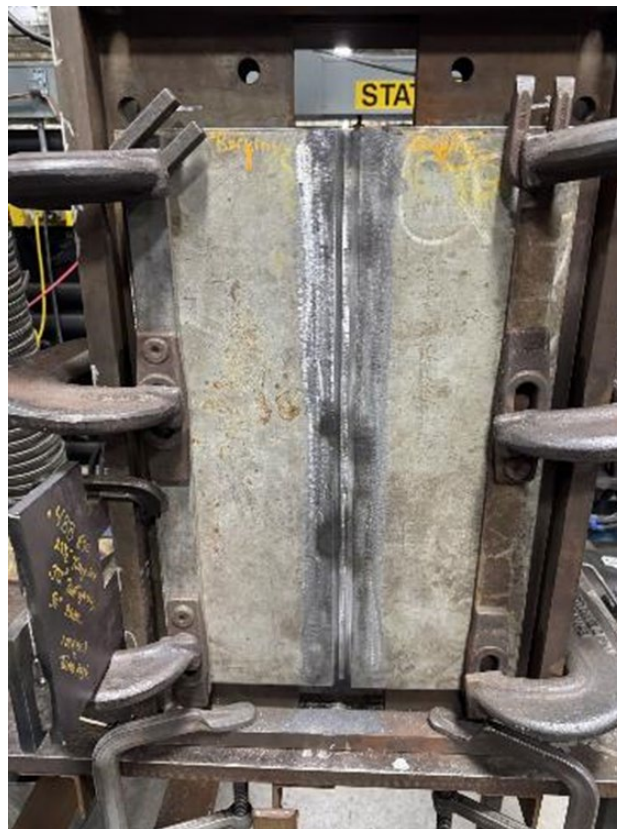
**Figure 5. Tech Pub 248 Qualification Demonstration Plate**

Using 1/2-in. thick HSLA 65 and a MIL-STD-22D B1V.1 joint design, the demonstration plate was welded in the vertical position with upward progression. The demonstration plate required 6 weld layers and 11 total passes to complete.

After verifying the developed parameters were sufficient for pit repairs, EWI welded a NAVSEA Technical Publication 248 qualification demonstration plate, shown in Figure 4.

The qualification demonstration plate was inspected by visual (VT), magnetic particle (MT), ultrasonic (UT), and radiographic (RT) testing. All acceptance criteria per MIL-STD-2035A, Class 1 were met.

Two face bends and two root bends were done, both meeting the acceptance criteria of NAVSEA Tech Pub 248. Two transverse tensile tests were done, showing an average ultimate tensile strength of 80,000 psi, meeting acceptance criteria.
