Shore Power Connector Tester

The National Shipbuilding Research Program

2019 Electrical Technologies Panel Project

FINAL REPORT

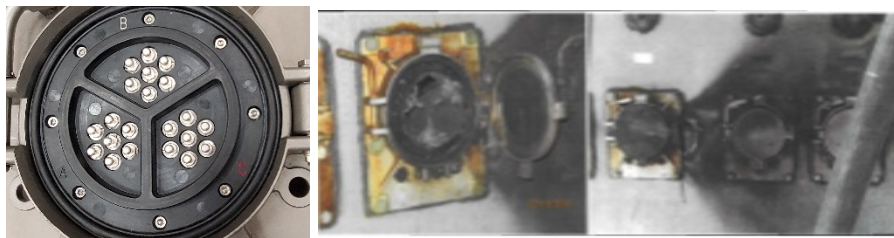
Figure 1 Healthy connector (left). Connector after arc flash event (right)

In February, 2018, there was an arc flash event on DDG 62 that resulted in an explosion of one of the 450V 400A shore power connectors. This event was traced to a pin failure in the connector. See Figure 1. As a result of this incident, and due to similar issues within the fleet, a new Maintenance Requirement Card (MRC – test procedure) has been issued that requires Megger testing not just between phases but between each pin in each phase to every other pin in each other phase. Every pin is also to be tested to ground.

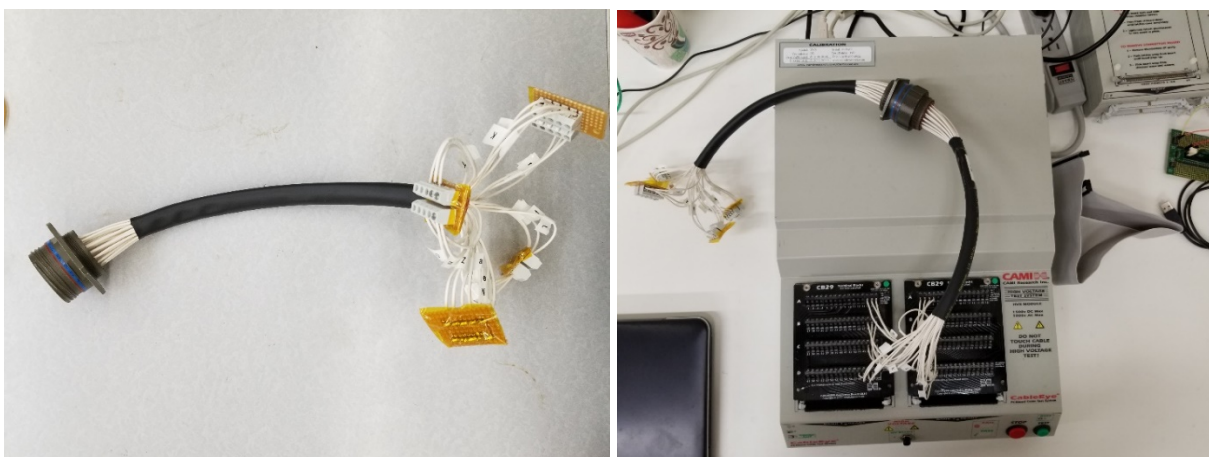
D'Angelo Technologies (D5T) created a surrogate connector for evaluating the capabilities of the CableEye Tester. See Figure 4.

Figure 4 Surrogate shipboard shore power receptacle alone (Left) and connected to the surrogate plug, which is connected to the tester (Right)

The surrogate connector represents the shipboard shore power receptacle. It uses 28 pins. 7 of the pins were connected together via terminal blocks to represent the Phase A pins of the actual connector, which are connected together behind the receptacle. Likewise, 7 pins were connected together to represent the B phase and 7 pins for the C phase. The remaining 7 pins were connected together and represent the ground connection (ship's hull).

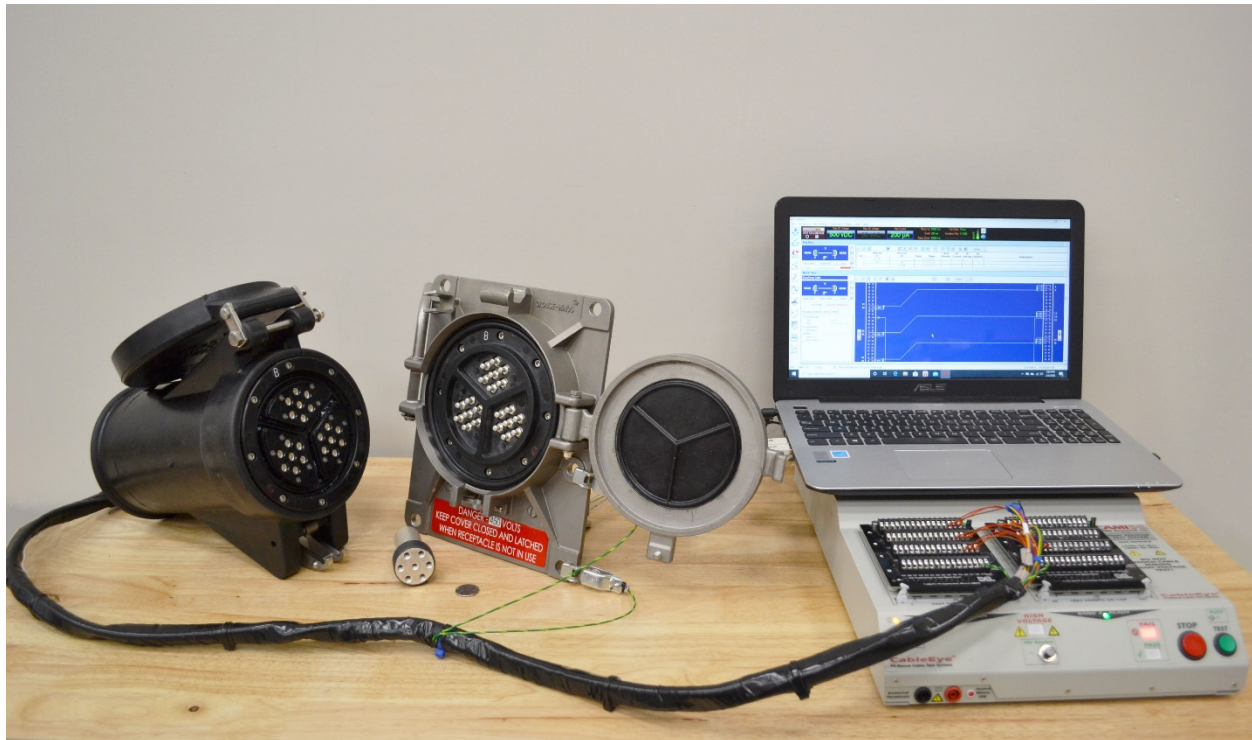
Figure 9 shows the actual shipboard plug connected to the tester with the shipboard receptacle in the center. The seven pins of each phase are clearly seen. The ship electrical system uses a 3 Phase Delta configuration, which has no absolute ground connection. Note the green and yellow wire from the plug cable bundle to a clip attached to the receptacle. The test requires checking each pin to ground. On ship, the receptacle housing or the bolts securing it are used for a ground connection. For this test, a ground wire from both the plug and receptacle are clipped to the receptacle.

The laptop computer on top of the tester gives a sense of scale to indicate the size of the plug and receptacle used on board the ship.

Figure 9 Cable tester set up with the shipboard plug and receptacle.

A new approach to validate shore power connections is being evaluated through this NSRP Panel Project as discussed herein. The new method utilizes an automated circuit tester to verify proper connections (i.e., connector pinned out properly), absence of short circuits, and proper insulation resistance readings prior to energizing the circuit. The new approach has the ability to reduce time for the testing process, to provide documented test results, and to eliminate the potential of arc flash incidents associated with damaged connectors. The proof of concept system utilizes a Cami Research CableEye HVX circuit tester attached to a shore power connector through a wiring harness. A computer interface (laptop or tablet) is used to run the test program and display results. The prototype test system used in the laboratory demonstration utilized a laptop as illustrated in Figure 9.

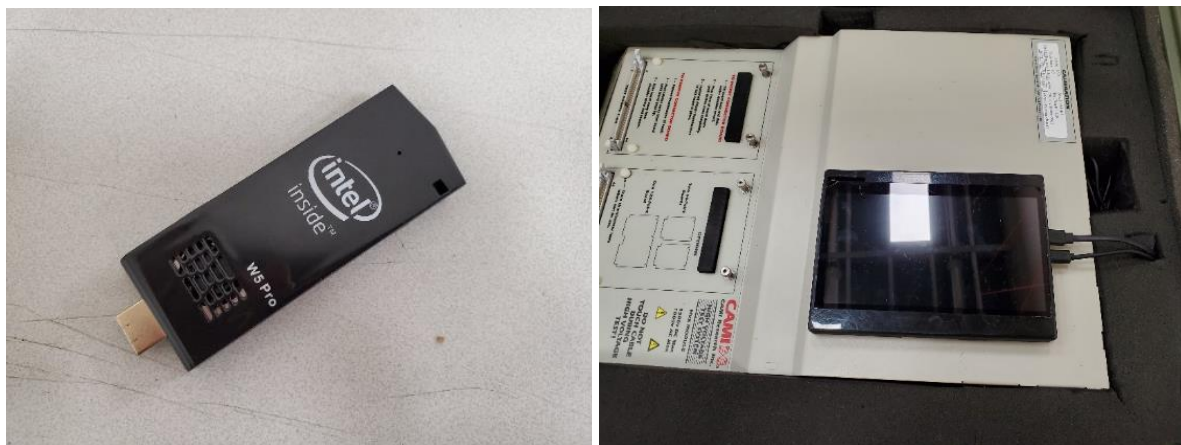
The laptop user interface was replaced with an Intel W5 Pocket PC. This computer is more than powerful enough to run the CAMI Research software and has a package size of 4" x 1.5" x 0.5". User interface was provided by a 7" touchscreen manufactured by Lebula, utilizing an onscreen keyboard. A 3D printed case was constructed for the touchscreen and it was mounted to the top of the CableEye Tester. See Figure 11.

Figure 11 W5 Pocket PC (Left) and Lebula touchscreen installed on tester (Right)

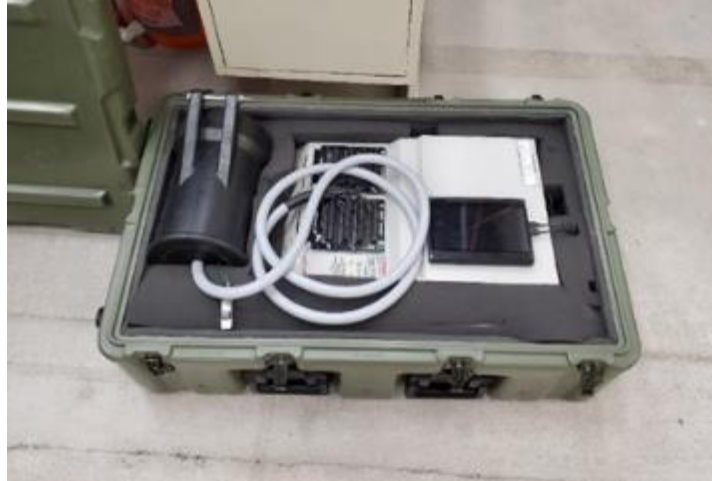
To make the unit portable, D5T selected a Hardigg 472 Medical Chest as a case for its size and durability. D5T removed the drawers and shelving from the case and installed case foam, creating cutouts for the appropriate components and channels for ventilation. The Pocket PC and the touchscreen monitor were powered with a 5Vdc power supply, while the CAMI Research HVX tester was powered directly with 120V from a IEC C14 receptacle installed in the side of the Hardigg case. This allowed for a self-contained tester on wheels. The wires from the plug to the tester were replaced by a single multiconductor cable and 3D printed covers were installed over the tester terminal blocks to guard against unintended contact with high voltage during the test. Figure 12 shows the system packaged in the travel case.

Figure 12 Packaged tester, computer and plug

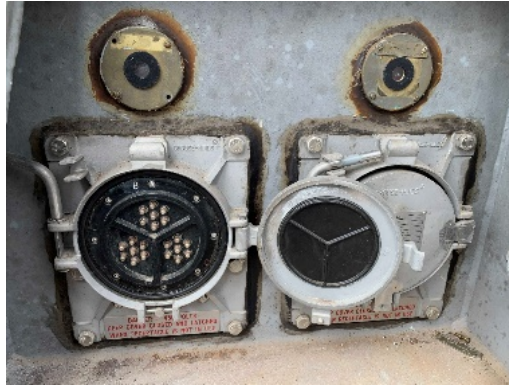
Testing was conducted on the receptacle at the starboard end of the shore power receiving station. There are twelve receptacles on this ship. See Figure 13. The ship was operating on generator power at the time, but the tested shore power receptacle circuit was secured and locked out, as per the MRC. The indicator light for the receptacle was first removed and then its fuse was pulled as per the MRC so that the light in the circuit did not influence the test. The tester was powered first from a shore power 120 VAC receptacle and later from ship's power (generator). Detailed notes about the test runs are included in Appendix B.

Figure 13 Two starboard most receptacles with indicator lights above

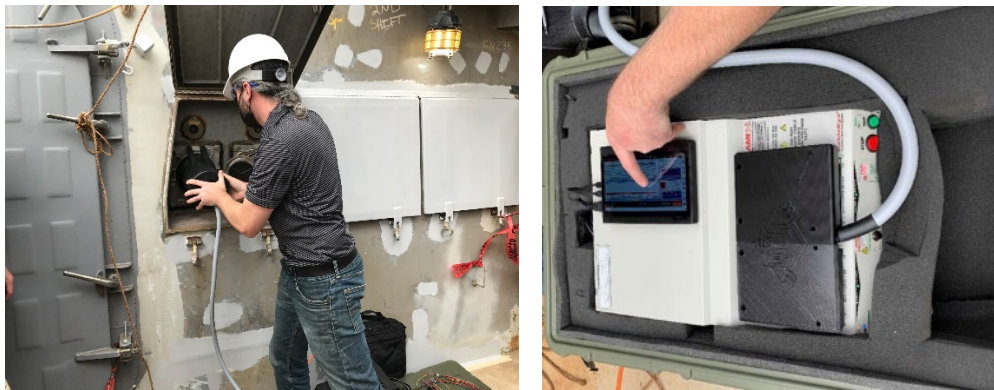
Figure 14 Inserting tester plug (L) and reading results on computer display (R)

Figure 14 shows the tester being demonstrated on the DDG 121.

The tester was unable to perform any tests with the shipboard shore power receptacle. The issue manifested itself in two ways. During the initial low voltage test, where the tester was seeking to verify that the circuit connected matched the circuit stored in its memory, it was unable to complete this test and continually repeated it. After a few minutes (around 10,000 of these measurements), the operator terminated the test. This happened for every test attempted with the tester connected to the ship receptacle. This occurred under all of the following conditions:

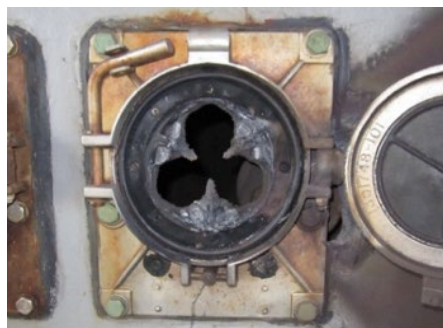
In 2018, while overhauling the USS Fitzgerald (DDG 62) an arc flash occurred on the #5 Shore Power receptacle. See Figure 15. This damage was extensive not only to the shore power receptacle, but also to the cable and corresponding circuit breaker. After this failure occurred, the local Navy team learned similar failures were occurring in the fleet. NAVSEA 05 and others were investigating the root cause of this issue. This resulted in the development of a new MRC card to test (megger) each pin to each other pin and ground. This new test drastically increases the amount of time it takes to perform shore power receptacle checks.

Figure 15 Damage from connector arc flash event

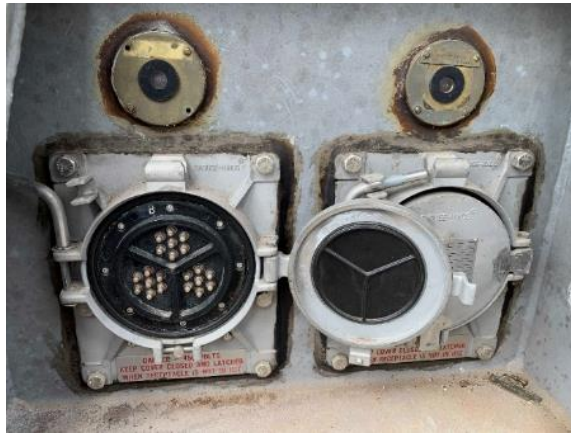
Shipyard facilities provide shore power to ships under construction through the shore power receiving stations. The electrical service provided may vary based on the ship class. Electrical service for an Arleigh Burke (DDG 51) Class Guided Missile Destroyer is 3 phase, 450 VAC. The shore power receiving station on a DDG 51 class ship includes twelve (12) receptacles as shown in Figure 16. Each receptacle is inspected and tested as per procedures given in MRC 65 2PN5 N. The shore power connector test includes verifying proper pin connections and insulation resistance for each of the twelve receptacles of the shore power receiving station. Insulation resistance readings are manually taken using a handheld meter similar to the Megger illustrated in Figure 2, above. Test results are noted for each of the pin to pin and pin to hull readings. This test is conducted each time the ship is transferred to shore power.

Figure 16: Shore Power Receiving Station (Two of twelve receptacles shown)

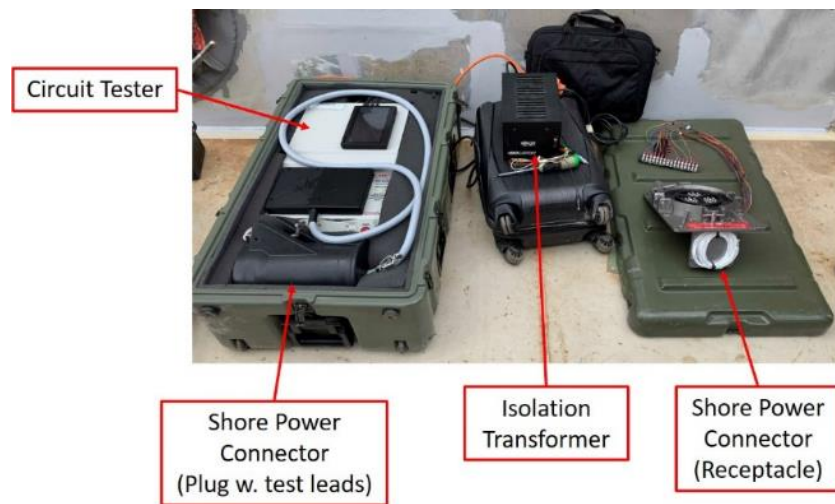
The proof of concept system was demonstrated at Ingalls Shipbuilding on October 6, 2020 aboard DDG 121. The shipboard demonstration system is shown in Figure 17. As illustrated, the system was packaged in a protective case for transport to the ship and a small computer interface (Figure 18) was added (replacing the laptop used in the lab demonstration). In addition to the test system, two additional pieces of hardware are shown; an isolation transformer was needed for the test set-up and a separate receptacle was provided to demonstrate simulated faults. The evaluation process included shipboard testing and laboratory testing. Testing conducted onboard DDG 121 included a test of shore power receptacle #12, followed by a demonstration of faults using a separate demonstration receptacle provided by the Project Team. The onsite testing and demonstration provided an overview of the proposed automated circuit testing approach. Additionally, this provided an opportunity to field test the system and identify any impacts of the shipboard environment that are not present in controlled laboratory testing. Additional detail is included in Section 2.6.

Figure 17 Field Demonstration System

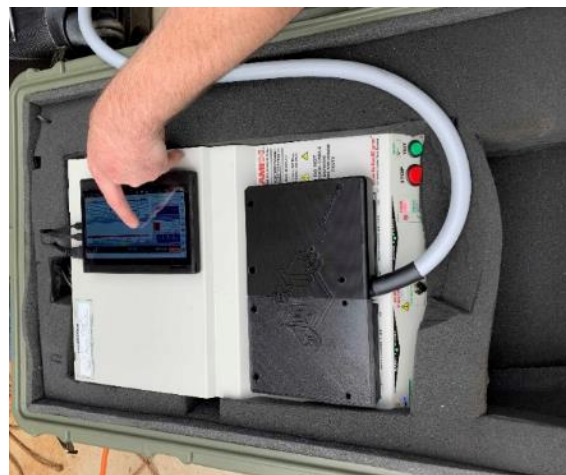
Figure 18 Shore Power Circuit Tester – Onboard Computer Interface and Test Results
