Verification of Fire Protection of Shipboard Electric Cables Using Intumescent Coating

24 September 2025

Hepburn and Sons LLC

NSRP Panel Project

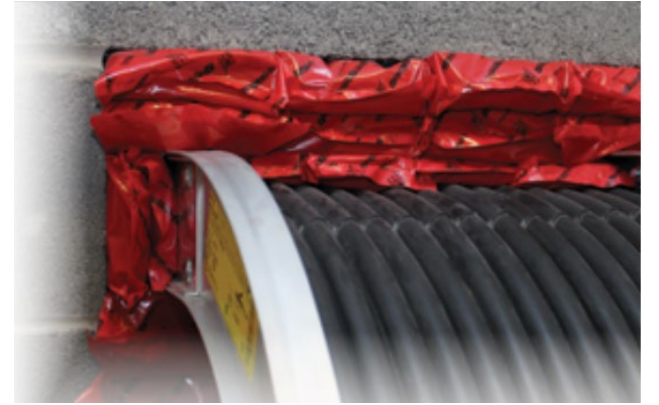
- Intumescent process releases gases as part of a chemical reaction triggered by thermal exposure
- Gas production with solid structure combines to form the char layer
- Char layer provides insulation and protection
- Products exist in various forms including sealants, paints, bricks, pillows and more.

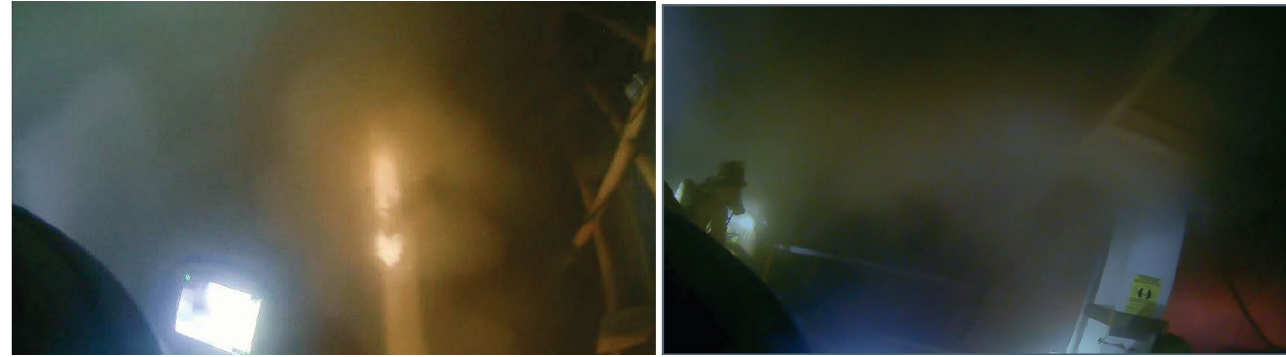
Helmet-cam view inside BHR published in Command Investigation into the Fire Aboard BHR

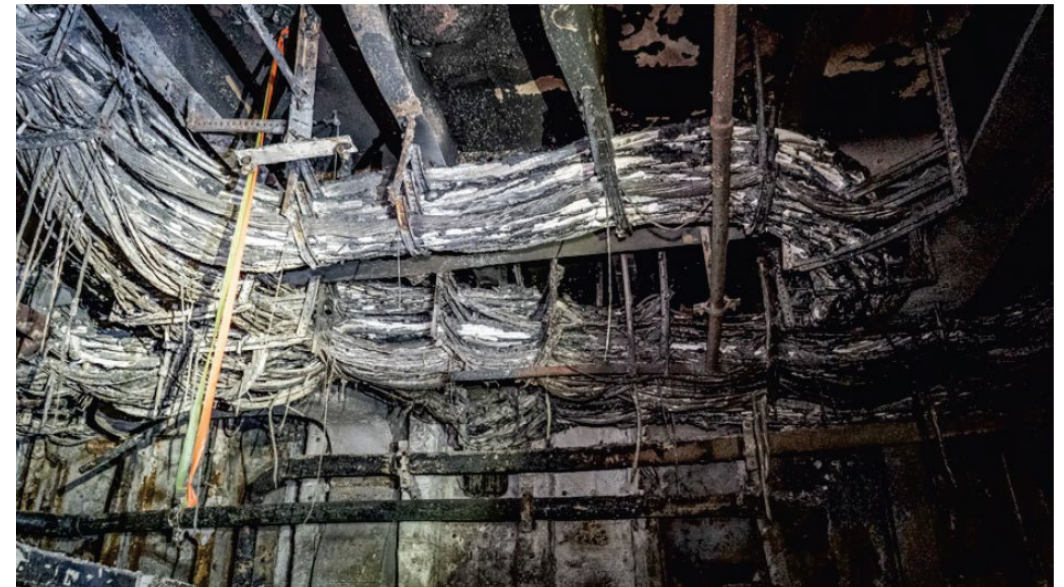
Damaged cableways published in Command Investigation into the Fire Aboard BHR

“Fire extensively damaged cables and cableways spanning the entire length of BONHOMME RICHARD” & “The entire 4 MILLION feet of combat systems and C5I cabling would require replacement.”
SECTION IX.

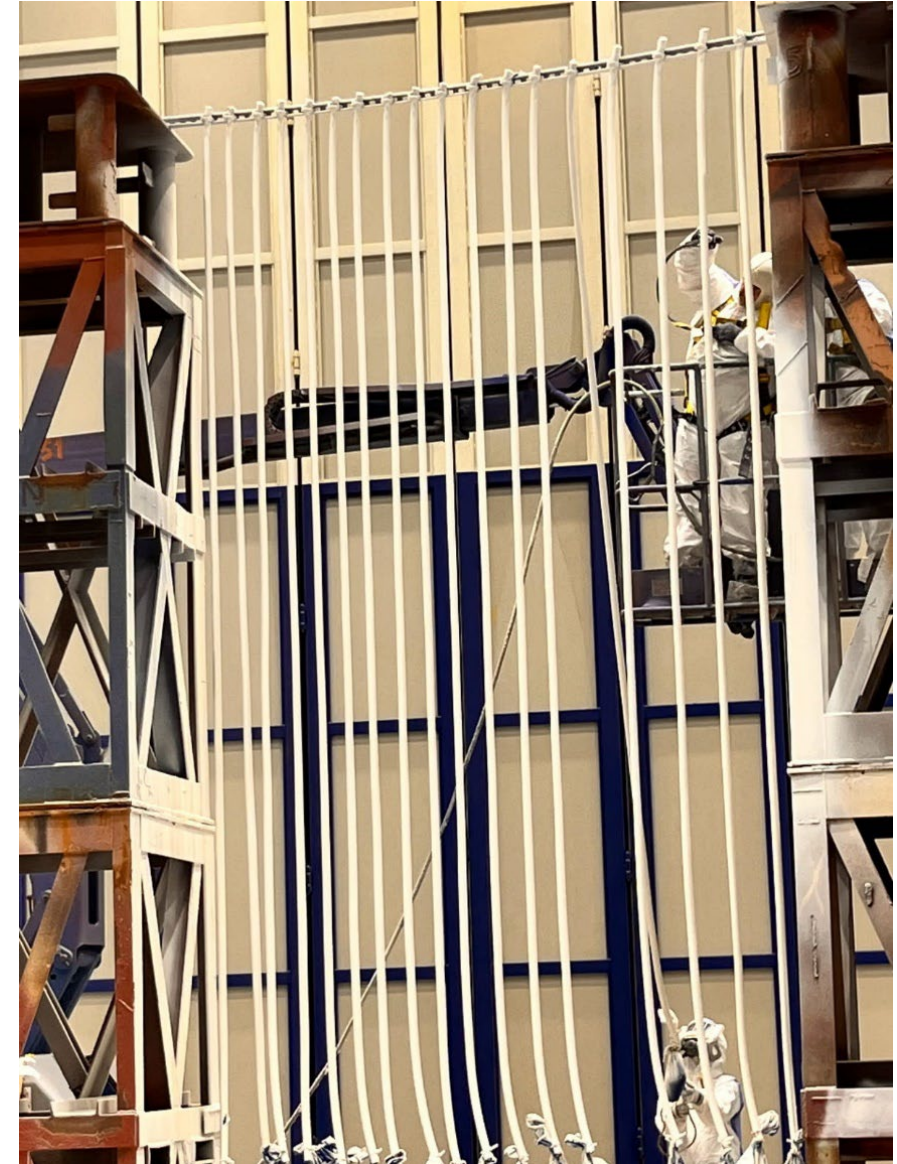
- FMM procured approximate 600 feet of cable necessary for test execution
 - LS2SWU-12 per MIL-DTL-24643/33G
- STI delivered MCC to FMM, provided virtual training on recommended equipment configuration and application and had personnel on site during coating process.
- FMM established internal coating instructions, QA procedures, and shipping plans.
- Cables were coated during the week of 16 April.

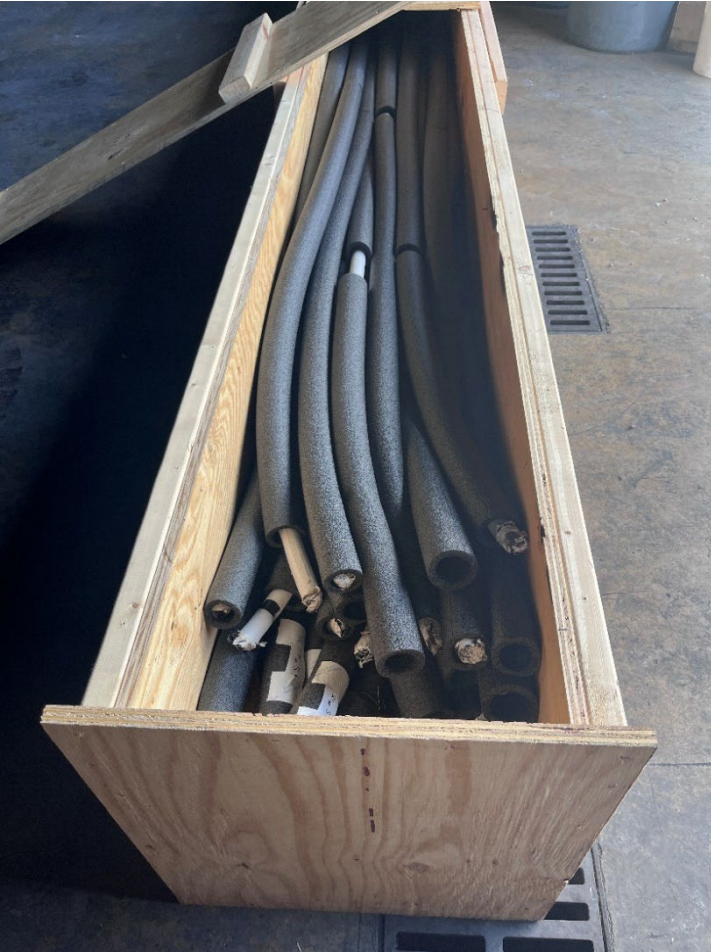
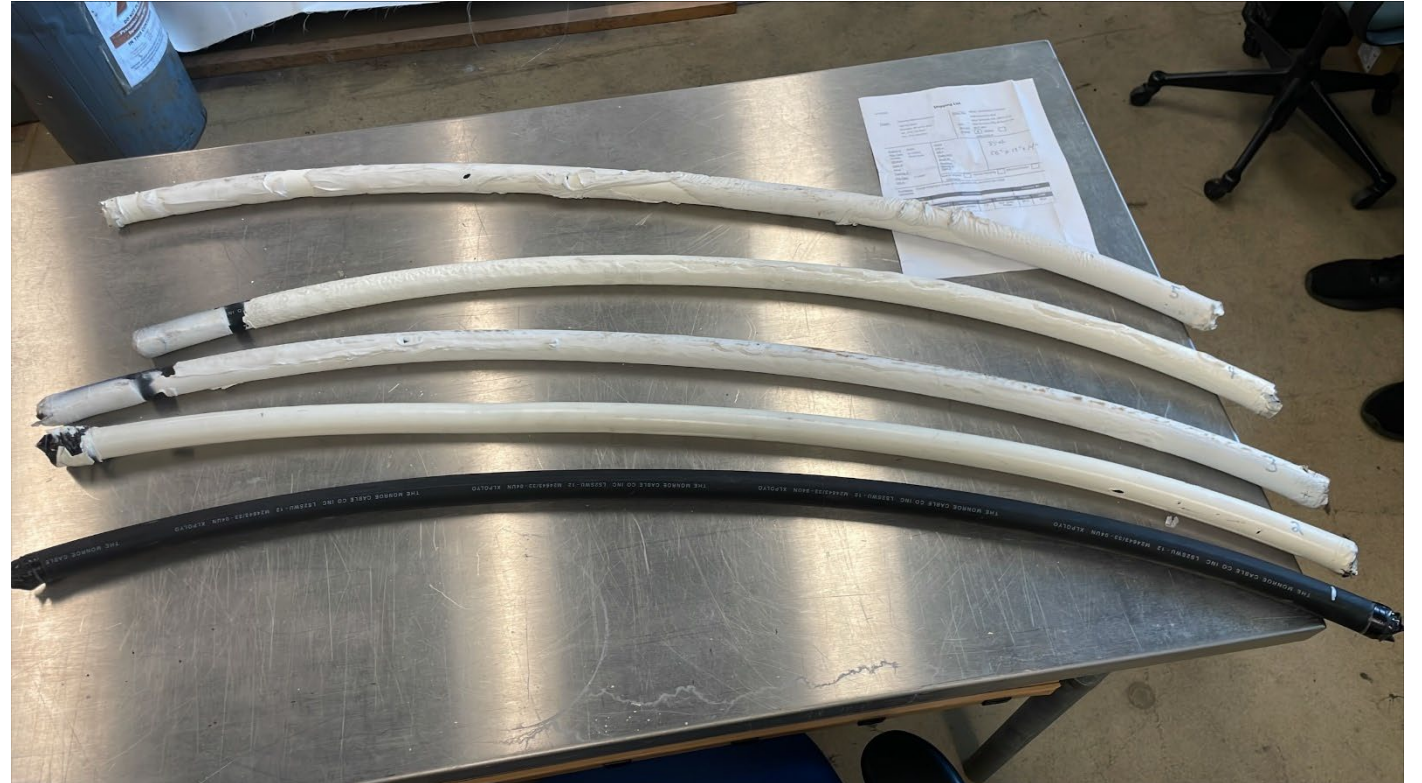
- Test Cables were shipped to both SWRI and NSWCCD during the week of 20 June.

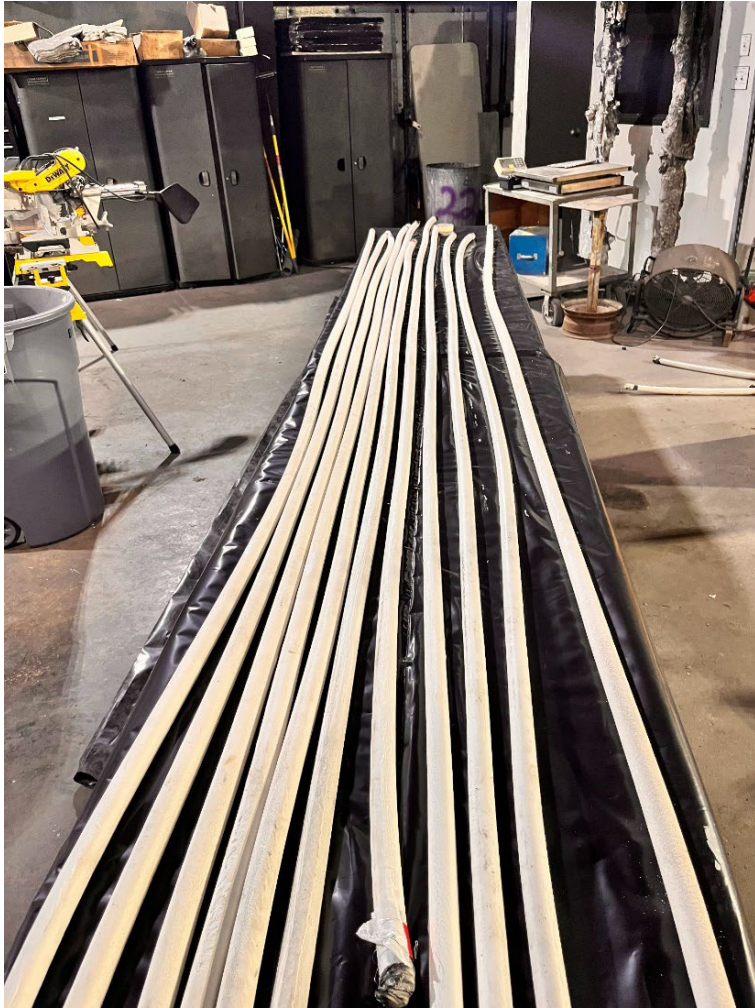
STI had personnel at SWRI to inspect and repair coated cables from any damage from shipping during the week before testing. (20 August)

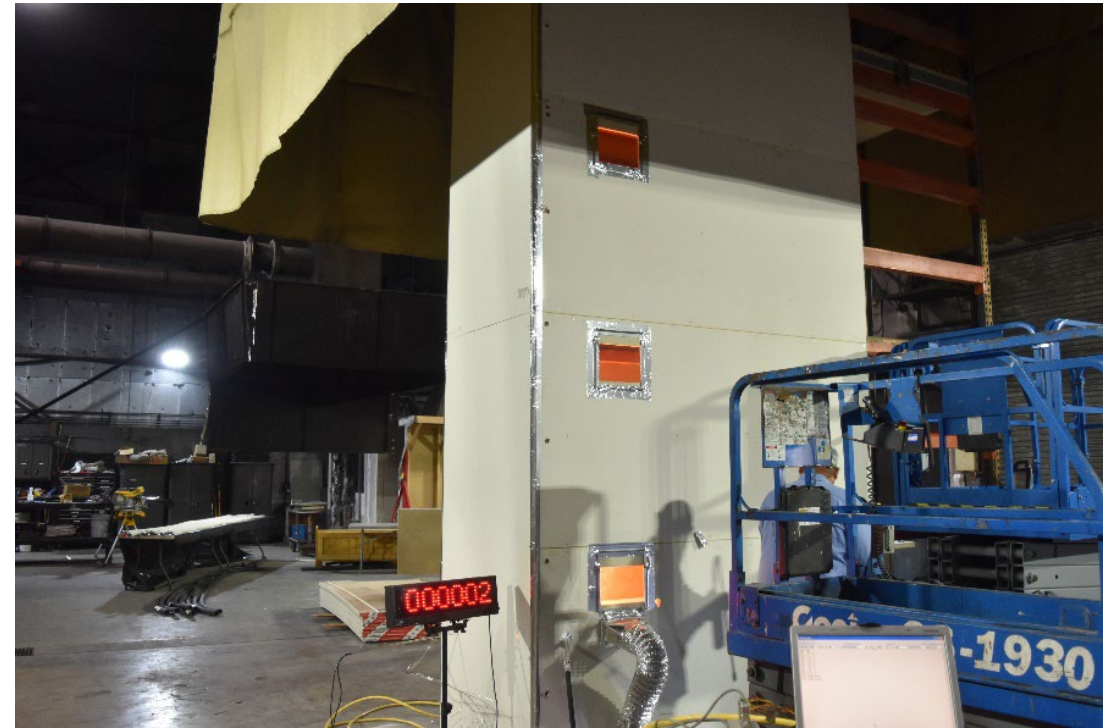
SWRI prepared the Fire Chamber for testing

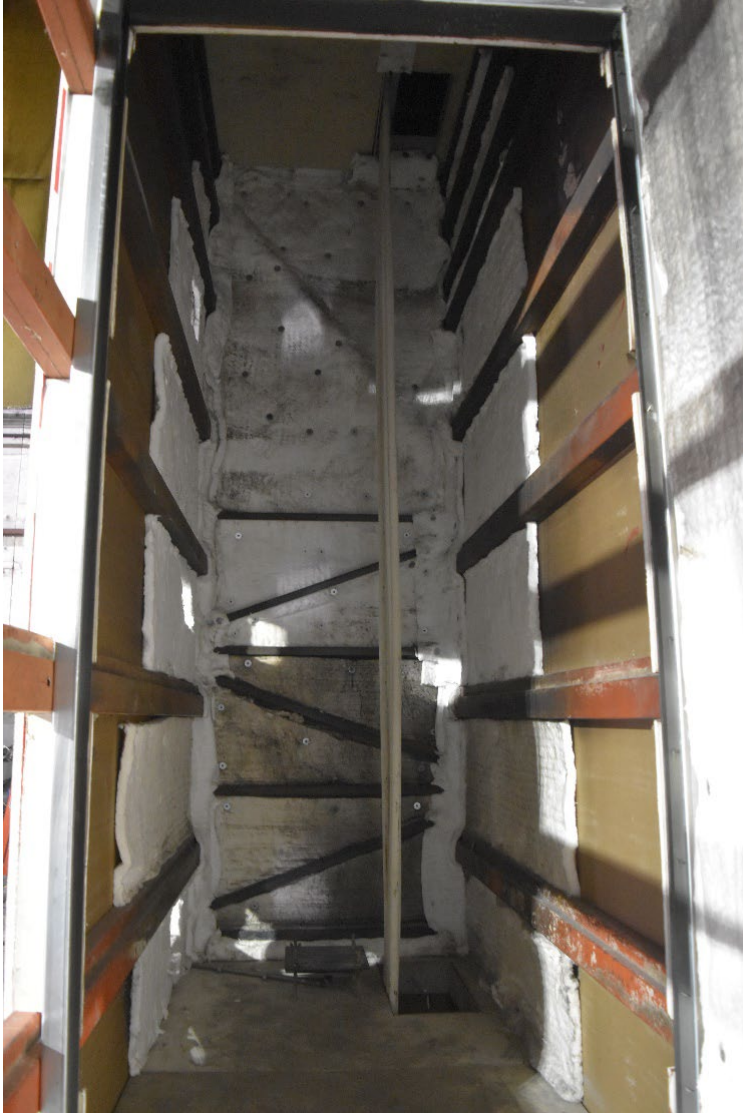
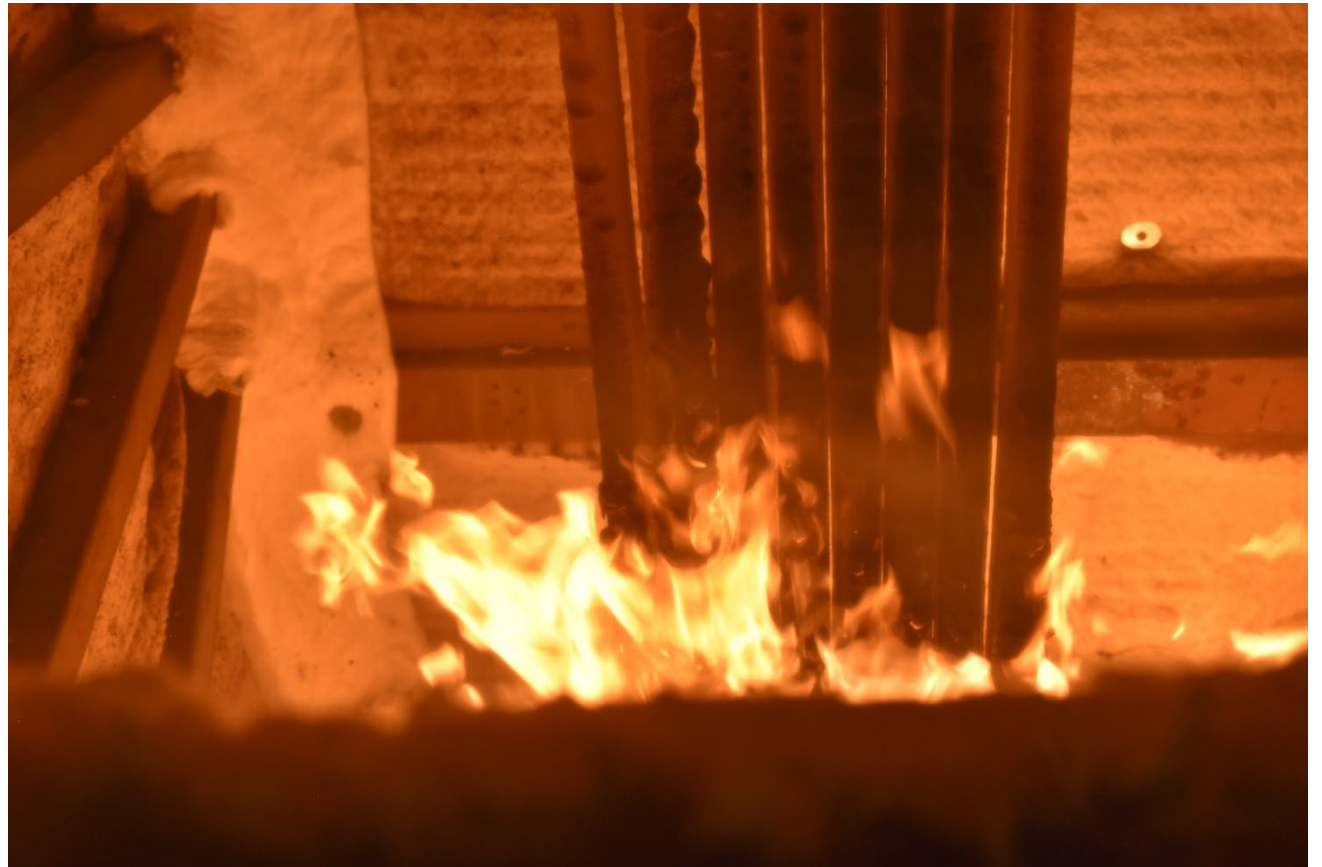
Coated Cable Setup and Test

- As of 19 September, SWRI had not provided their Report and Findings to Hepburn.
- From the pictures received from SWRI, it appears the coating system did not perform as expected.
- Final determination of coating performance and comments will be made once the SWRI information has been received and reviewed. Results will be provided in the project's Final Report.

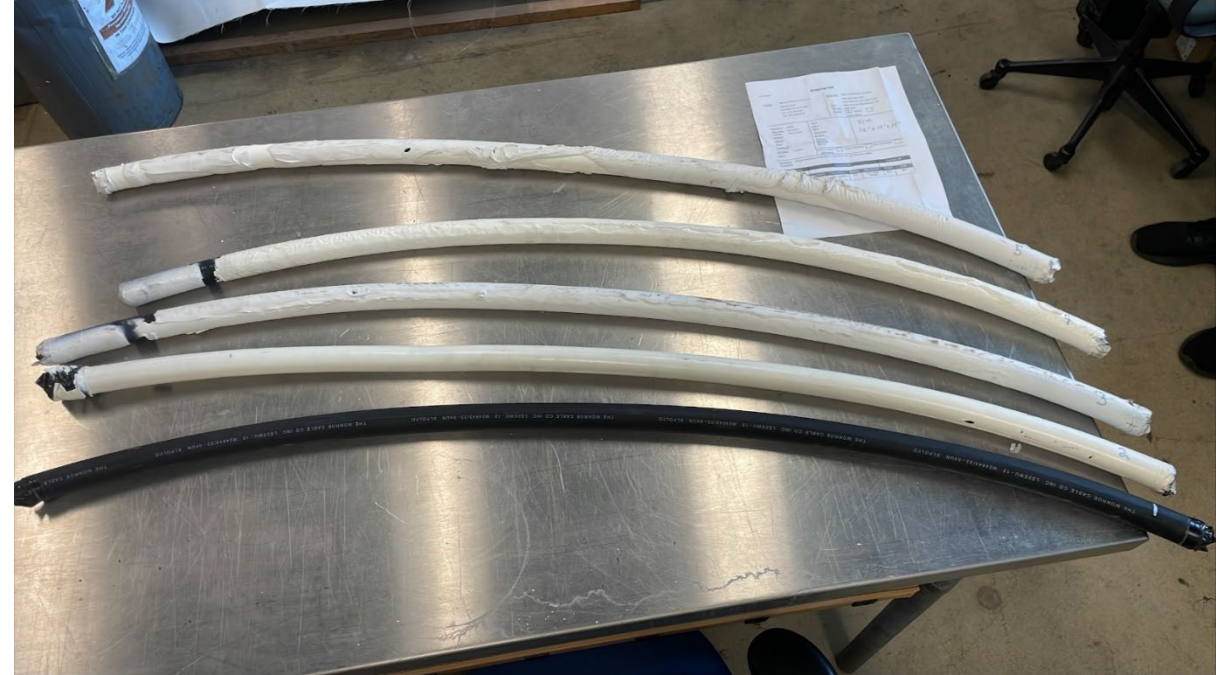
- Cone Calorimetry testing at NSWCD has been delayed due to broken equipment. The needed parts have been ordered and awaiting delivery.
- Concerns have been raised regarding the coating application quality from NSWCD personnel.
- Once testing is completed, NSWCD personnel will provide their report to Hepburn. Results will be included in the Final Report.
