# Testing and Analysis of Anti-Biofouling Coatings

NSRP Surface Preparation & Coatings Meeting  
Hampton, VA  
September 9, 2025

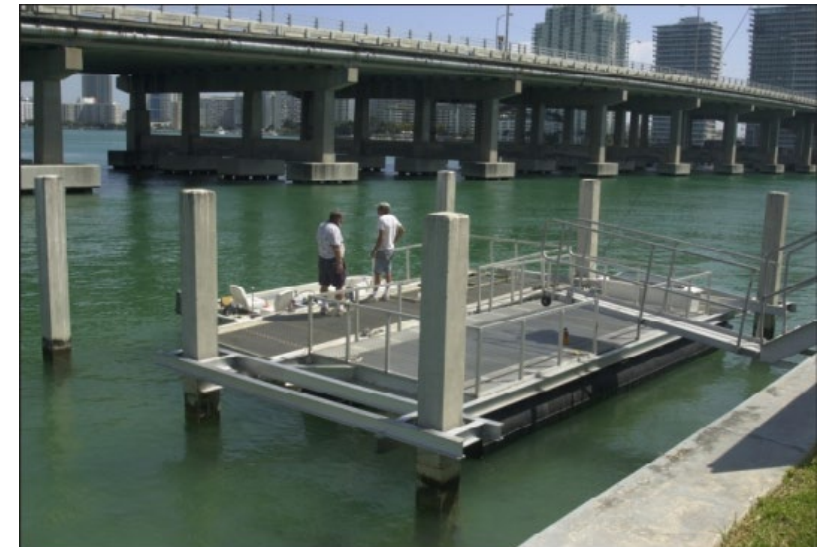
- Fiberglass panels for exposure (12"x6"x0.25")
- 12 panels per vendor
  - 3 panels per rack
  - Allowed up to 4 variations of coating
- Evaluated simultaneously against conventional MIL-PRF-24647 variants: Interspeed 640, Intersleek 1100SR
- Caged, horizontal submersion in Biscayne Bay
- Monthly inspections of status
- Flow testing at NRL Key West facility at conclusion

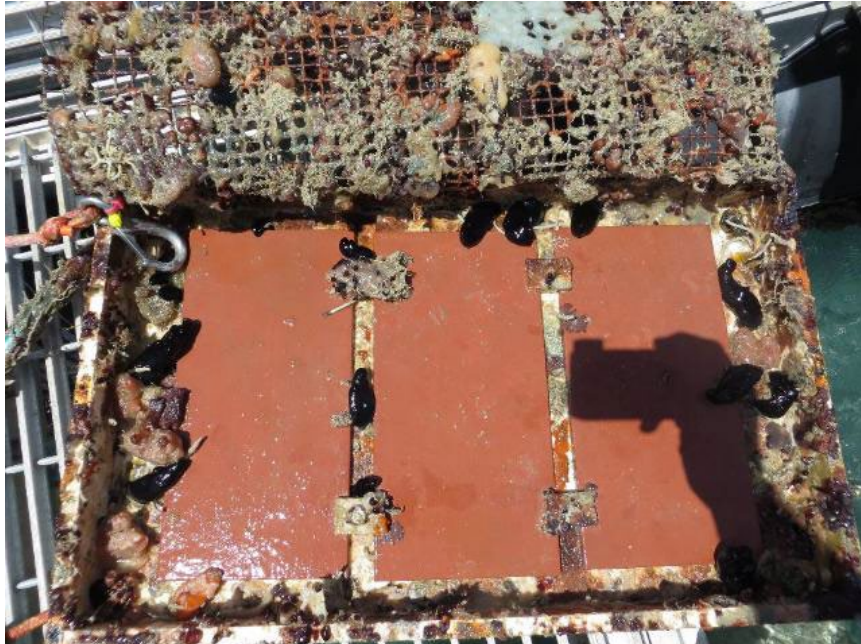
Intersleek  
1100SC

Intersleek 1100 – 10-15% fouled  
most likely overgrowth  
anchored off test sample.

- Most samples appear not to have ablative properties like the Interspeed BRA 640 (control) as they are exhibiting heavy fouling. Biofouling consists of mostly soft organisms, with the possibility of some hard fouling.

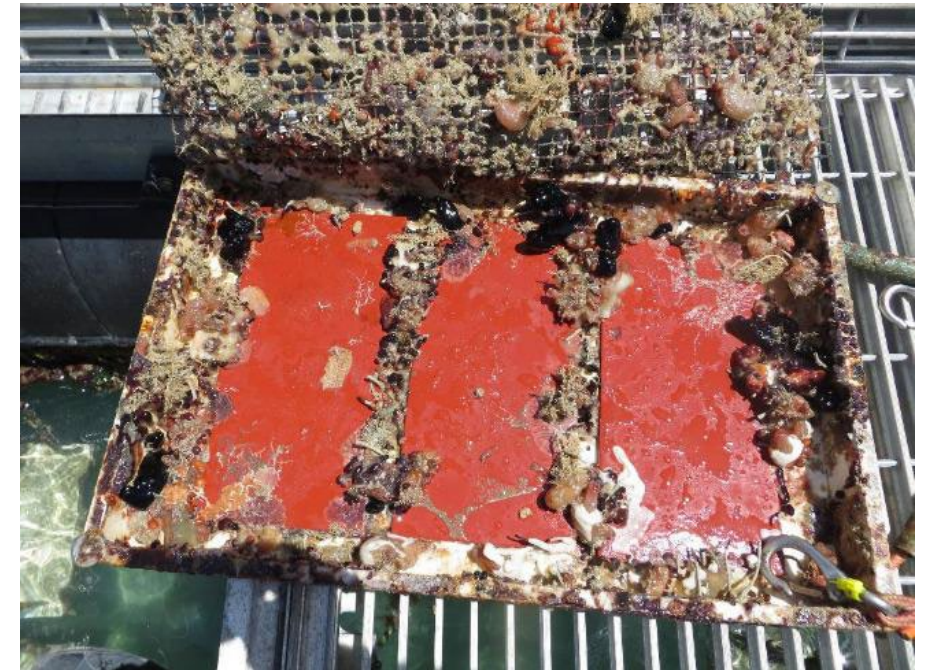
Interspeed  
BRA 640

BRA 640 – 0%, fouled ablative  
coating.

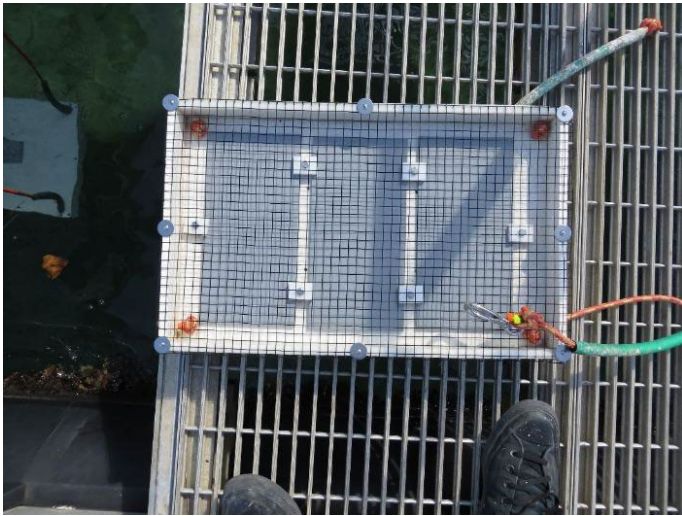
BIPB1

90% or more fouled with soft fouling, (black solitary tunicates, orange & brown colonial tunicates, white mat tunicates, dark brown encrusting bryozoans, light brown branching arborescent bryozoan), and possibly some hard fouling (mangrove oysters), under the others.

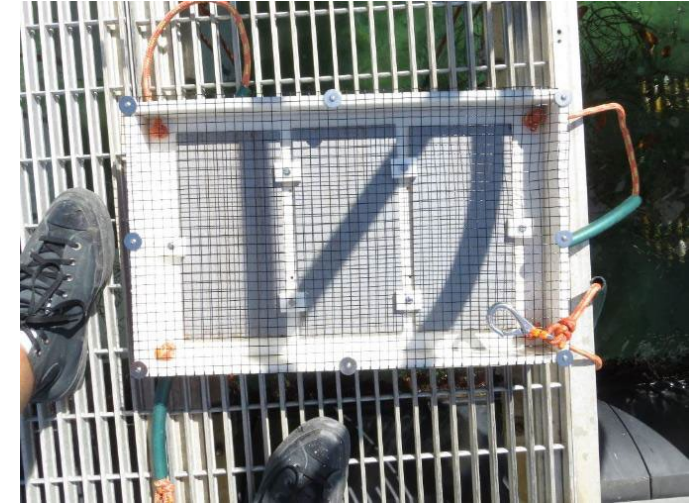
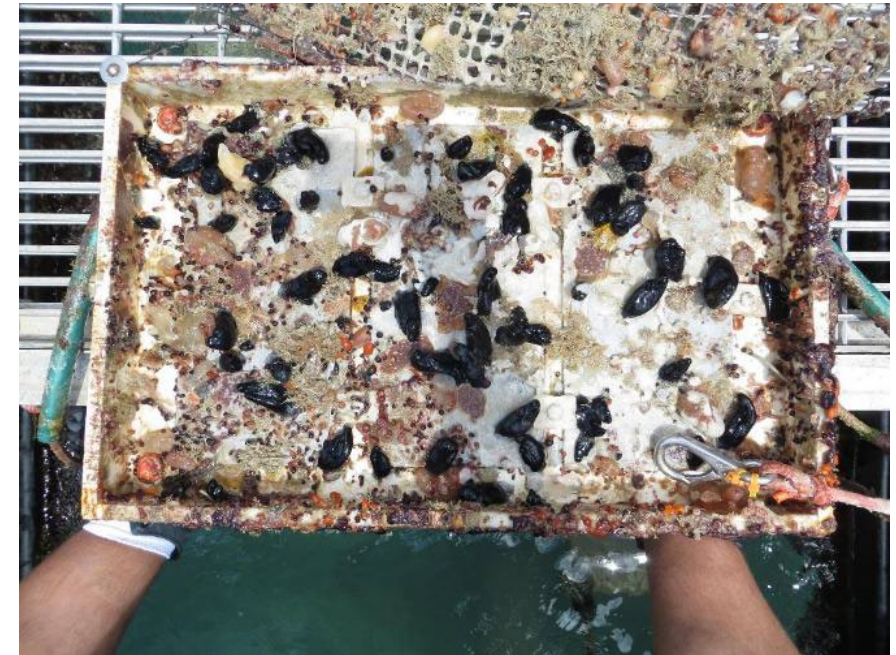
BIPX1

90% or more fouled with soft fouling, (black solitary tunicates, orange & brown colonial tunicates, white mat tunicates, dark brown encrusting bryozoans, light brown branching arborescent bryozoan), and possibly some hard fouling (mangrove oysters), under the others.

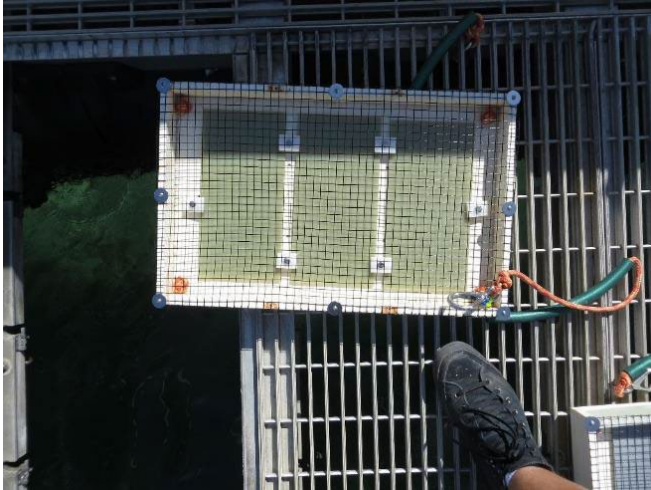
Group 1

95% or more fouled with soft fouling, (black solitary tunicates, dark brown encrusting bryozoans), and slight possibly of some hard fouling (mangrove oysters).

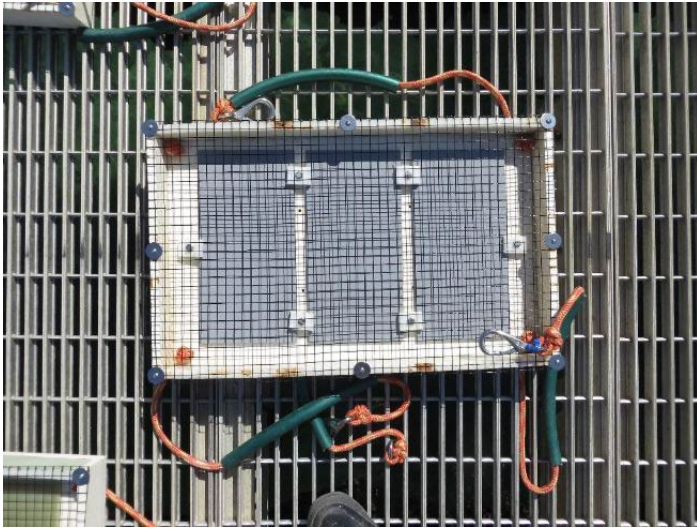
Group 3 - 90% or more fouled with soft fouling, (black solitary tunicates, pink tunicates, white mat tunicates, orange colonial tunicates), and some hard fouling (mangrove oysters).

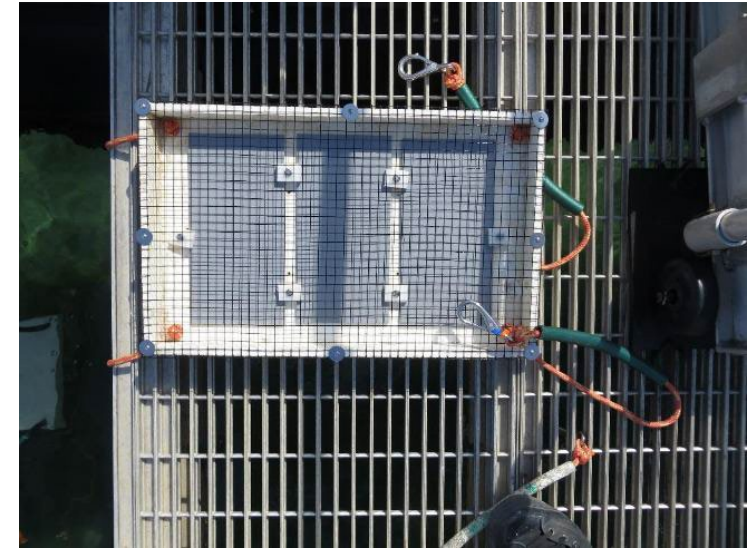
Group 4 - 70% or more fouled with soft fouling, (black solitary tunicates, pink tunicates, and white mat tunicates, orange colonial tunicates), and some hard fouling (mangrove oysters).

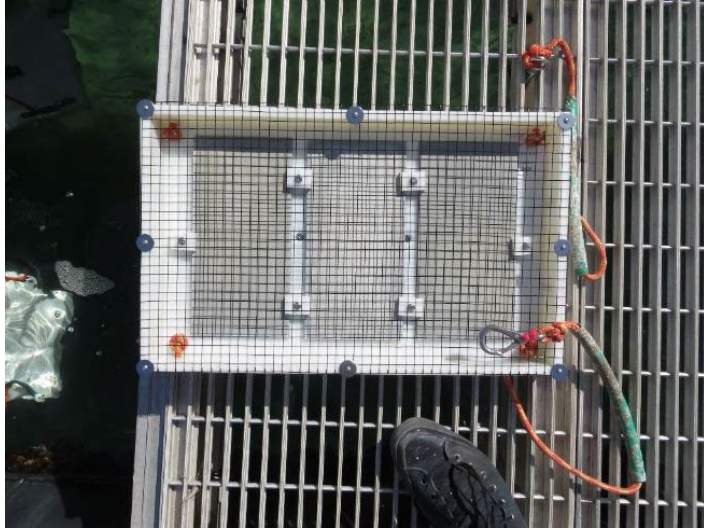
Group 1 - 95% or more fouled with soft fouling, (black solitary tunicates, pink tunicates, white mat tunicates, orange & brown colonial tunicates, light brown branching arborescent bryozoan), and slight possibly of some hard fouling (mangrove oysters).

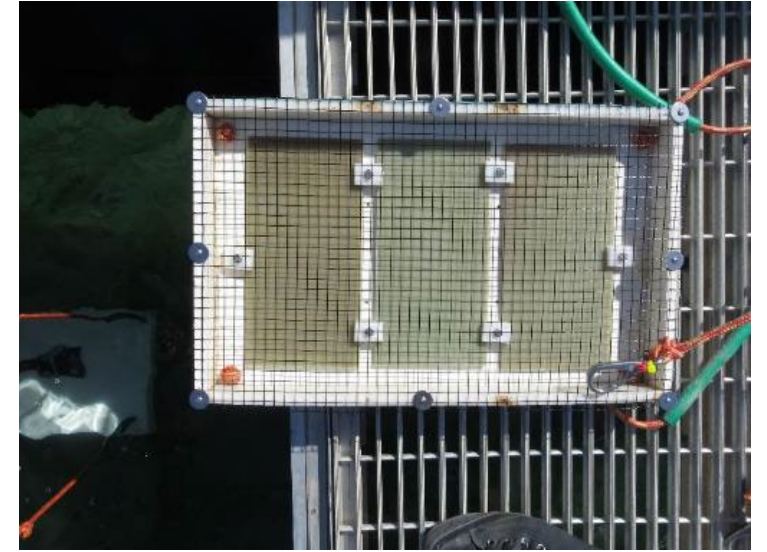
Group 2 - 95% or more fouled with soft fouling, (black solitary tunicates, pink tunicates, white mat tunicates, orange & brown colonial tunicates, light brown branching arborescent bryozoan, brown encrusting bryozoans), and some hard fouling (mangrove oysters).
