Review of Acceptable Flash Rusting for Ship Coatings

Final Report

Advanced Technology Institute

Atlantic Marine Florida, LLC
Elzly Technology Corporation

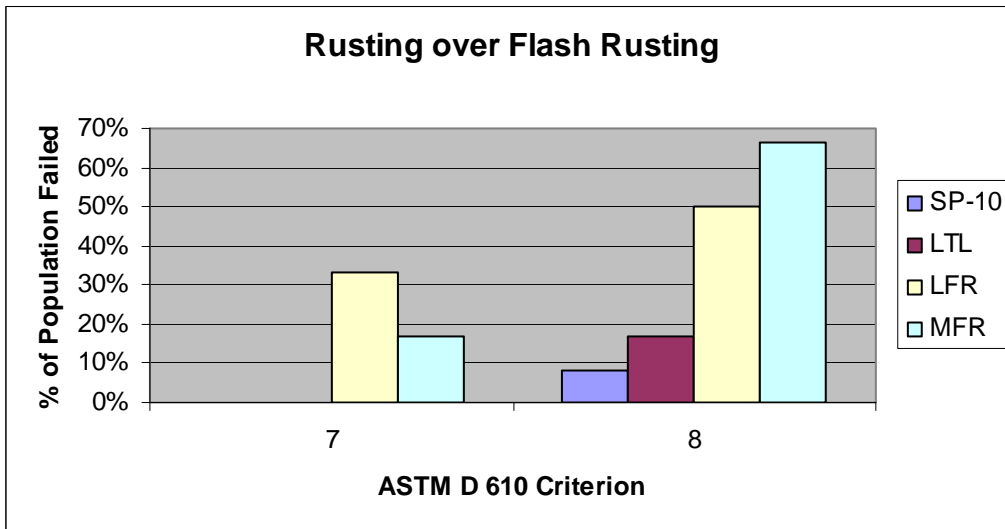
Figure 1 - Percent of Population Failing for Different ASTM D 610 Criterion

Figure 1 plots the percent failed at the end of testing assuming an ASTM D 610 failure criteria of “8” (corresponding to 0.1% of the surface with corrosion) and a rating of “7” (0.3% surface corrosion). First, observe that the percentage of the test panels which failed varies depending on how failure is defined (i.e., as “7” or “8”).

Consider the data associated with a failure criterion of “8” in Figure 1. The data show that flash rust per se, tends to increase rust-through vs. a clean surface. Increased levels of flash rusting correlate with incremental coating failure over conditions ranging from clean steel to medium flash rust.

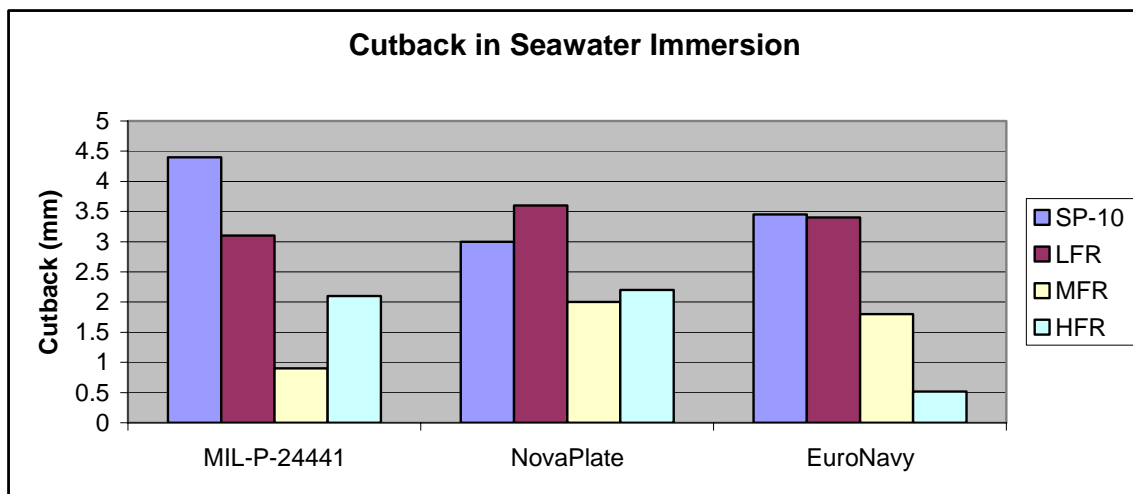
Figure 2 - Cutback on Flash-Rusted Panel (Freely Corroding)

Figure 2 shows a plot of the magnitude of cutback from an intentional scribe following 9 months of seawater exposure. The data do not show a gross effect of surface condition on the extent of cutback – all of the observed levels are low within the context of other, similar controlled tests. This data implies that flash rust may not decrease coating performance if the flash rust is free of invisible contaminants (e.g., salts).

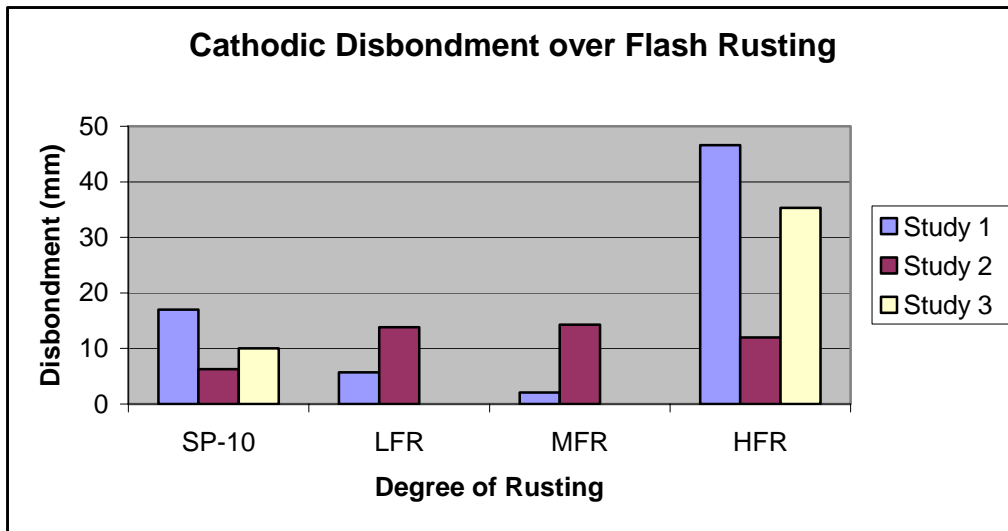
Figure 3 - Cathodic Disbondment over Flash Rusting

The Navy strives to employ some form of cathodic protection on all immersed surfaces. Thus, cathodic disbondment may be of more concern in an immersion environment as compared to the underfilm cutback for freely corroding steel. Figure 3 shows a compilation of cathodic disbondment data for immersion coatings applied over clean steel and flash rusted steel in three studies. The first two studies were previously described. The third study⁴ included panels that were water-jetted in a simulated seawater ballast tank; all of the panels were considered to be either SP-10 or medium/heavy flash rust (the data are plotted as heavy flash rust). In studies one and three,

heavy flash rusting seemed to cause significantly more coating disbondment vs. the SP-10 control surface. Study two showed negligible effect of flash rust on cathodic disbondment.

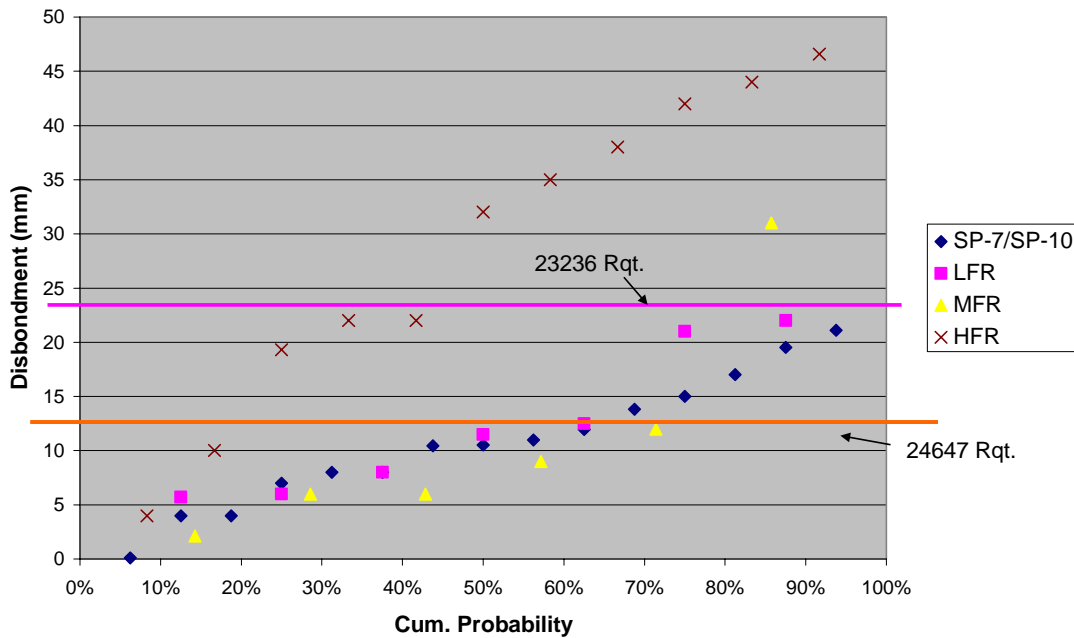
Figure 4 - Distribution of Cathodic Disbondment Cutback Data from Various Sources

Figure 4 is a probability distribution function for cathodic disbondment data from various studies in the literature. The plot shows that cathodic disbondment over “heavy” rusting is more significant than over SP-10, light, or medium conditions. This finding suggests that painting over heavy levels of flash rusting may be a concern. To place the finding into perspective, the two lines on the plot are requirements from MIL-PRF-23236 (4% of total panel surface area) and MIL-PRF-24647 (0.5 inch or 12.7 mm of cutback).⁵ Note that the mathematical mode (probability of 0.5) of the heavy

data is higher than the requirements for MIL-PRF-23236 and MIL-PRF-24647. The data for Light and Moderate flash rust has a similar trend to the data for the abrasive blasted surfaces. The performance in this test does not necessarily correlate to a given service life, but it does suggest that coatings could meet the specification requirements when applied over Light and Moderate levels of flash rust. The similarity of the data suggests a similar level of risk for performance over these two levels of flash rust and abrasive blasting.

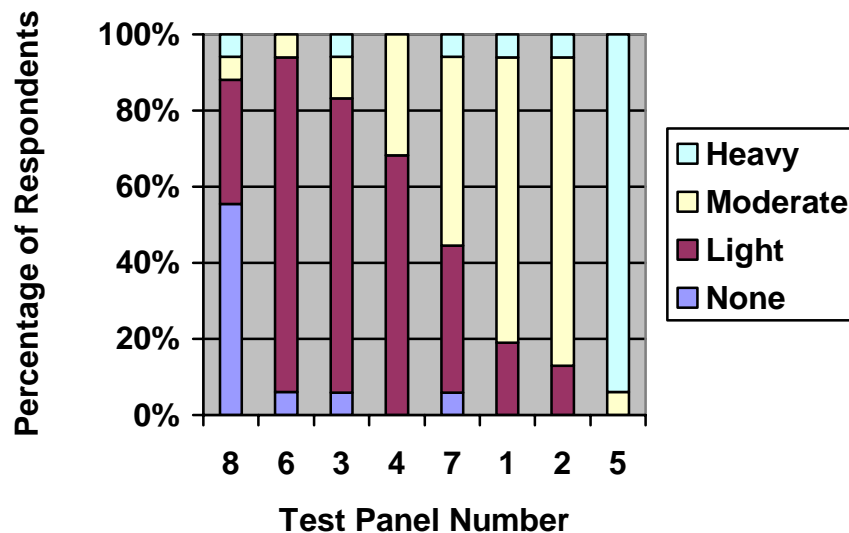
Figure 14. Distribution of Panel Ratings.

Appendix C contains photographs and detailed results for each of the test panels in the study. Figure 14 shows a summary of the percentage of people rating each panel “light,” “moderate,” or “heavy.” In Appendix C and in Figure 14, the panels are sorted in order from lightest to heaviest based on the average rating received.

The data suggest strong consensus on the panel judged to have “heavy” flash rust. All but one of the participants determined that this panel had heavy flash rust (94% agreement). The panels rated “light” or “moderate” had between 88% and 75% consensus with the exception of panel 7. There was significant disagreement over whether panel 7 had moderate (50%) or light (39%) flash rust.

Panel 8 was predominately judged to have no flash rust (56%), though it should be pointed out that much of the preconstruction primer remained on this panel after waterjet cleaning. The panel had a dark gray appearance with some pinpoint rusting where the primer was adequately removed.

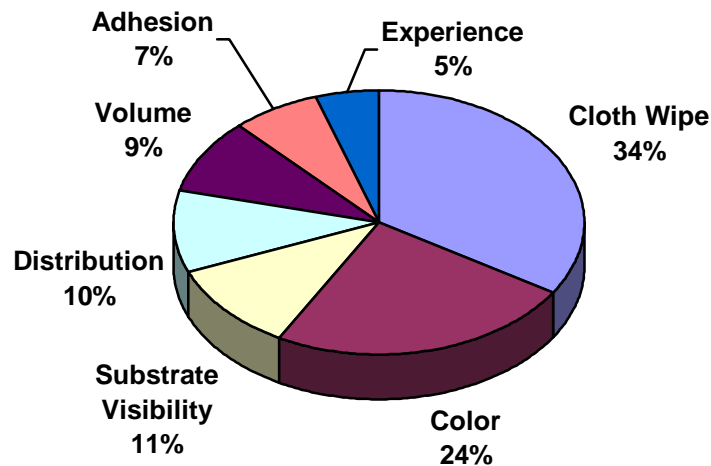
Figure 15. Criteria Reported to be Used in Determining the Level of Flash Rust

Each of the participants was asked to provide comments regarding the reason for their rating. About two-thirds of the ratings were accompanied by some comment regarding the reason for their rating. These comments were evaluated to see if any one criteria dominated the evaluations. Figure 15 shows the distribution of criteria reported by users to have factored into their rating. While the cloth wipe criteria is the most popular, it does not appear to overshadow other criteria (color, visibility of substrate, etc) in determining the level of flash rust.

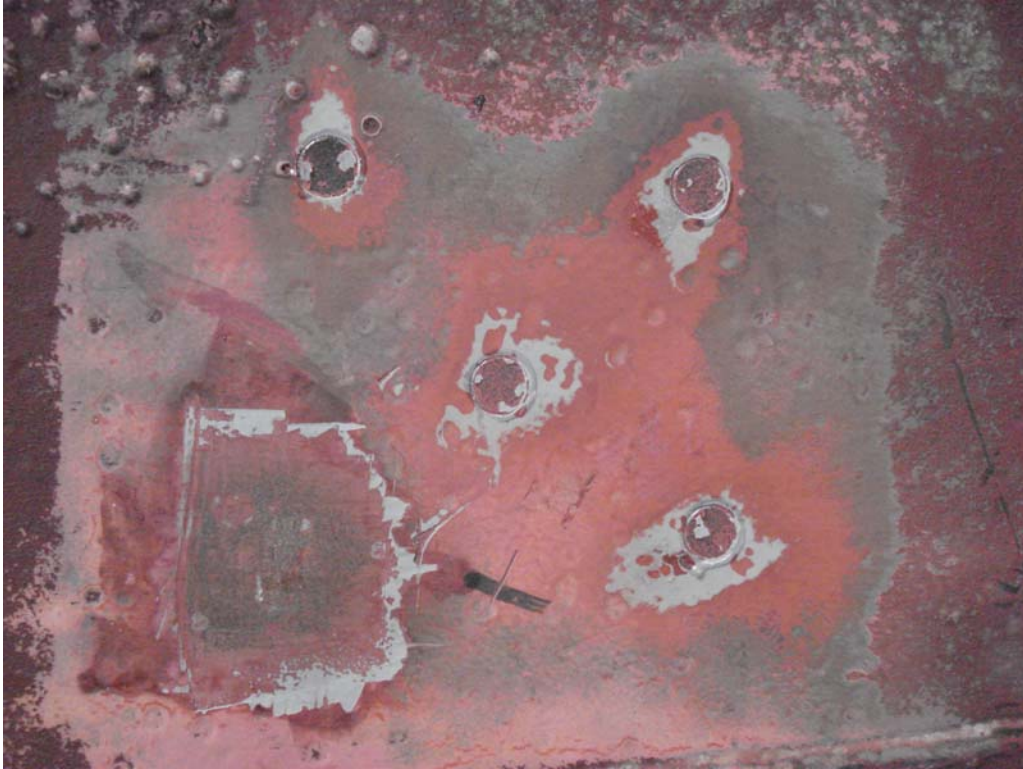
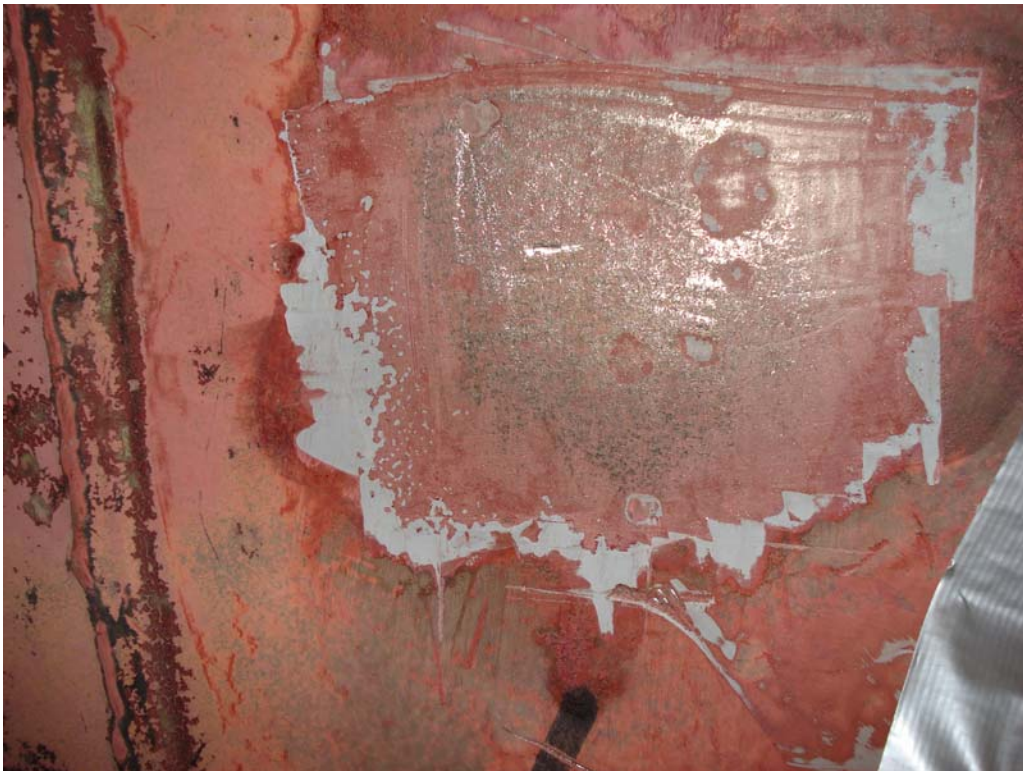
USS Boone Hull Coating Evaluation
Test Location 1

Photograph of test location 1 subsequent to test completion.

Exposed steel substrate at test location 1.

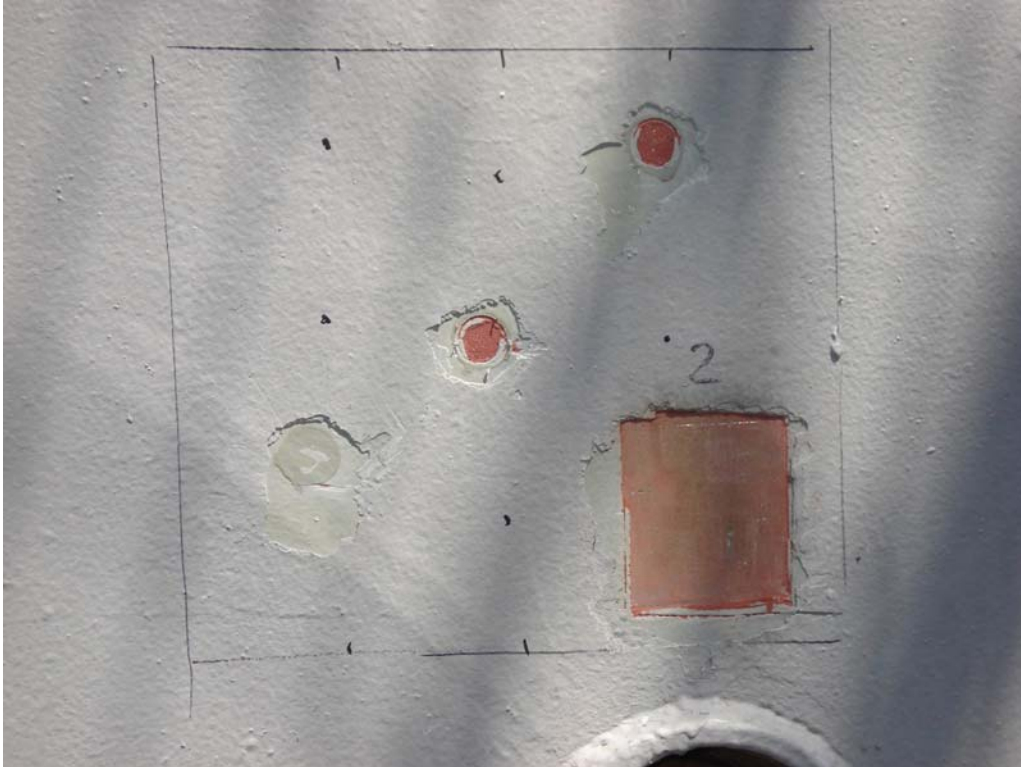
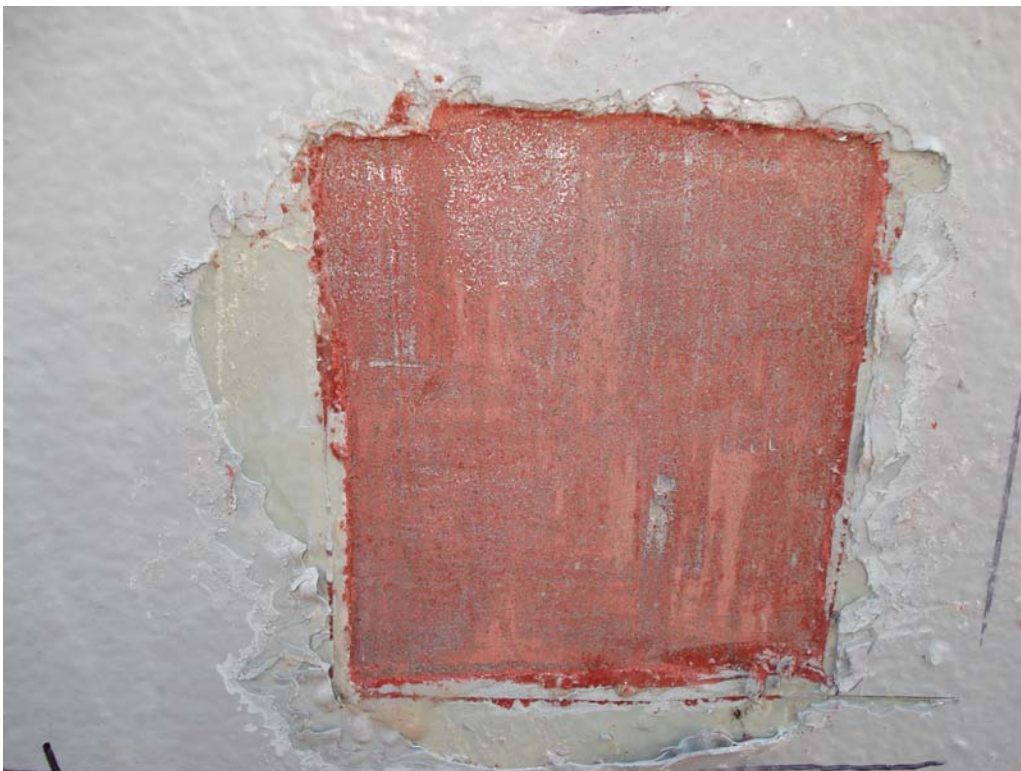
USS Boone Hull Coating Evaluation
Test Location 2

Photograph of test location 2 subsequent to test completion.

Exposed steel substrate at test location 2.

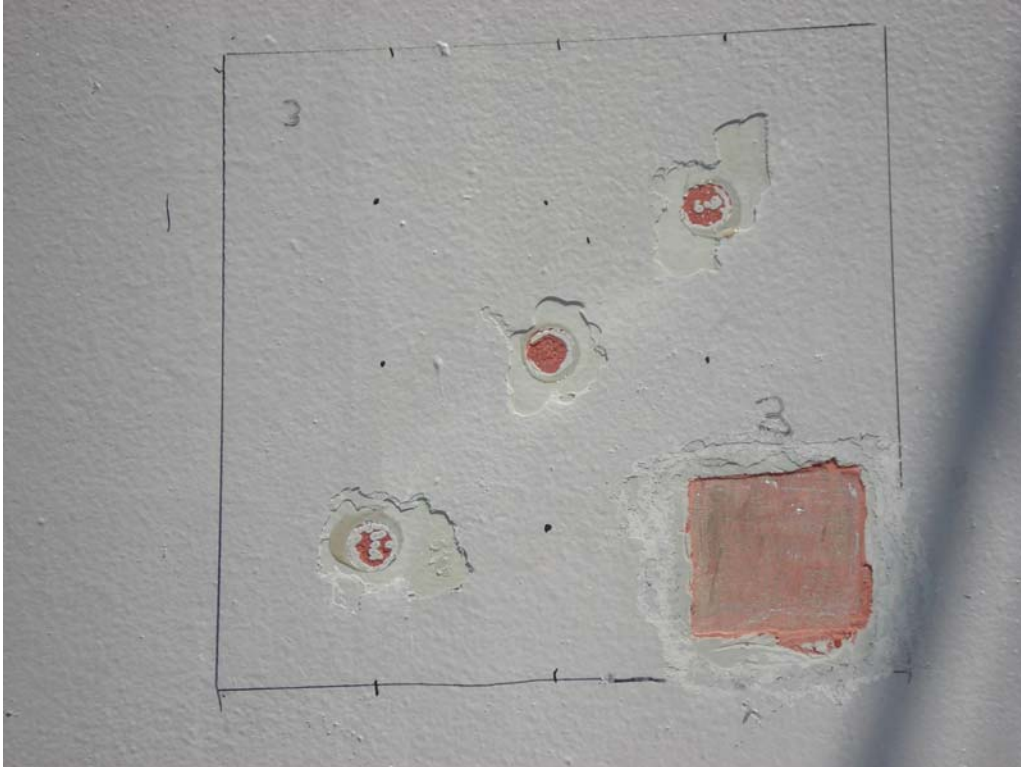
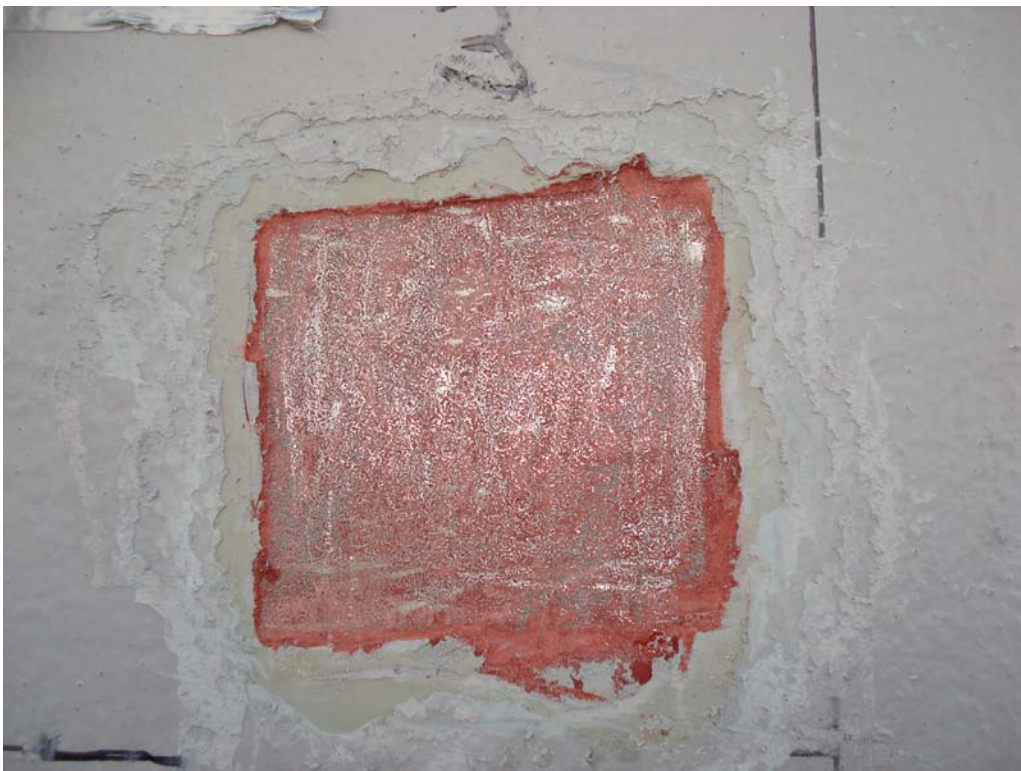
USS Boone Hull Coating Evaluation
Test Location 3

Photograph of test location 3 subsequent to test completion.

Exposed steel substrate at test location 3.

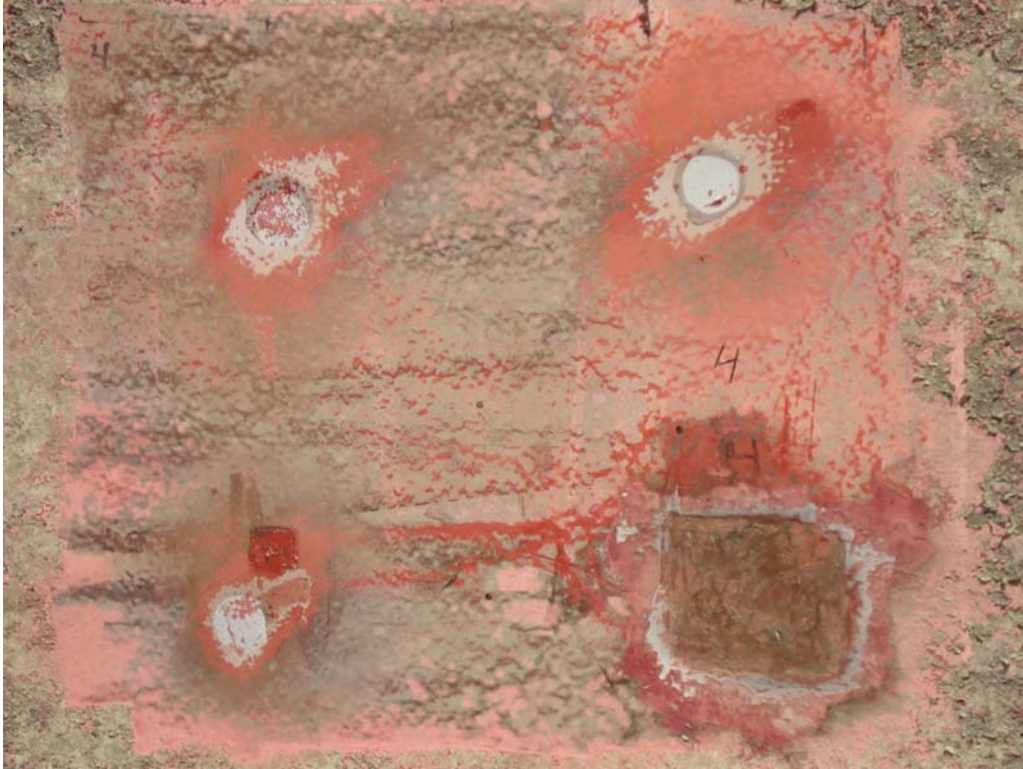
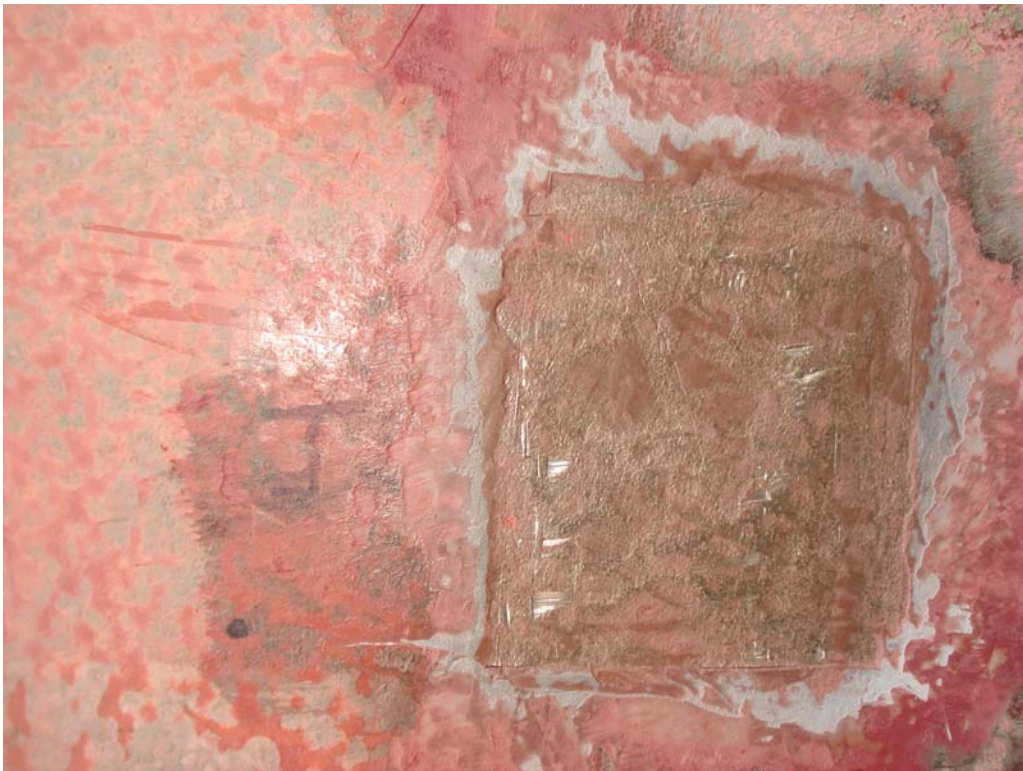
USS Boone Hull Coating Evaluation
Test Location 4

Photograph of test location 4 subsequent to test completion.

Exposed steel substrate at test location 4.

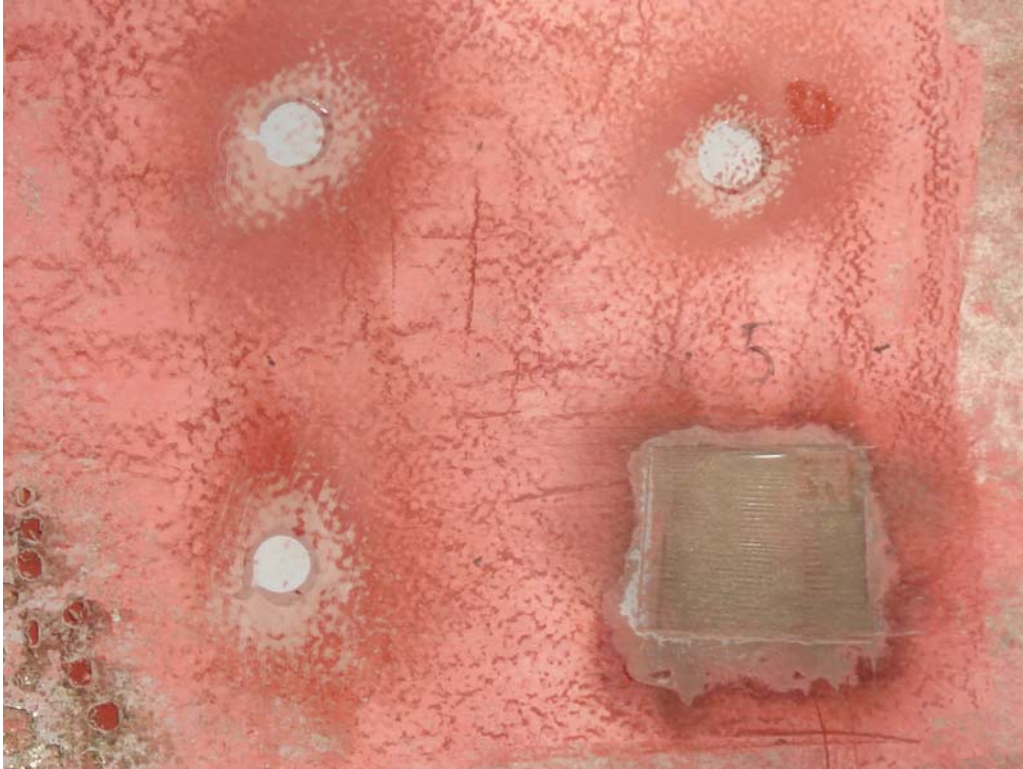
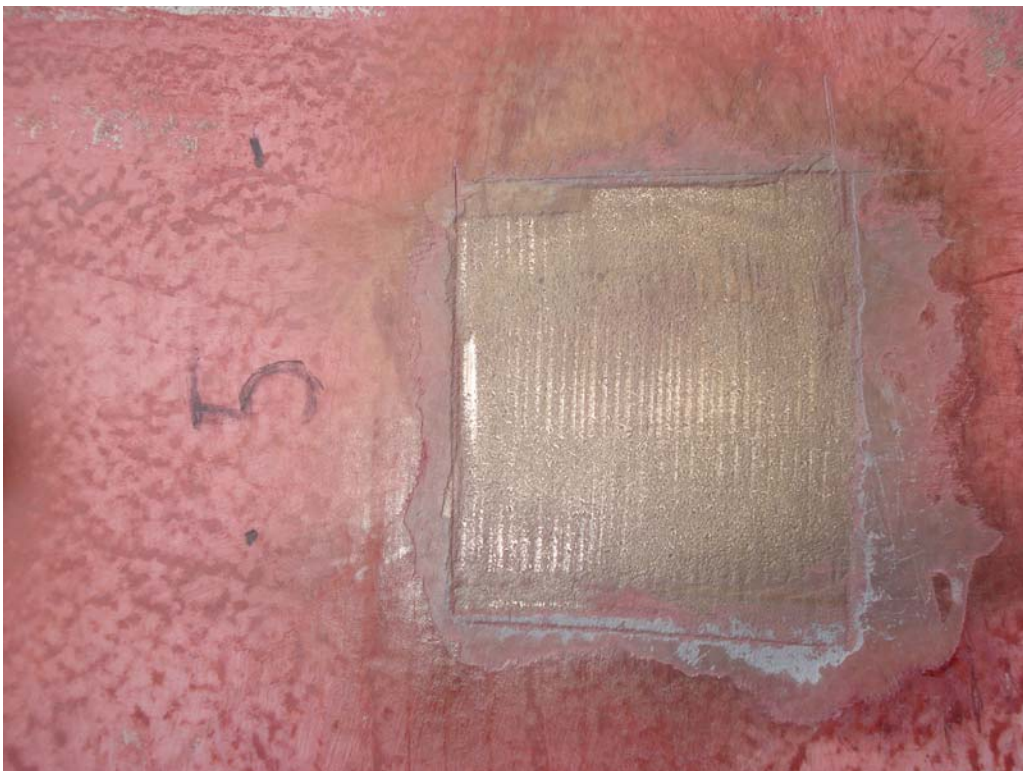
USS Boone Hull Coating Evaluation
Test Location 5

Photograph of test location 5 subsequent to test completion.

Exposed steel substrate at test location 5.

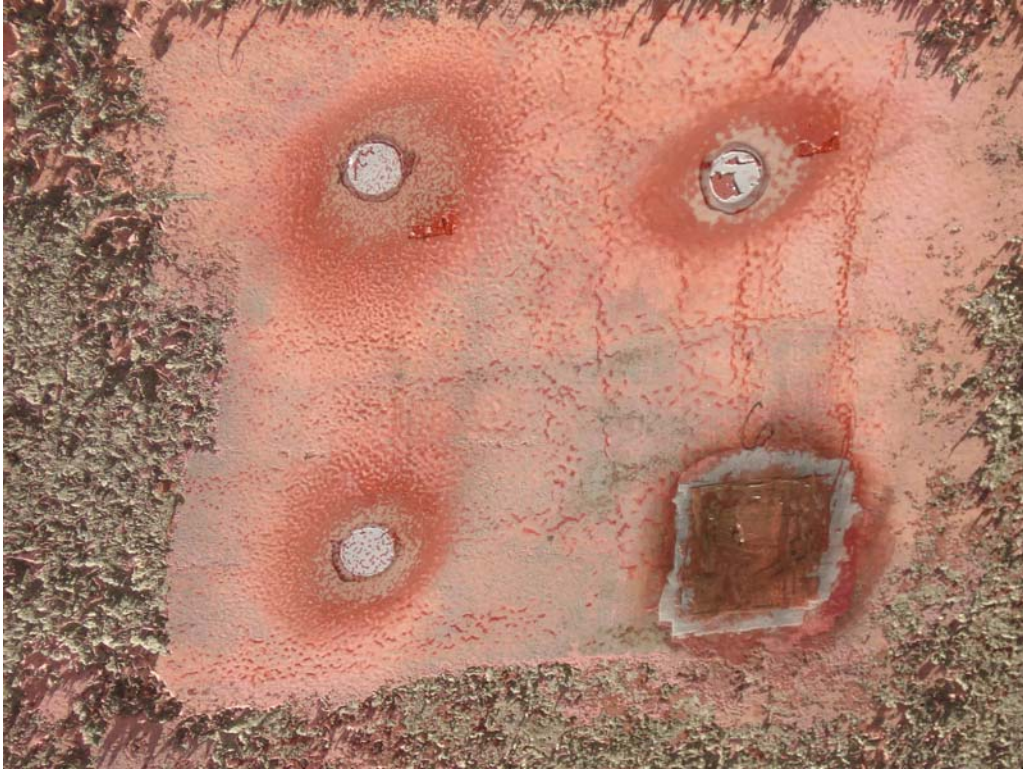
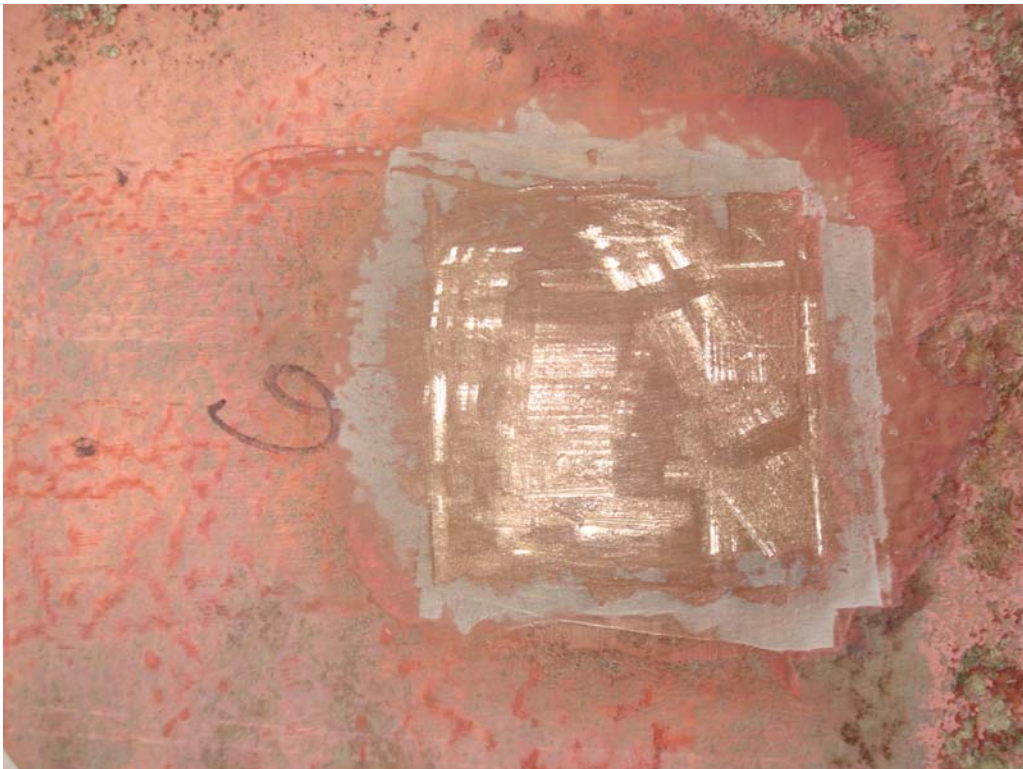
USS Boone Hull Coating Evaluation
Test Location 6

Photograph of test location 6 subsequent to test completion.

Exposed steel substrate at test location 6.

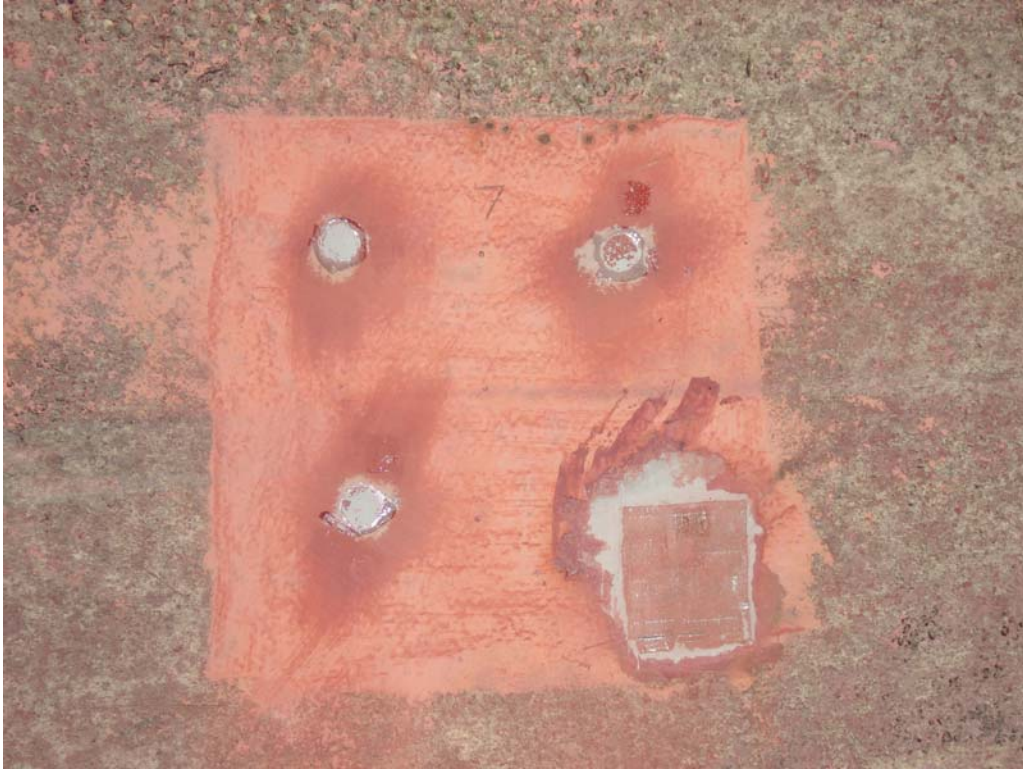
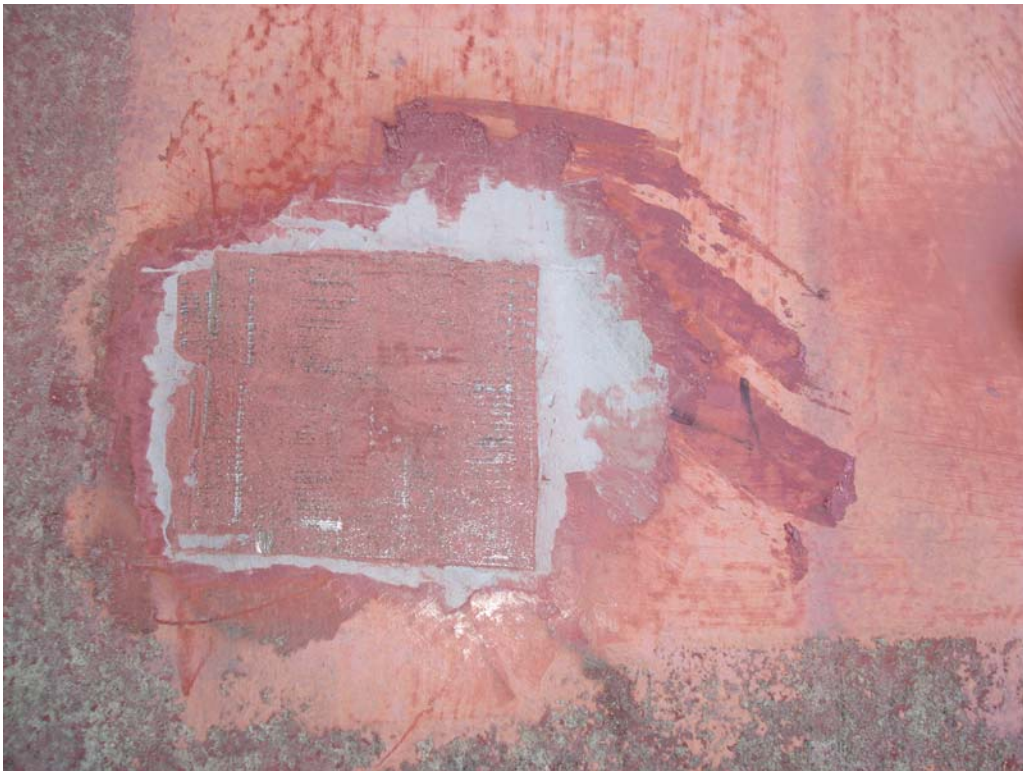
USS Boone Hull Coating Evaluation
Test Location 7

Photograph of test location 7 subsequent to test completion.

Exposed steel substrate at test location 7.

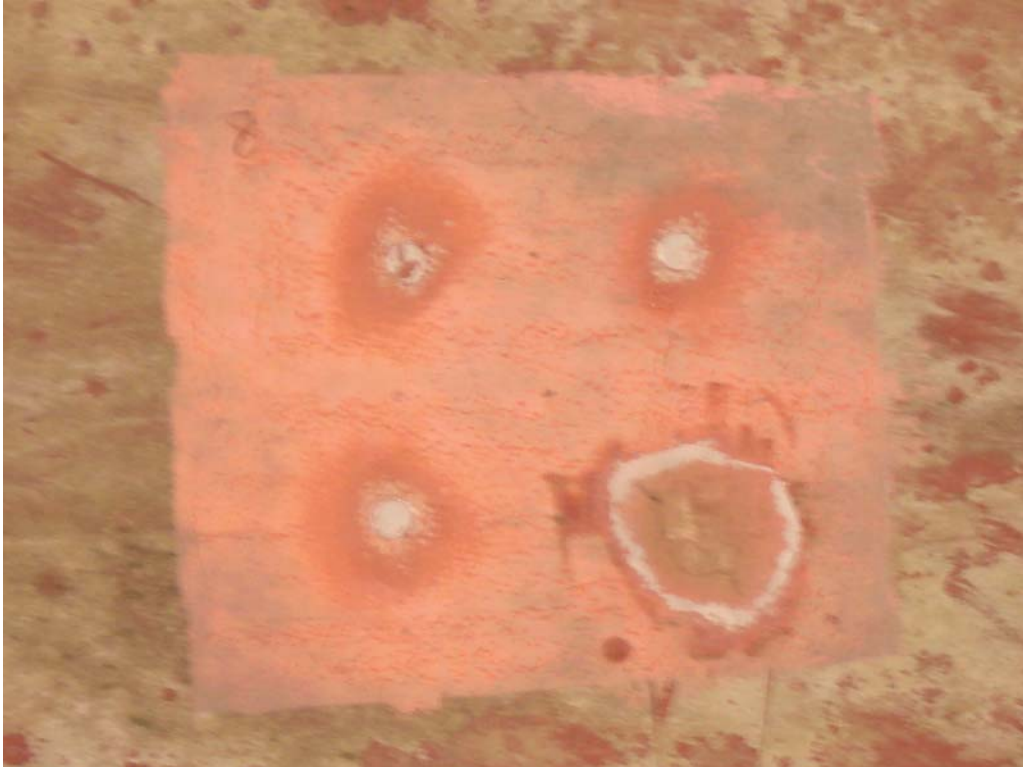
USS Boone Hull Coating Evaluation
Test Location 8

Photograph of test location 8 subsequent to test completion.

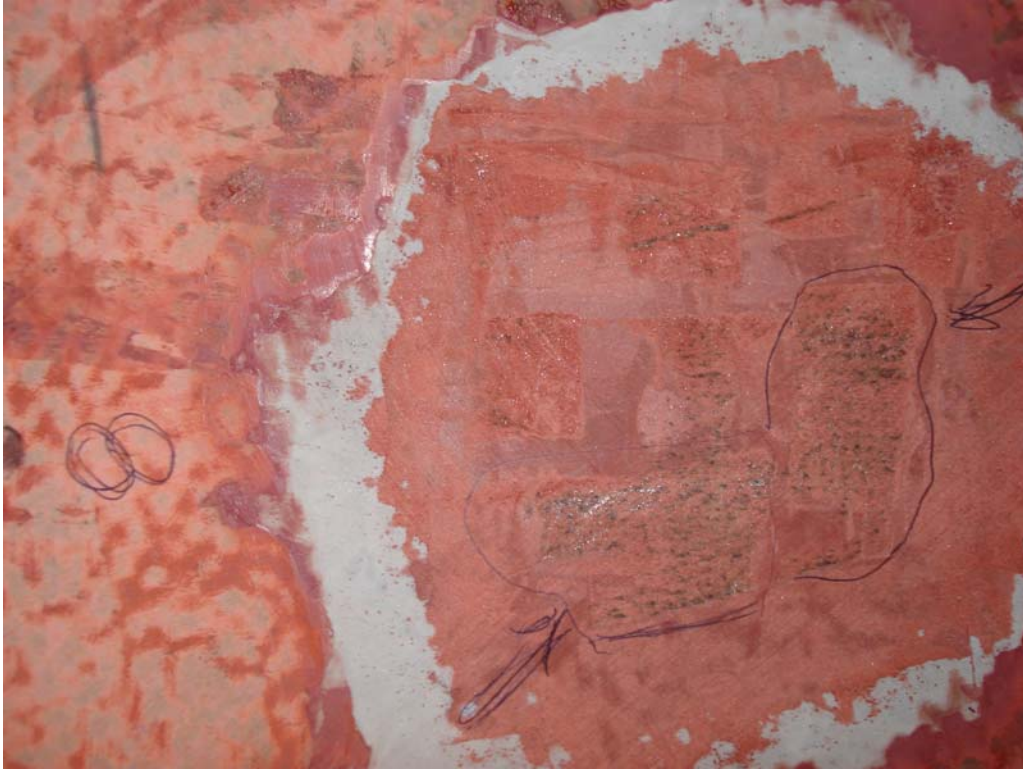
USS Boone Hull Coating Evaluation
Test Location 8

Exposed steel substrate at test location 8.

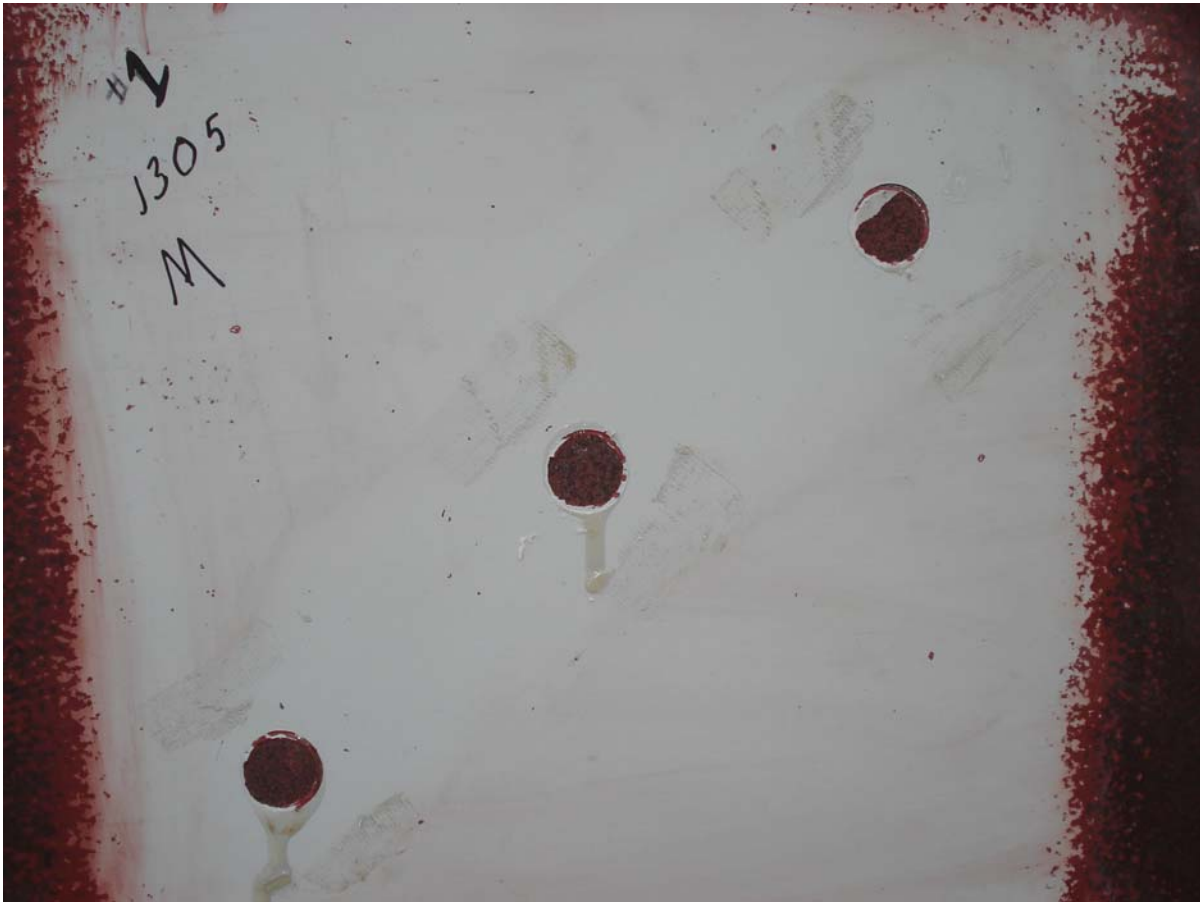
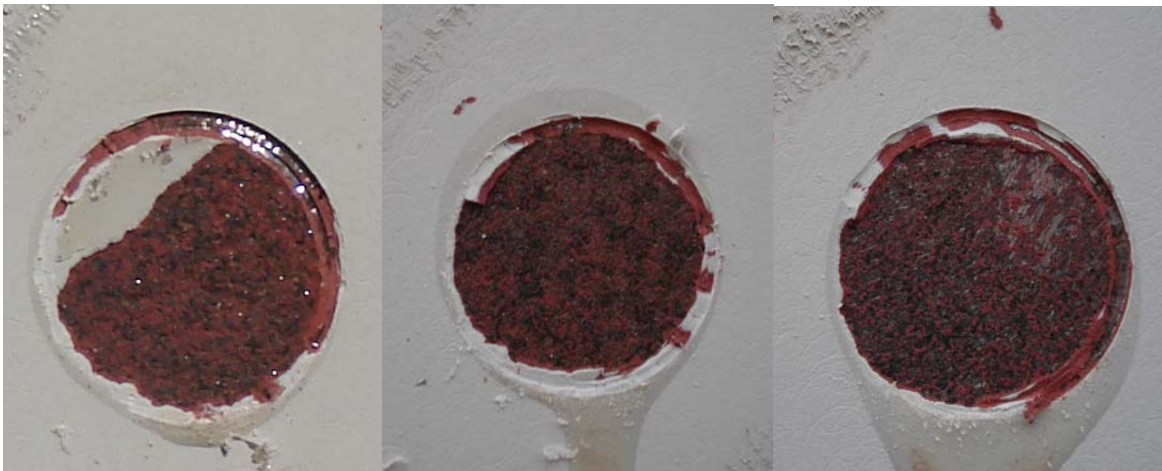
USS Samuel B. Roberts Hull Coating Evaluation
Test Location 1

Photograph of test location 1 subsequent to test completion.

Close-up of adhesion tests at test location 1.

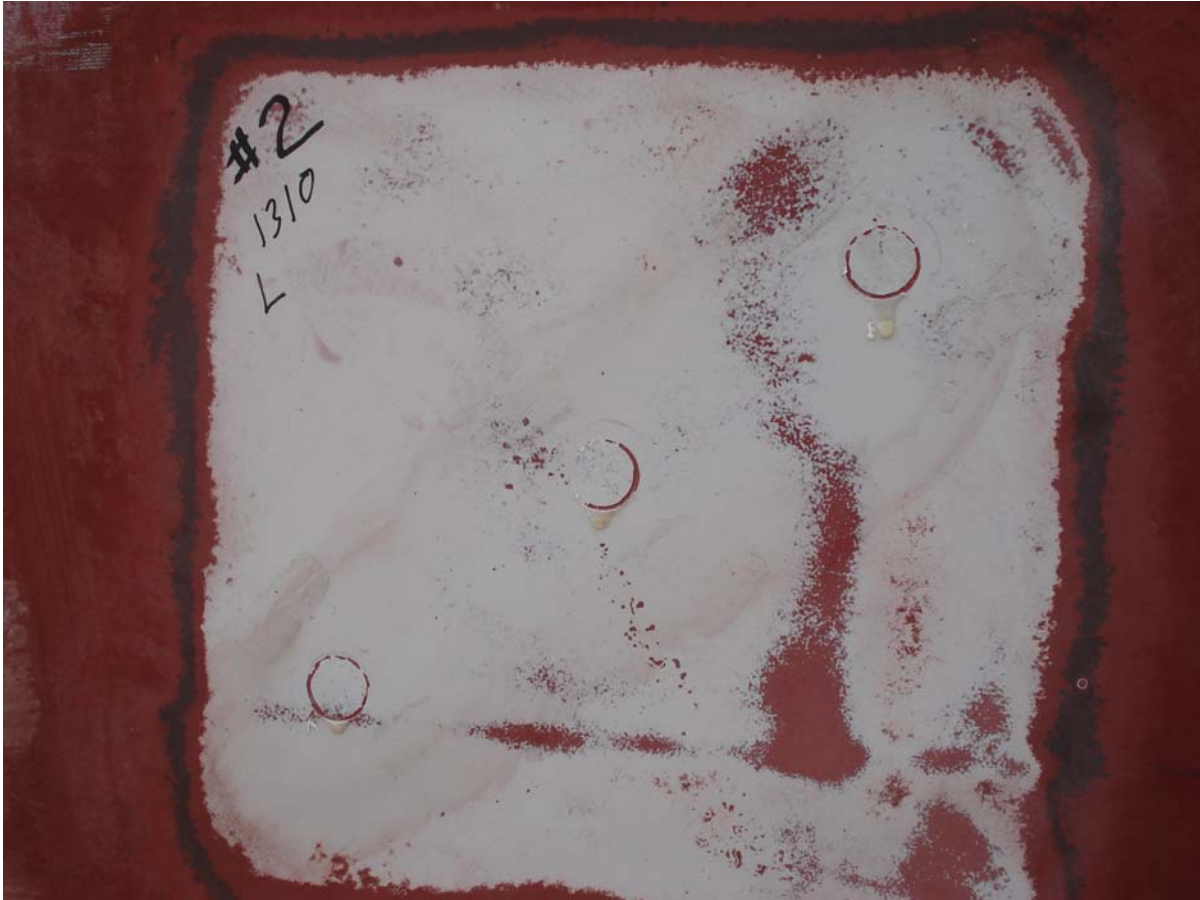
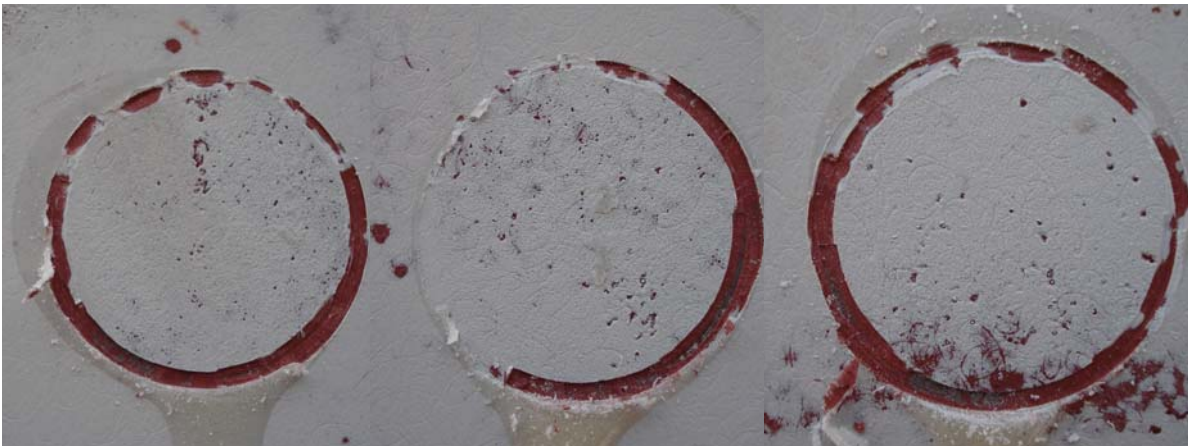
USS Samuel B. Roberts Hull Coating Evaluation
Test Location 2

Photograph of test location 2 subsequent to test completion.

Close-up of adhesion tests at test location 2.

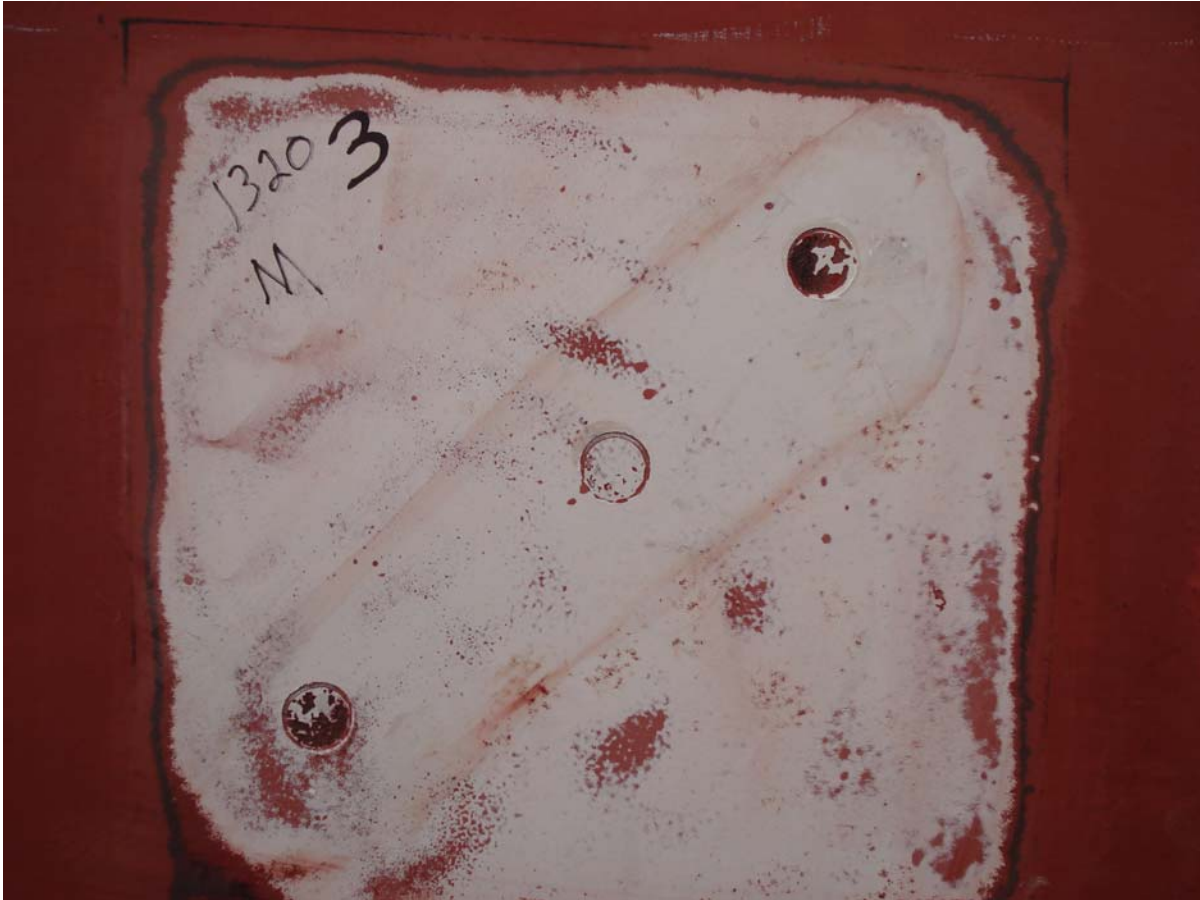
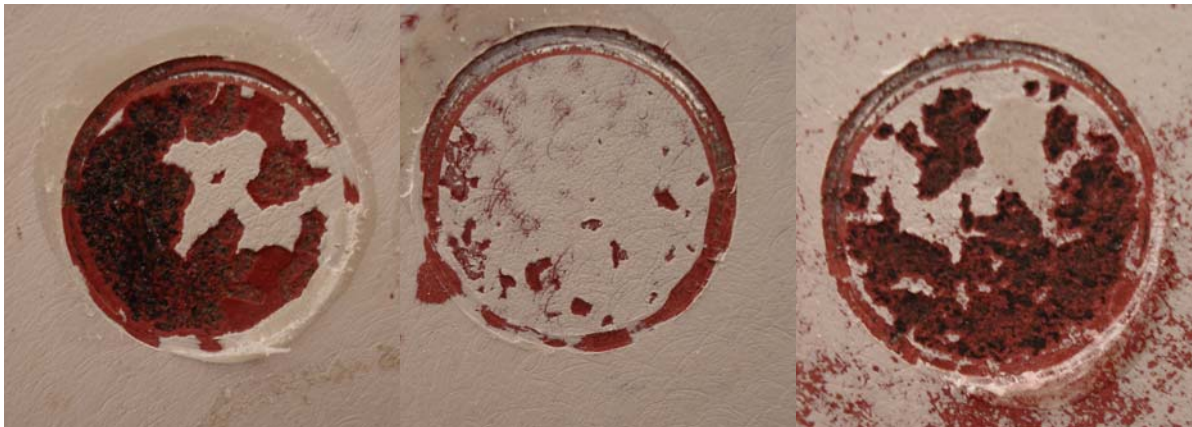
USS Samuel B. Roberts Hull Coating Evaluation
Test Location 3

Photograph of test location 3 subsequent to test completion.

Close-up of adhesion tests at test location 3.
