Review of Acceptable Flash Rusting for Ship Coatings

Final Report

Advanced Technology Institute

Atlantic Marine Florida, LLC
Elzly Technology Corporation

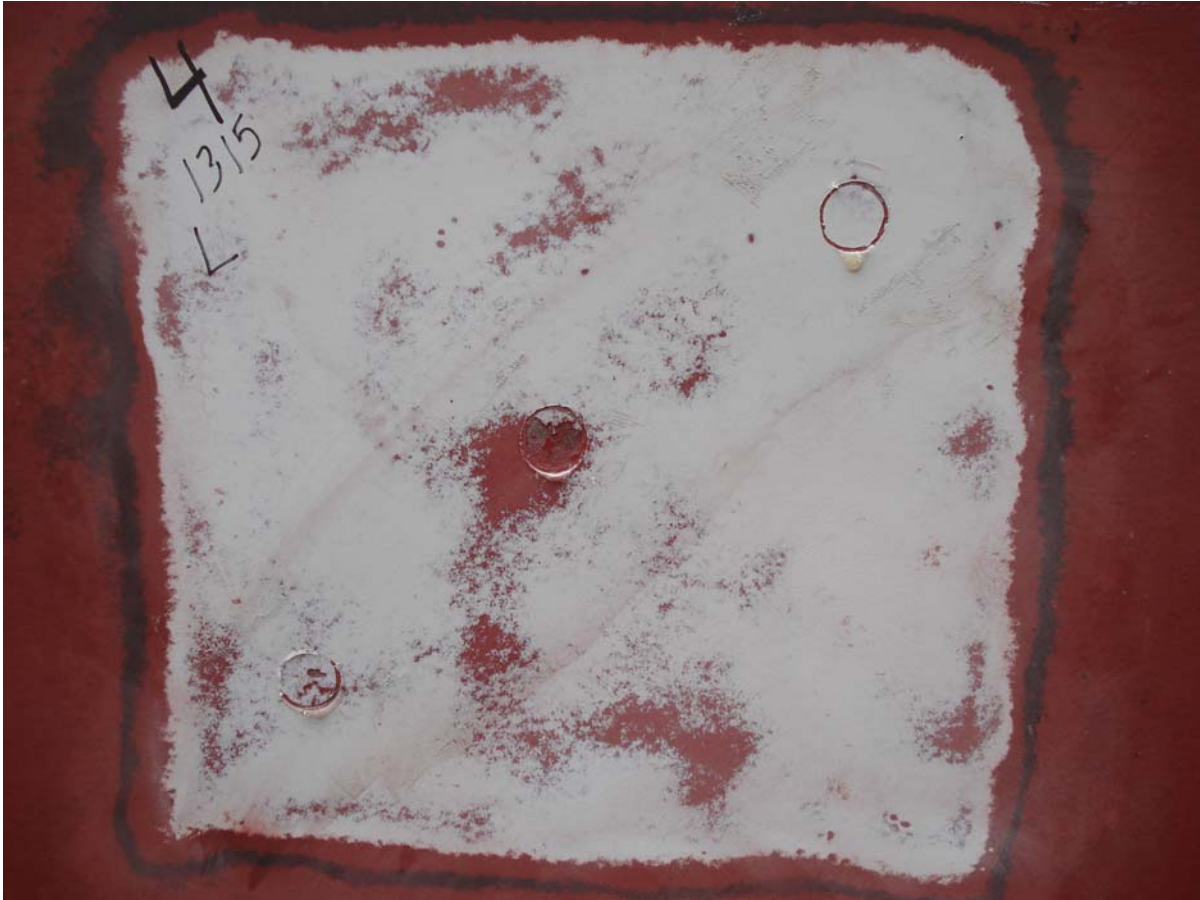
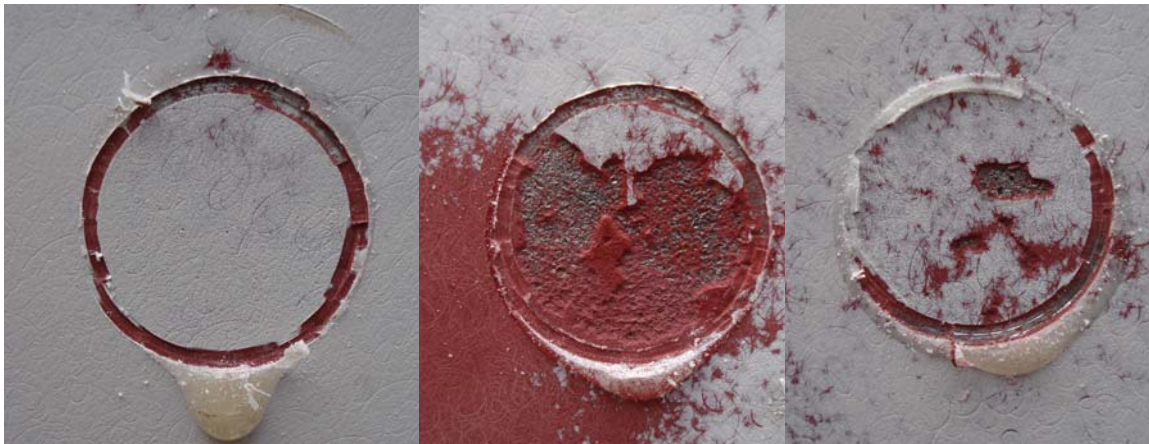
USS Samuel B. Roberts Hull Coating Evaluation
Test Location 4

Photograph of test location 4 subsequent to test completion.

Close-up of adhesion tests at test location 4.

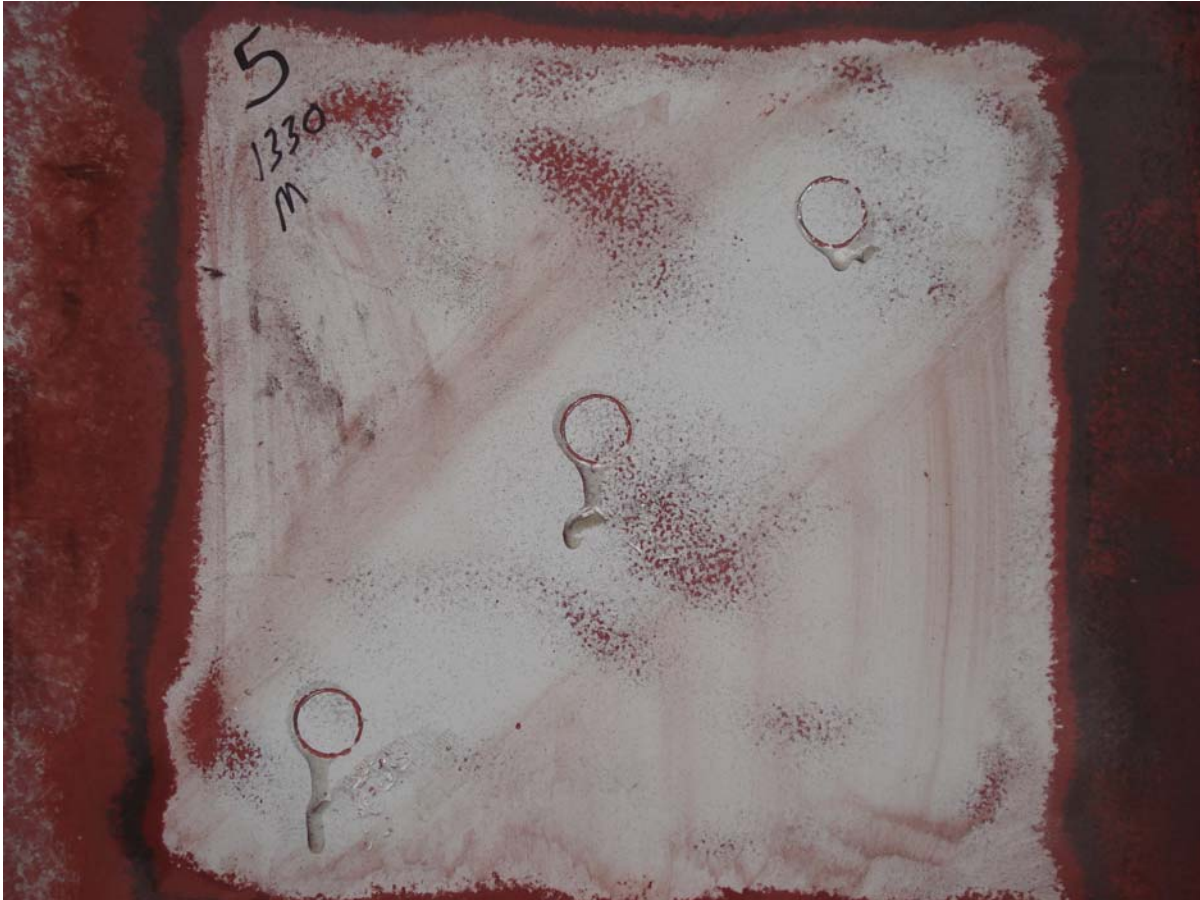
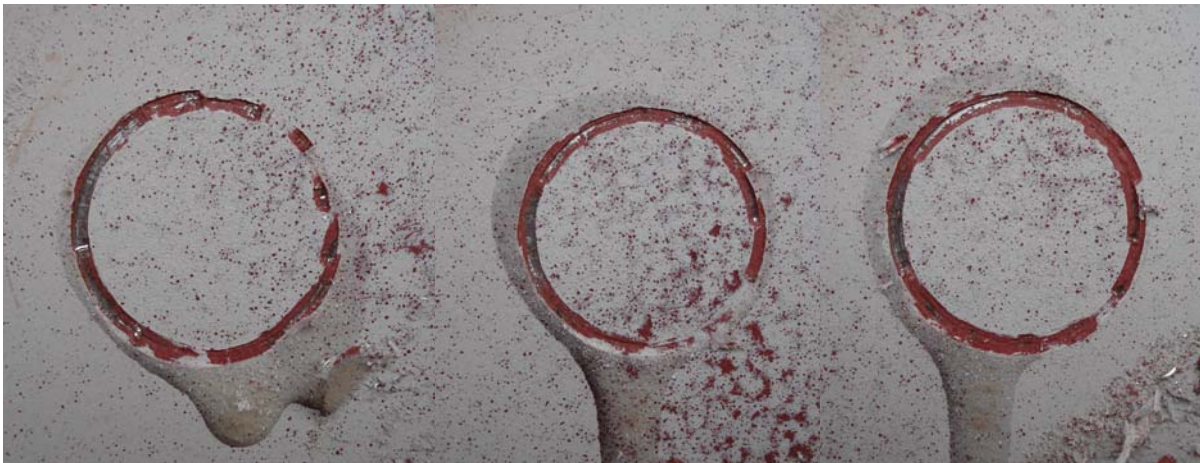
USS Samuel B. Roberts Hull Coating Evaluation
Test Location 5

Photograph of test location 5 subsequent to test completion.

Close-up of adherence tests at test location 5.

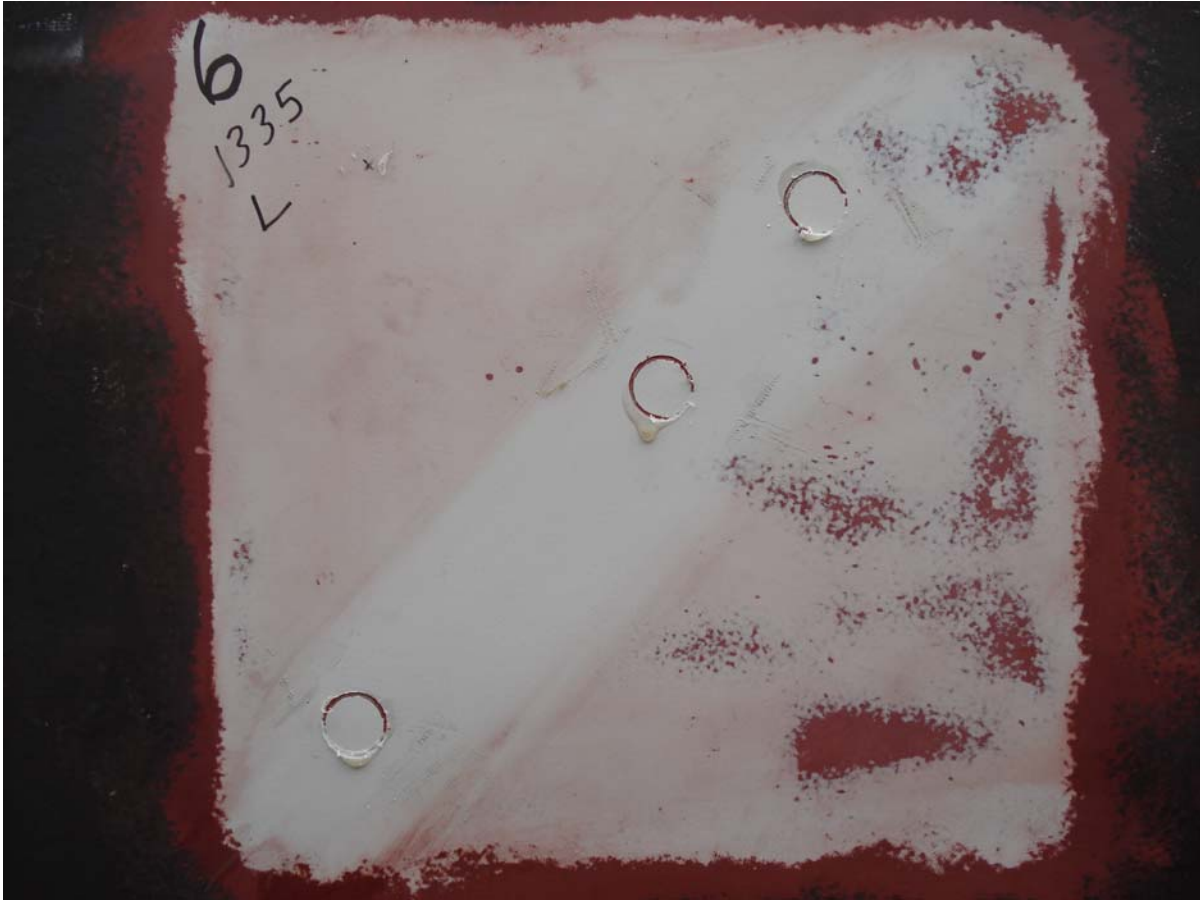
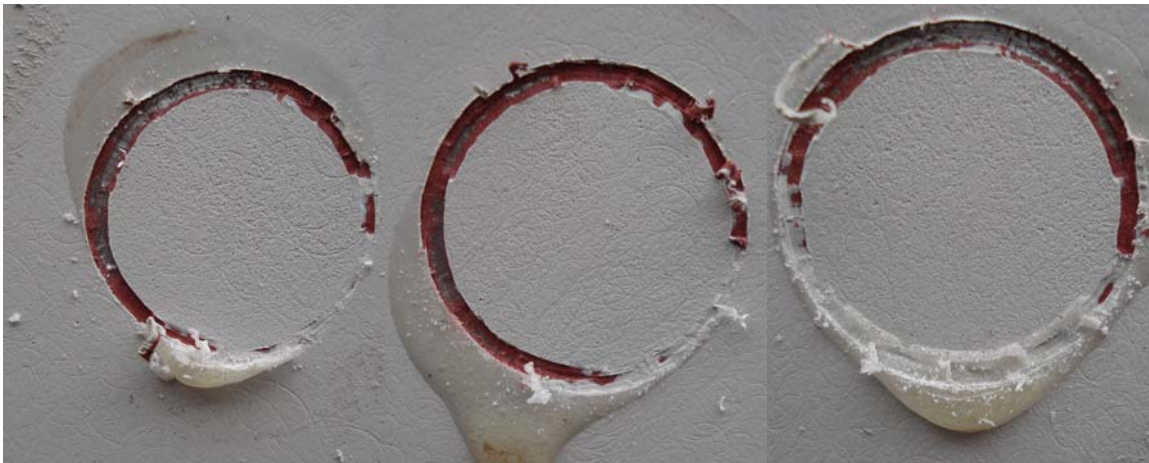
USS Samuel B. Roberts Hull Coating Evaluation
Test Location 6

Photograph of test location 6 subsequent to test completion.

Close-up of adhesion tests at test location 6.

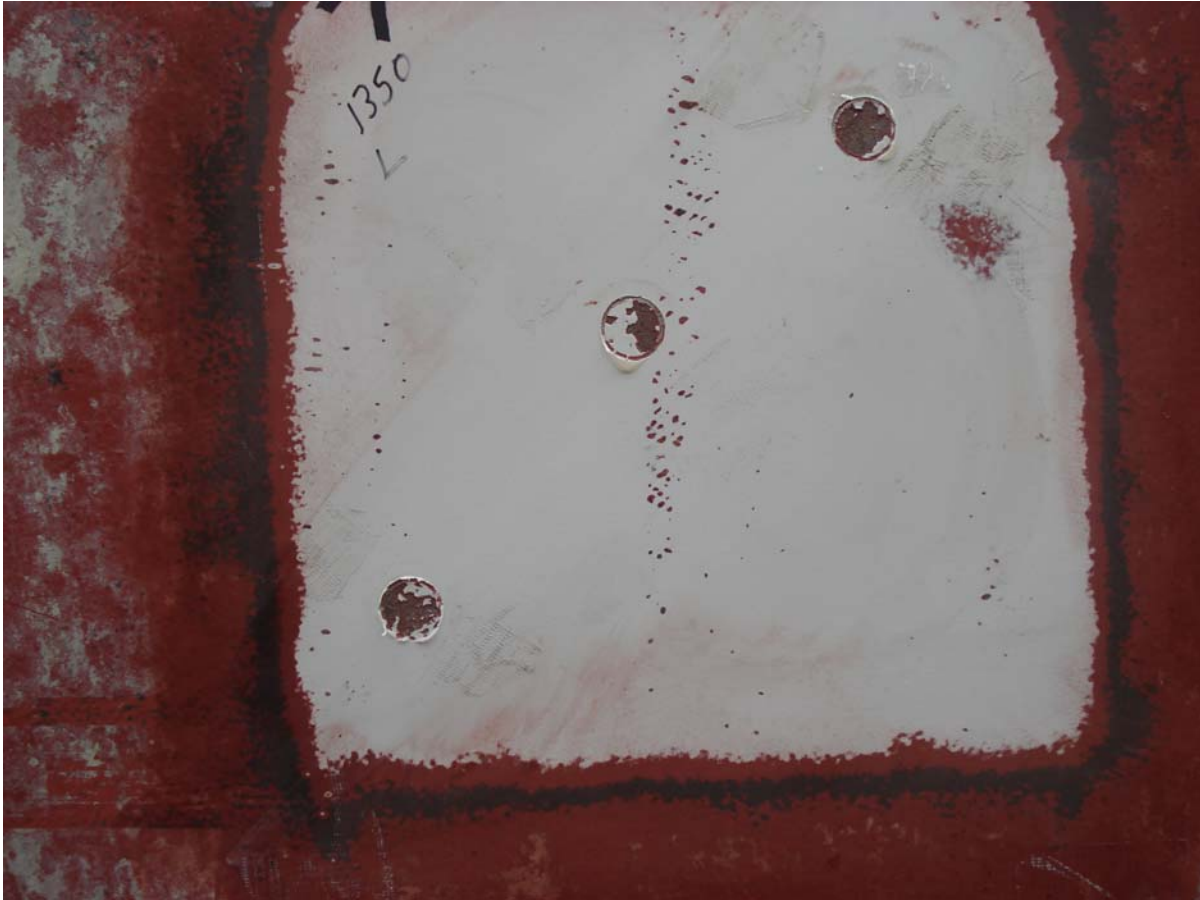
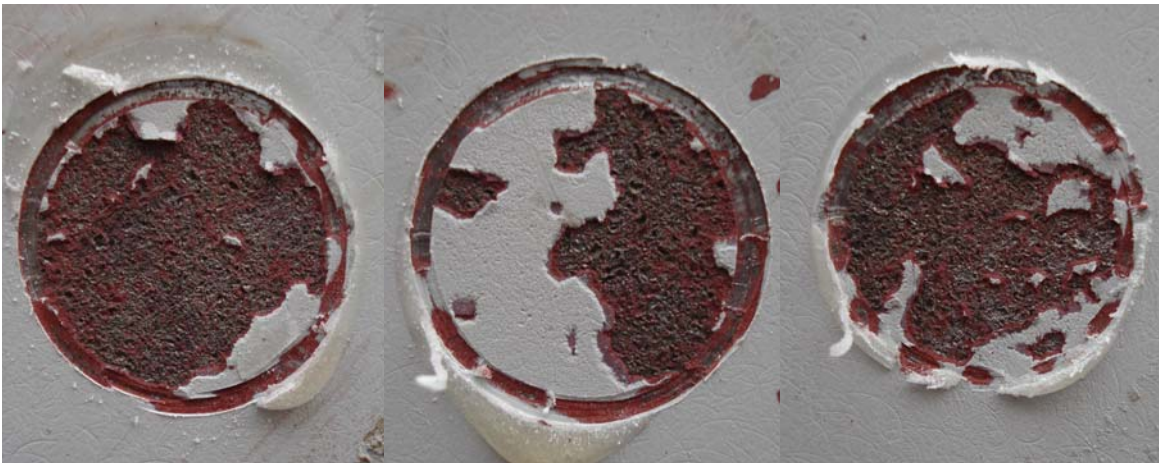
USS Samuel B. Roberts Hull Coating Evaluation
Test Location 7

Photograph of test location 7 subsequent to test completion.

Close-up of adhesion tests at test location 7.

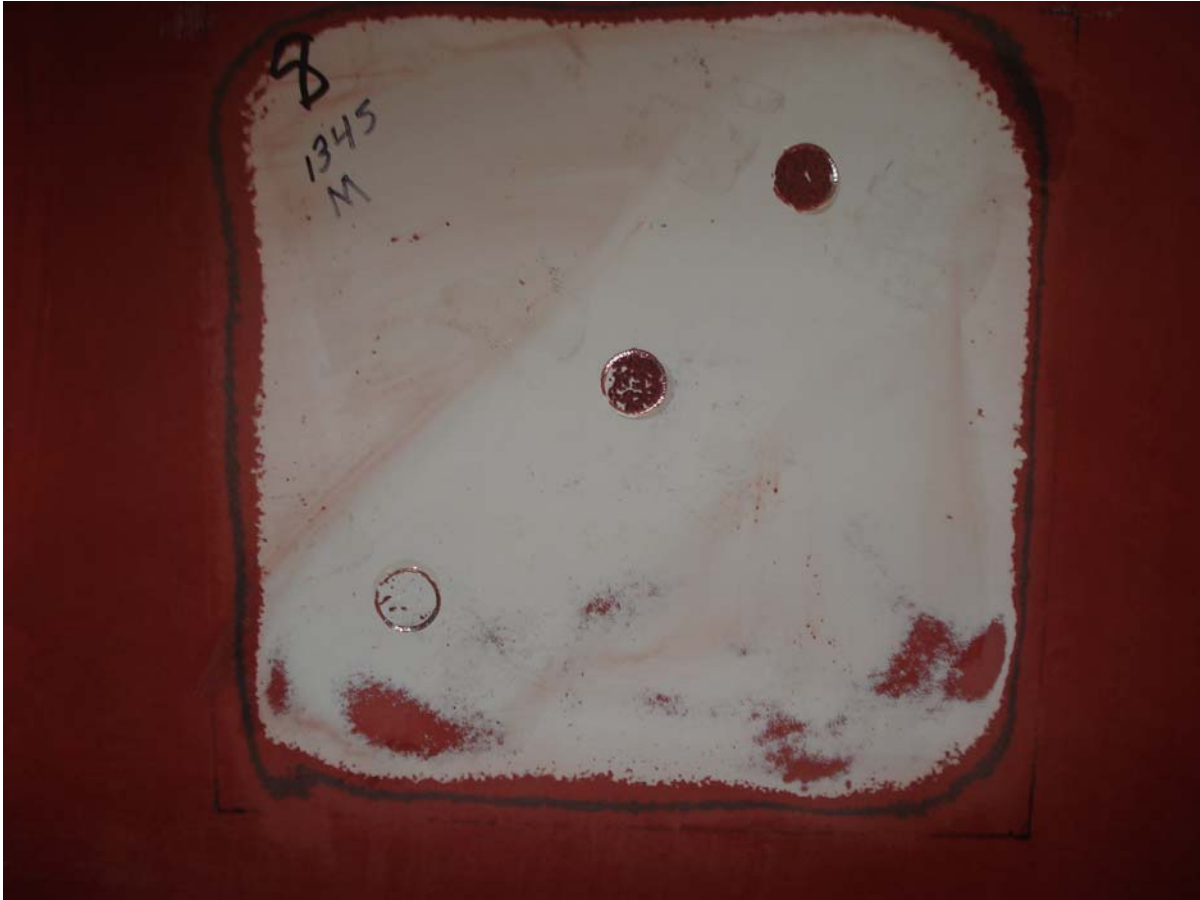
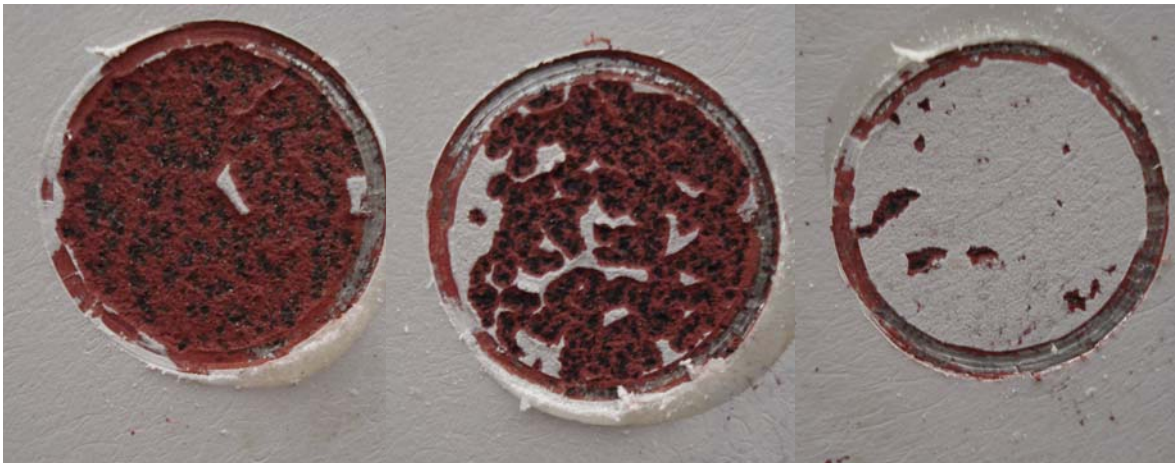
USS Samuel B. Roberts Hull Coating Evaluation
Test Location 8

Photograph of test location 8 subsequent to test completion.

Close-up of adhesion tests at test location 8.

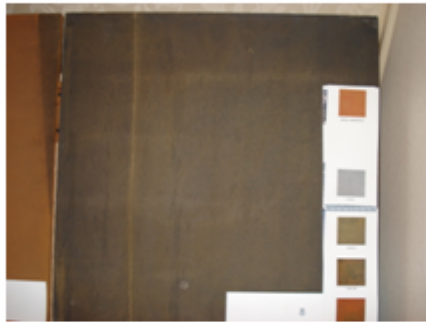
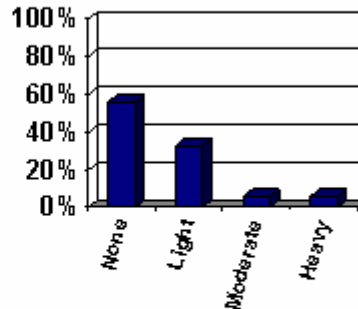
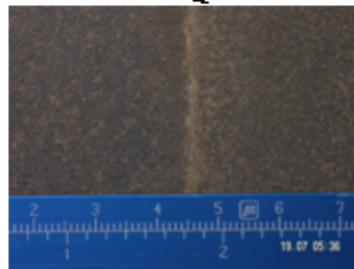
Panel 8 – “None” (1.61)

- Weathered zinc PCP
- 40,000 psi Hydroblasted
- Sheltered storage for <12 hrs

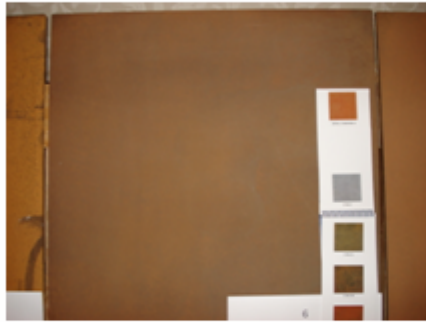
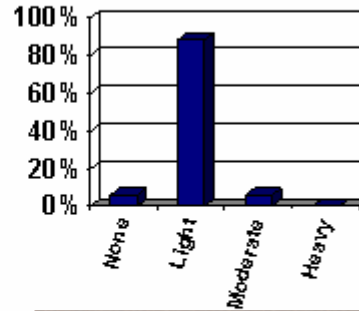
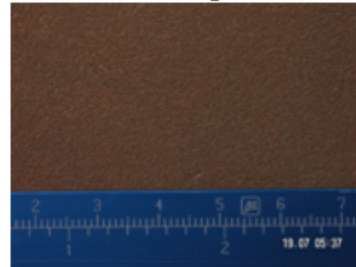
Panel 6 – “Light” (2.00)

- PCP removed by abrasive blasting
- Weathered outside for 1 week
- 40,000 psi Hydroblasted
- Unsheltered storage for ~48 hours
- Low pressure rinsed
- Sheltered storage for ~24 hours addl
- Solvent wiped

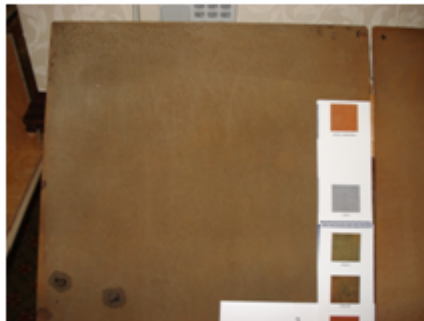
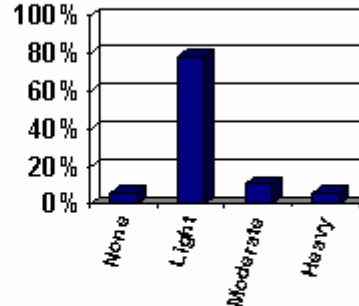
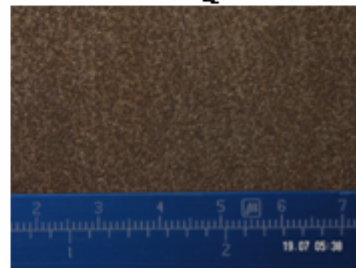
Panel 3 – “Light” (2.17)

- PCP removed by abrasive blasting
- Weathered outside for 1 week
- 40,000 psi Hydroblasted
- Sheltered storage for ~48 hrs

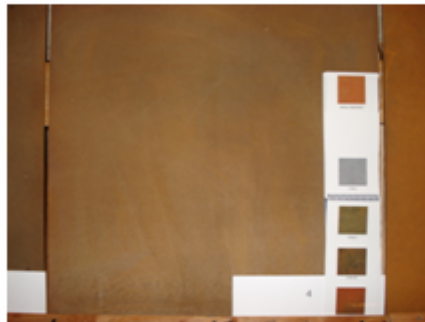
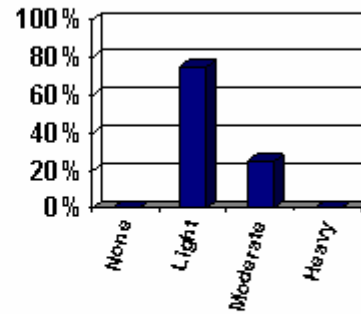
Panel 4 – “Light” (2.25)

- PCP removed by abrasive blasting
- Weathered outside for 1 week
- 40,000 psi Hydroblasted
- Sheltered storage for ~48 hrs

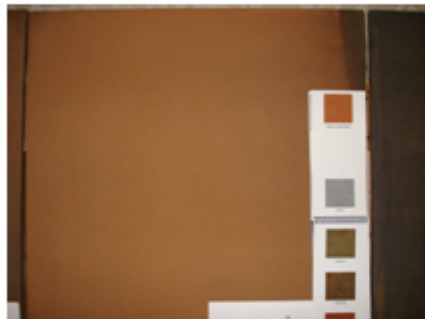
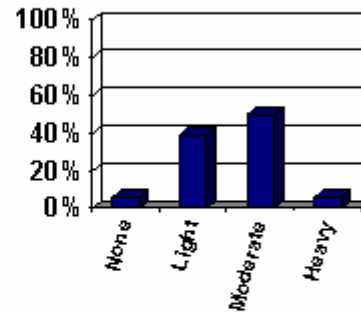
Panel 7 – “Moderate” (2.56)

- PCP removed by abrasive blasting
- Weathered outside for 1 week
- 40,000 psi Hydroblasted
- Unsheltered storage for ~24 hrs
- Solvent wiped

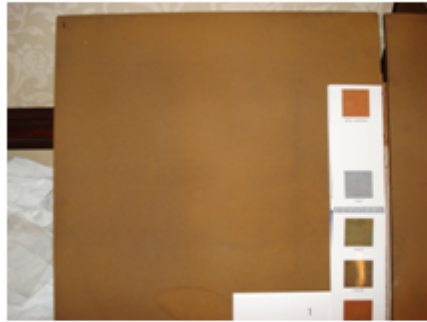
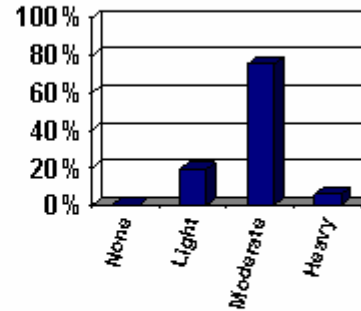
Panel 1 – “Moderate” (2.88)

- PCP removed by abrasive blasting
- Weathered outside for 1 week
- 40,000 psi Hydroblasted
- Sheltered storage for ~24 hrs
- Low pressure rinsed
- Sheltered storage for ~24 hrs addl

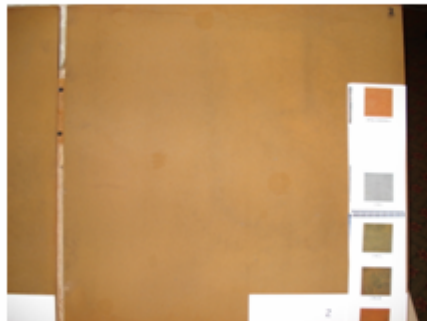
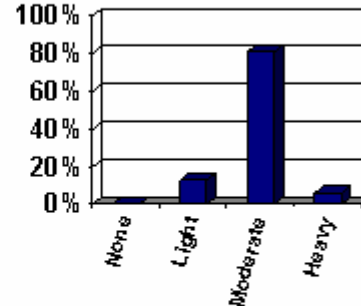
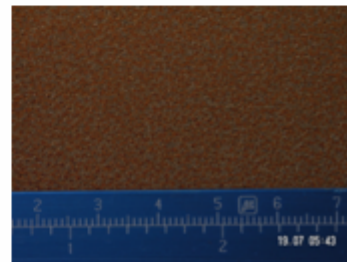
Panel 2 – “Moderate” (2.94)

- PCP removed by abrasive blasting
- Weathered outside for 1 week
- 40,000 psi Hydroblasted
- Sheltered storage for ~24 hrs
- Low pressure rinsed
- Sheltered storage for ~24 hrs addl

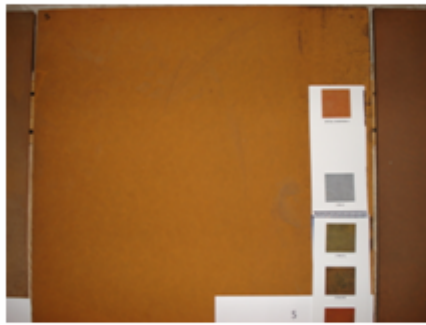
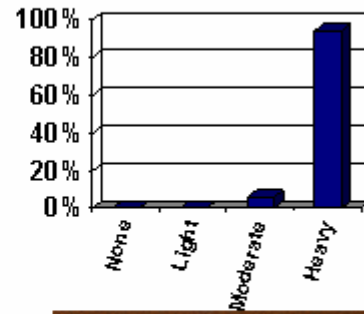
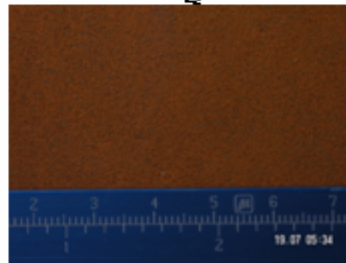
Panel 5 – “Heavy” (3.94)

- PCP removed by abrasive blasting
- Weathered outside for 1 week
- 40,000 psi Hydroblasted
- Unsheltered storage for ~ 72 hours
