# Safer Thermographic Inspection of Medium Voltage Electrical Panels on Navy Ships

The National Shipbuilding Research Program

2015 Electrical Technologies Panel Project

**FINAL REPORT**

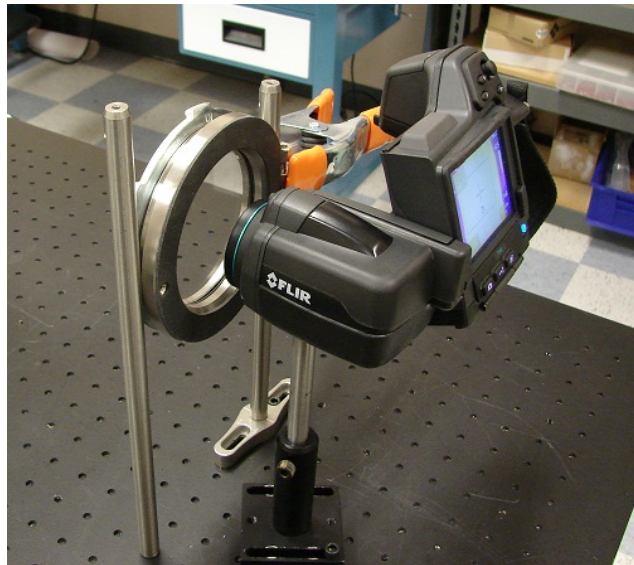
Figure 1 Camera and Window Holding Fixtures

different tests. The windows were approximately 1 inch in front of the camera lens. Figure 1 shows the FLIR T440 camera mounted on the vertical post with the FLIR IRW-4S window clamped on the fixture in front of the camera lens.

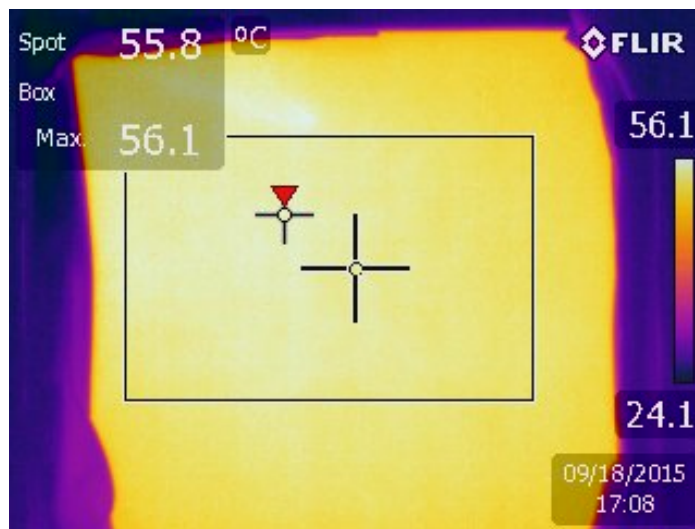
Figure 3 FLIR T440 Camera Captured IR Image

Figure 3 shows the image captured from the FLIR camera at the 55°C setting.

The yellow is the image from the black body source and is uniform across nearly its entire surface. The borders are somewhat irregular as they were masked off with black tape and the tape was not exactly straight. As this was outside the area of interest, it was ignored. The colder temperatures on the border of the picture are the frame of the blackbody source, which is essentially at ambient temperature.

It may be noted that the spot temperature in the image differs slightly from that recorded in the table. Even with everything held fixed, the temperature readouts on both cameras would vary up to half a degree or more. The temperature was noted at a different time than when the image was recorded. These variations are common to all of the camera measurements.

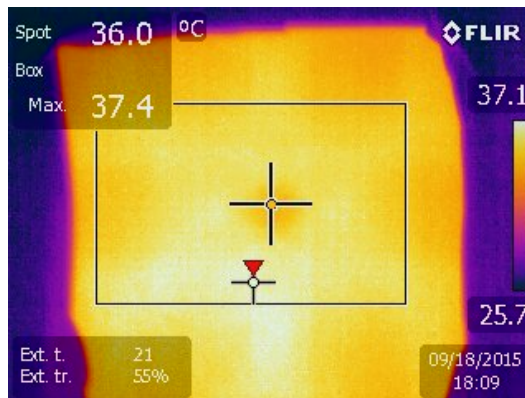
Figure 5 Thermal Image, IRISS Window Grid Lines

The reinforcing grids on the polymer windows caused some difficulty getting consistent readings. Figure 5 shows the thermal image taken through the hexagonal grid on the IRISS window at 35°C.

In the image, the hexagonal grid pattern is plainly visible. The camera position was moved until the spot measurement was between the grid lines, which indicates somewhat colder than where the grid lines are. The hottest spot, shown by the smaller crosshairs in the box sits where the grid lines cross (at a node) it reads 1.4°C higher than between the grid. While this difference is small, it does illustrate that care must be taken in camera placement when these grid lines are present.

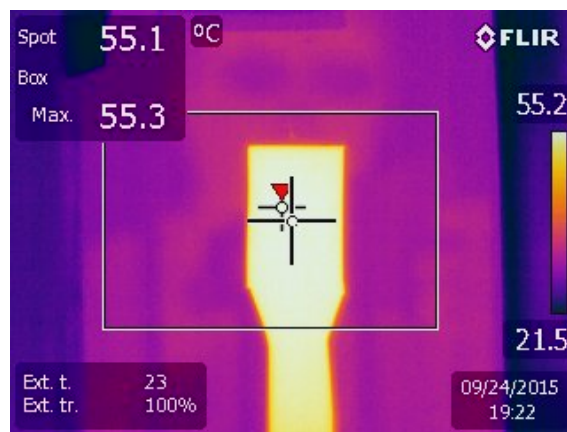
Figure 8 Blackbody Mask Simulating Cable Lug

The rear of the plate was polished shiny to reflect radiation and the front painted black to emit radiation. The result was that the plate itself remained close to ambient temperature while the lug shaped hole permitted the set temperature of the blackbody source to be visible. Figure 8 shows a thermal image of the target.

The mask itself is not perfect, showing a somewhat higher temperature than the edges of the blackbody source, and some reflection is visible on its surface. However, the place of interest within the box and at the spot crosshair shows a correct temperature.

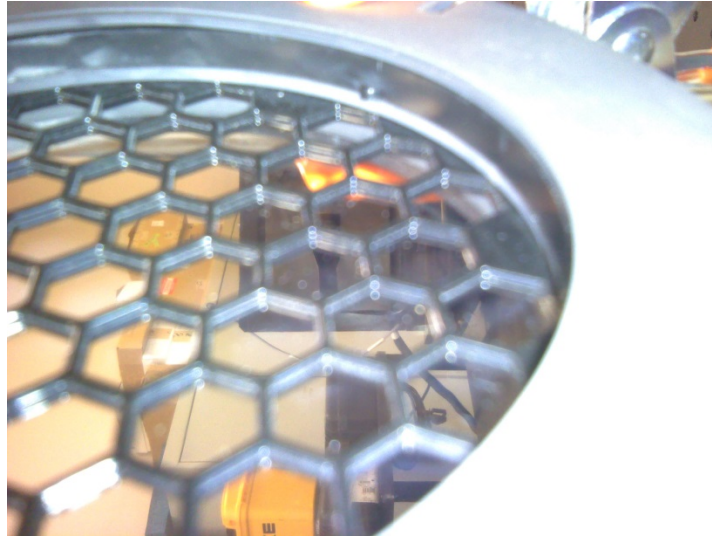
Figure 10 Digital Image through Polymer Window at Shallow Angle

reinforcing grid is the most likely cause of this attenuation. In addition to that effect on the thermal measurements, the reinforcing grid causes issues when trying to take a visible image. Figure 10 shows the digital image taken at 28 inches in the Up direction, where a useful thermal image was obtained.

The target can be made out, but it is largely obscured by the reinforcing grid.

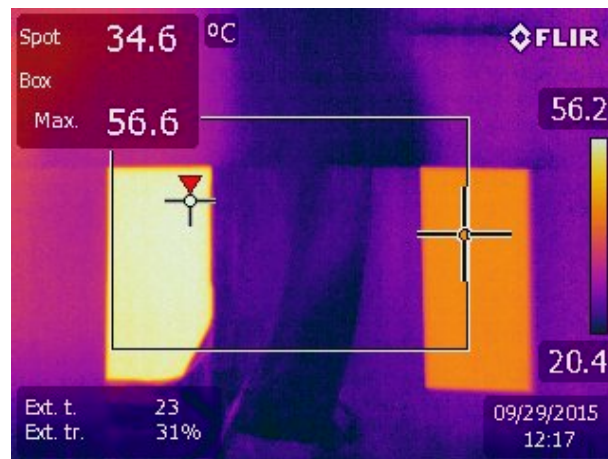
Figure 13 Thermal Image, Two Targets 20°C Apart, FLIR Window

Figure 13 shows the same targets through the FLIR Window.

In this image, the spot is on the right target, but the box covers both targets and therefore shows the maximum of the left target.

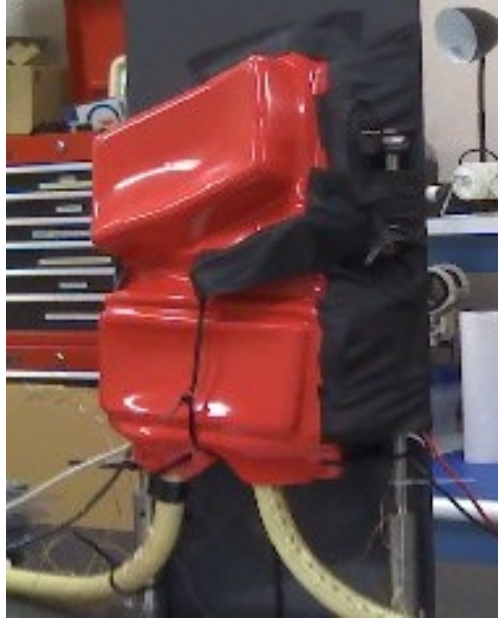
Figure 20 Boot Material Jury Rigged over Heated Lug

The boot material was then positioned over the heated lugs and secured so as to minimize the air gap. A backing plate behind the busbar, and tape over the side caps provided a means to contain the heat from the busbar inside the boot. In addition to this, the setup was left energized for up to six hours to allow the heat to be transferred to the boot. Figure 20 shows a picture of the setup. This test was done with no window and the transmissivity set to 100%. Also, to get the entire area of interest in the same field of view of the image, the camera was moved back to 27" distance from the target.

The setup was examined approximately 4 hours and 6 hours after being energized. Measurements were taken at several points across the surface of the boot material. There was no significant difference between the measurements taken at 4 hours and those taken at 6 hours. After the last measurements were taken, the boot material was removed and the black tape adjacent to the left lug and the right lug was measured to get a number for the connection temperatures. Several actual hot spots were visible in the thermal image as shown in Figure 21.

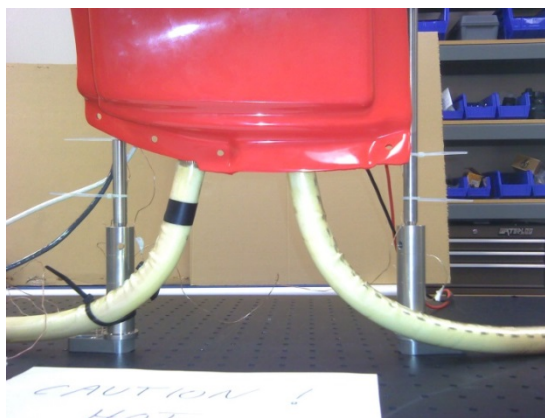
Figure 23 Dust Boot Material Over Heated Lugs

Figure 23 shows a digital image of the dust boot material covering the connections but not the cables.

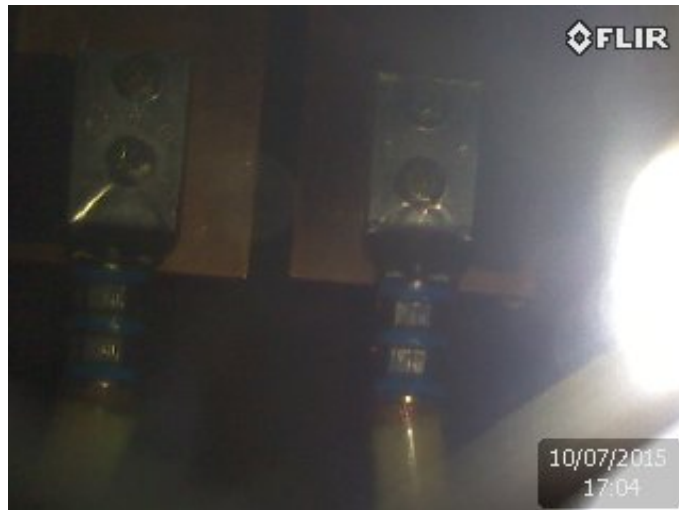
Figure 30 Digital Image through IRISS Window, Lamp On

Even with maneuvering of the camera (Figure 30), the reinforcing grid and subsequent reflections off of portions of it make it difficult to get a good image of the target area.

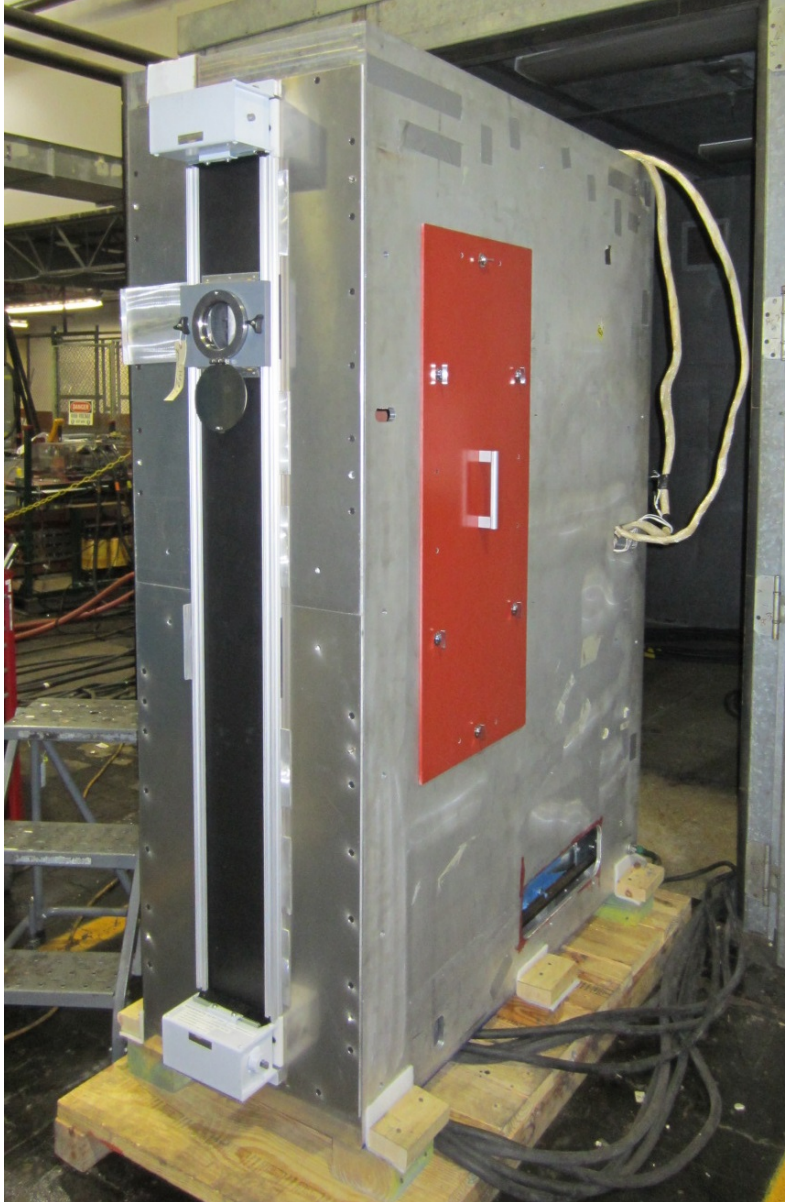
**Figure 1 DRS Test Cabinet - Rear View**

A rear view of the DRS cabinet is shown in Figure 1.

The cabinet is 81" high by 23" wide by 54" deep. The cabinet is designed to hold three circuit breakers in the top section (one for each electrical phase) and three more in the bottom section. The breakers are in the front of the cabinet. There is an interior wall that separates the breaker compartment from the rear compartment where the connections are made. The rear of the cabinet was the area of interest as that is where the shipboard connections are made. The red panel on the side of the cabinet covers an opening that typically allows the horizontal bus bars for the three phases to connect to adjacent cabinets. There could be as many as four cabinets side by side in a single unit. The black electrical cables at the bottom of the cabinet are the test cables that bring the current in and out of the test box.

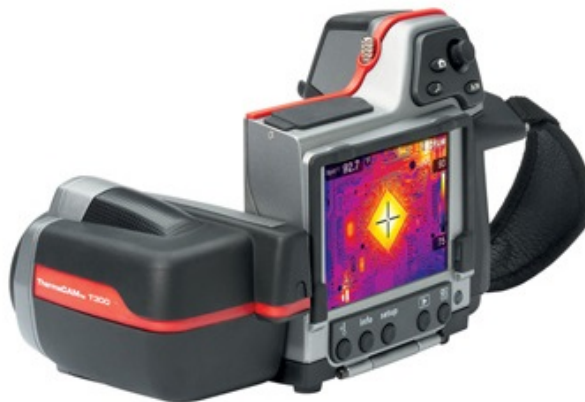
Figure 5 FLIR T300 Infrared Camera

The FLIR model T300 (Figure 5) is comparable to the FLIR 400 series thermal cameras currently used by the Navy for thermographic inspections. It has both visible and IR cameras, a variety of settings to compensate for the testing conditions, including a setting for the transmissivity of the IR window, and the ability to store the images. It was established in the lab tests that the best measurement tool on the camera to use was the box. The box can be made any size and placed anywhere on the image and the camera will return the highest temperature noted within the area of the box. The T300 has the ability to put multiple boxes on the image (even overlapping) and will return the highest temperature in each box. Two boxes were used in most of these tests.

The visible camera lens and its accompanying lamp are offset approximately two inches from the center of the IR camera lens. This became an issue in some of the tests.

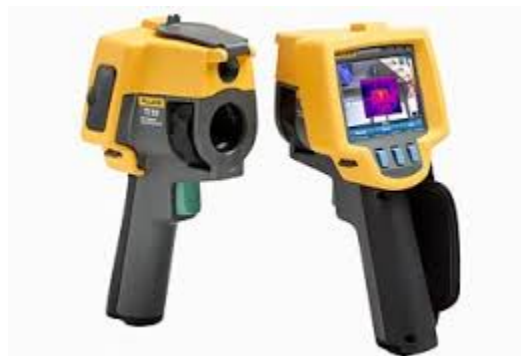
Figure 6 Fluke TI10 Infrared Camera

The Fluke model TI10 (Figure 6) was borrowed from Huntington Ingalls shipyard. It is of the same series of Fluke camera as the TI32 camera that Ingalls supplied for the laboratory tests, only it has a much reduced feature set. The TI10 has the emissivity permanently set at 0.95 with

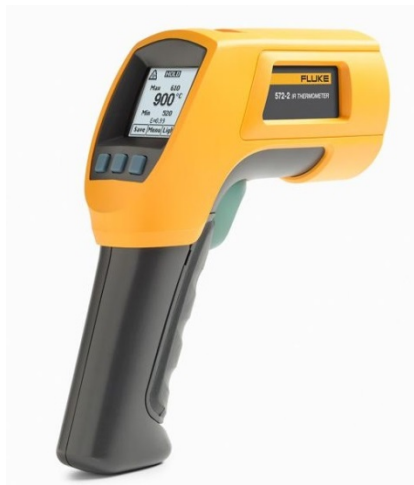
Figure 7 Fluke IR Thermometer

This is not a camera, but a hand held infrared thermometer (see Figure 7). It has a digital readout of temperature and a laser pointer to provide feedback to the operator for pointing the device at the surface where the temperature is to be read. It has an adjustable emissivity setting but the setting was not recorded. This was used by the DRS test personnel to determine when the temperature inside the box had stabilized. Temperatures at the various connections and on the bus bars were noted as the tests were set up and when parameters changed.

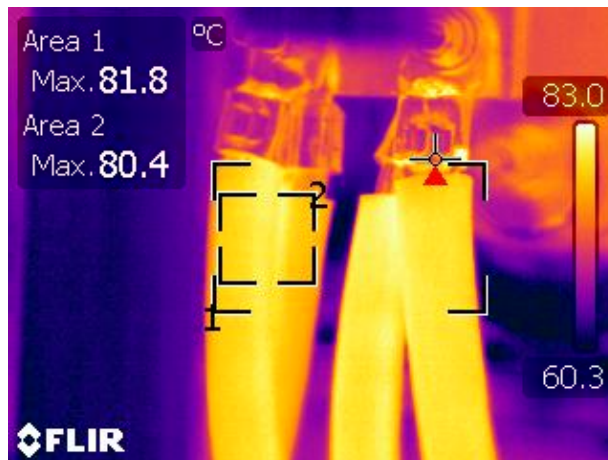
Figure 10 Cables at Position C from Window Position 1

Figure 10 shows a similar image but focused on the cables right below where the connections are made. With the emissivity of the cable jackets more uniform, the measured temperatures are closer together.

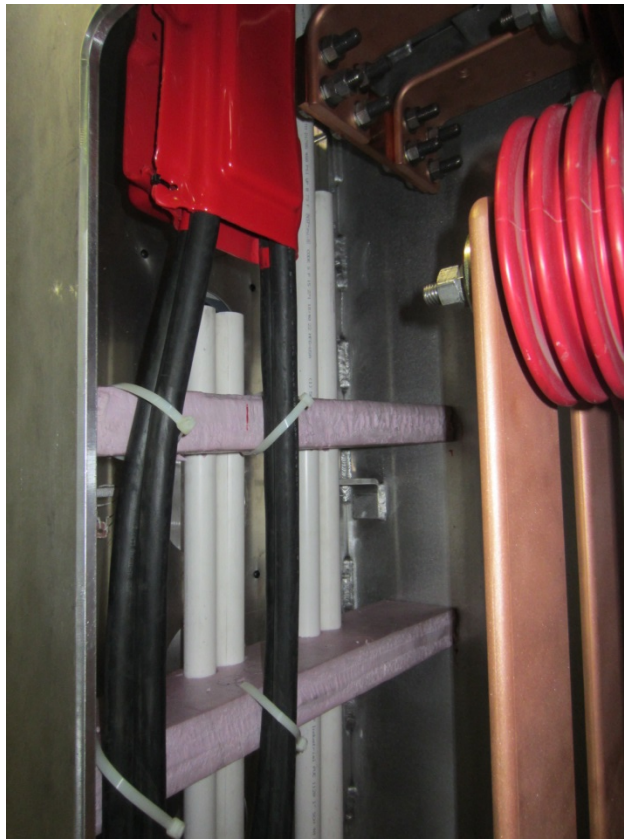
Figure 17 View of Rubber Dust Boot from Cabinet Side Opening

The window was moved to Position 3, 68" above the bottom of the cabinet and approximately in line with the top row of connections, as shown above in Figure 8. The connections at Position B were covered by the rubber dust boot. The red rubber boot can be seen in Figure 17.

The view in the figure is from the cabinet side opening and is seeing the boot from the rear. The rubber dust boot completely covers the connections at Position B, both front and rear. The boot was not made for this geometry, so it was secured by wire ties. It also extends a considerable distance below the area where the connections are made. The point where the cables exit the bottom of the boot is at least 6 inches below where the cables terminate into lugs that are bolted to the bus bar. The boot was secured in this orientation at first since some openings in

the boot corresponded with the shape of the bus bar. This boot has raised areas in the front and rear to accommodate the bolts that secure lugs or bus bars and these areas are not symmetrical. It is not particularly evident in the figure, but the higher of the raised areas is in the front in this orientation, toward the IR viewing window. This means that there is a larger air gap between the connection bolt and the inner surface of the boot in the front (toward the window) than there is in the rear.

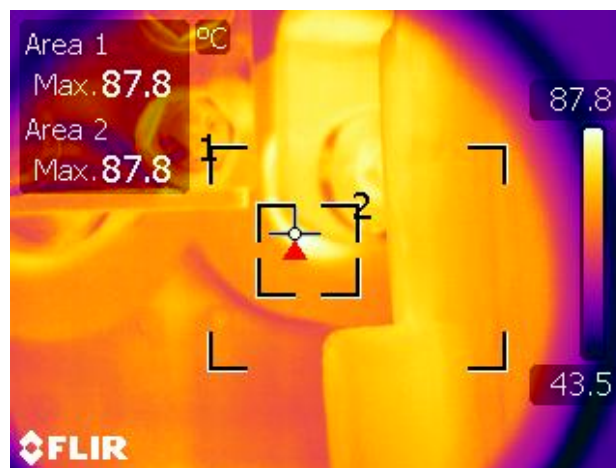
Figure 19 Bolts at Position A and Boot at Position B

Figure 19 puts the boot into some context. This image shows the bolts from Phase B at Position A in the upper left of the corner, partly obscured by the temperature readouts. The boot material fills the right side of the image up to the circular bezel of the window. Note that the bus bar and bolt visible just to the left of the boot and behind it in the picture is not the connection under the boot. This is the stationary connection of the Phase C bus bar to the breaker in the other compartment of the cabinet. The connections at Position B are completely covered by the boot. Figure 20 shows the same view with the Fluke camera.

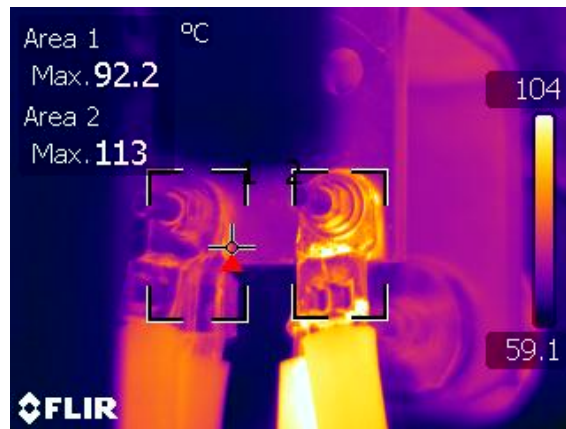
Figure 23 Fault Condition at Position C Seen From Window Position 1

The window was placed at Position 1, 19.25 inches from the bottom of the cabinet and even with the row of connections that included the fault condition. Figure 23 shows the two connections at Position C.

The connection on the right of the image was the one that was loosened. It can be seen from this image that the temperature is about 20°C higher than the tight connection on the left.

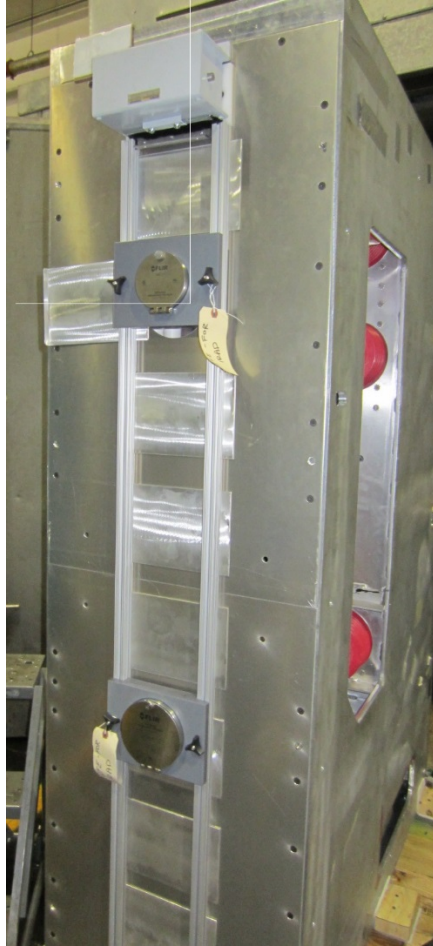
Figure 30 3 and 4 Inch Windows Installed

To avoid having to disassemble the rack each time the window was switched, both windows were installed on the rack at the same time. The 3 inch window was slid in first. The 4 inch window was installed just below the 3 inch window. At the bottom of the cabinet, there is actually a position below Window Position 1 (see Figure 8). This allowed either the 3 inch window or the 4 inch window to be placed at Position 1 or Position 2. At the upper end of the cabinet, Window Position 3 is the highest position, so only the 3 inch window could be placed at Position 3. Either window could be placed at Window Position 4.

Figure 30 shows both windows installed and the curtain removed. Three inch window is above.

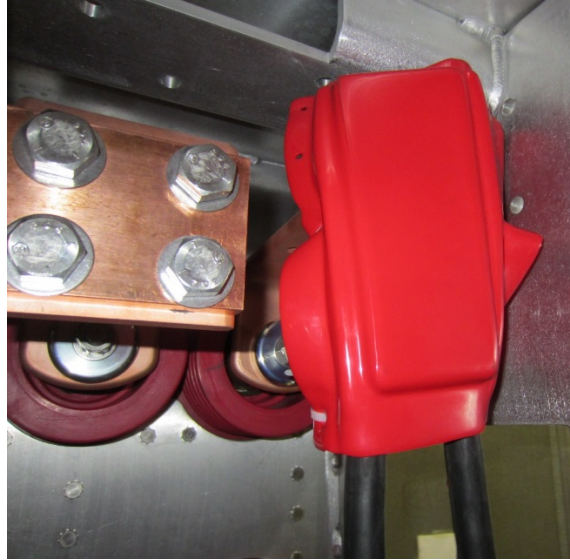
**Figure 31 Rubber Boot Repositioned over Upper Phase C Connections**

Figure 31 shows the repositioned rubber boot over the loose connection at Position B.

In this orientation, the openings in the boot do not line up well with the bus bar and cable in the cabinet. Wire ties were used to hold the boot in place. There is more of a gap behind the boot, which allows some heat to escape, but in the front, the boot is much tighter to the connections. The side of the boot facing front in the photograph is the shallower side, so it is practically touching (or possibly actually touching) the bolt where the loose connection is located.

Also, the boot is now positioned so that the bottom of the boot is only about one inch below the connection lugs on the end of the cables. As before, the loose connection is the one on the left as viewed here and the connection on the right remained tight. No connections were loosened at the bottom of the cabinet. Based on the thermal images of the cables taken the previous day, it was determined to include more images of the cables as they exit the boot. With the boot in this position, the visible parts of the cables are much closer to the connections and will be more indicative of the temperatures at the actual connection points.

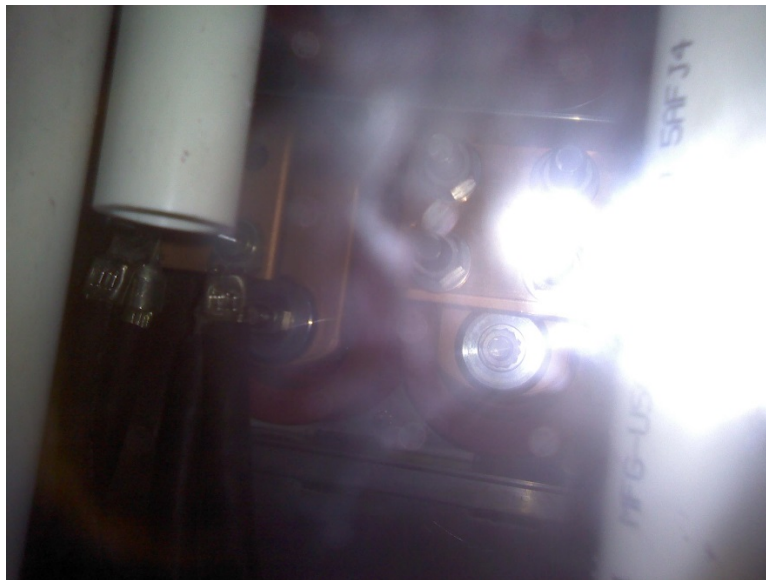
Figure 32 Visible image of Position C and Position D, Camera Lamp On

The camera lamp was turned on. Figure 32 shows a visible image of the cables and lugs at Position C and the bolts and bus bar at Position D.

While it is possible to make out details inside the cabinet in the area of interest, there is also a reflection of the camera lamp from the window that obscures part of the connection area toward the right.

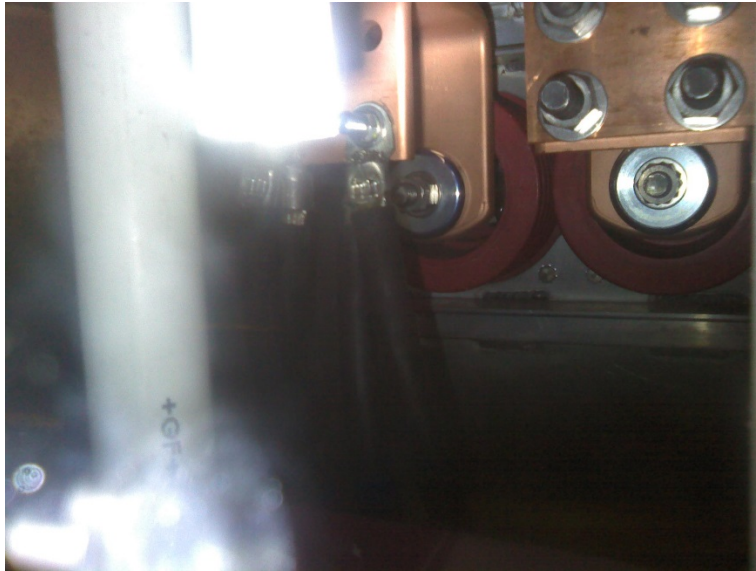
Figure 33 Positions C and D, Camera Lamp Off, Secondary Illumination

Figure 33 shows the same scene from the same window. In this image, the camera lamp was turned off and a secondary light source (flashlight) was held against the window adjacent to the camera lens.

Some slight reflection from the window can be seen at the lower left, which is outside of the area of interest. The majority of the reflections off the window have been eliminated. The reflections remaining in the image are coming from components inside the cabinet, namely the PVC pipe.

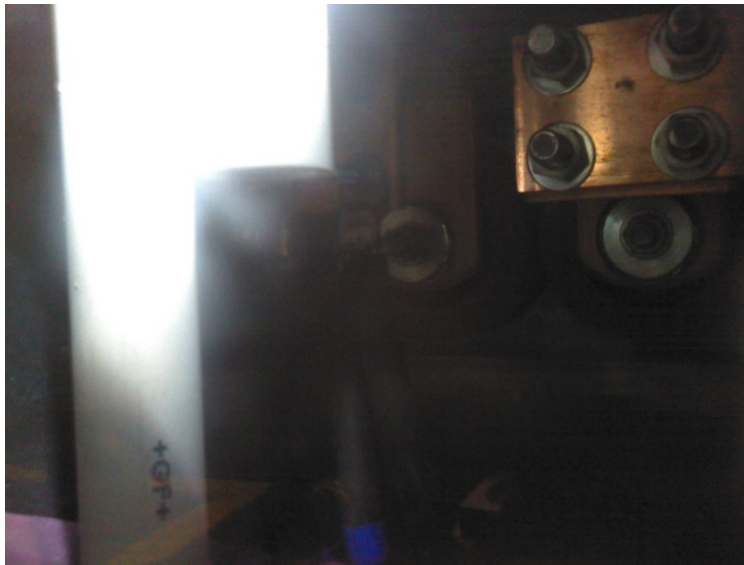
Figure 34 Positions C and D, Secondary Illumination from Above

Figure 34 again shows the same scene, but with illumination from above.

In this image, the camera lamp was again off, but the flashlight was held in Window Position 2, shining down onto the area of interest. There is considerable reflection off of the white PVC pipe, which would not be installed in an actual cabinet. This does show that a properly placed light source in a different window or opening can illuminate the area of interest.

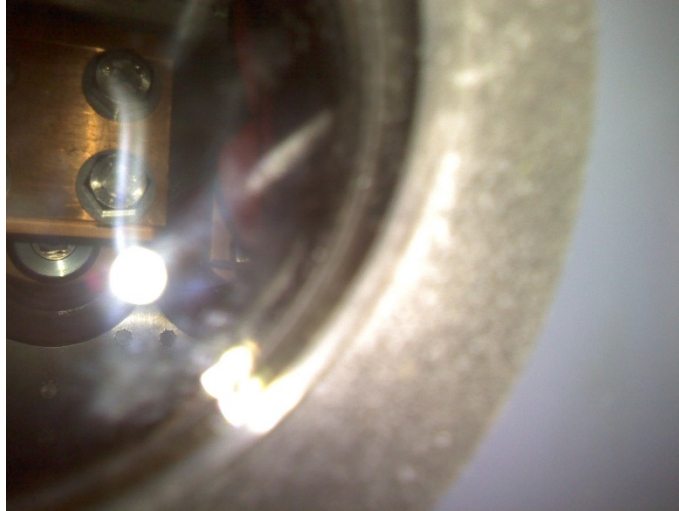
Figure 36 Positions A and B through 3 Inch Window

Imaging was now performed through the three inch window at Window Position 3 (top position). Figure 36 shows a visible image through the three inch window of the bolts and bus bar at Position A and a bit of the dust boot covering the connections at Position B.

This illustrates one issue with the three inch window. The camera was aimed for the best view for the infrared image. On this camera and similar models, the center of the visible image lens is offset from the center of the IR lens by about two inches. It can be seen in the above image that the visible camera captured most of the window bezel and panel cover outside of the window. Again, the reflection from the camera lamp affects the image.

The next image (Figure 37) is the same view as in Figure 36, except that the visible image was used to line up the camera. It can be seen that the area of interest is much better framed. However, in this image, no consideration was given to the framing of the infrared image. For this smaller three inch window, it is better to take separate IR and visible images to make sure the camera angles and image framing are optimized. The camera lamp was on and again reflection can be seen off of the window.

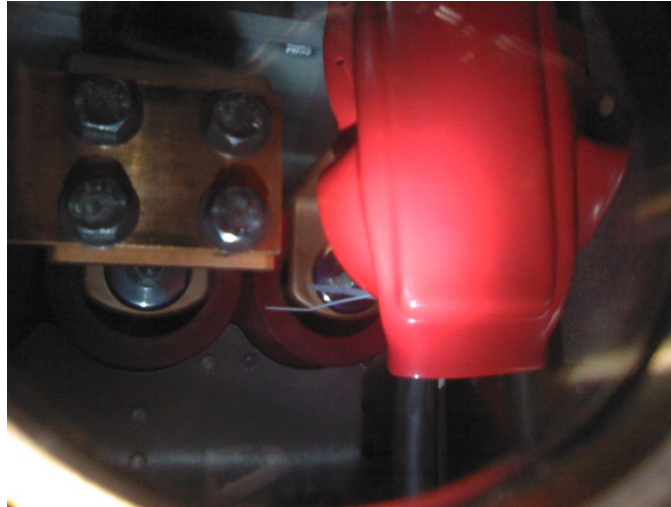
Figure 38 Positions A & B with Secondary Illumination

Figure 38 shows the same scene, but with the camera lamp turned off and the flashlight at Window position 4 (8 inches below and aiming up).

With the three inch window, the camera lens takes up most of the available space. The above image shows a workable use of another light source in another opening. This eliminates the reflection, but does allow some features to be in dimmer light and is sensitive to the exact aiming of the secondary light.

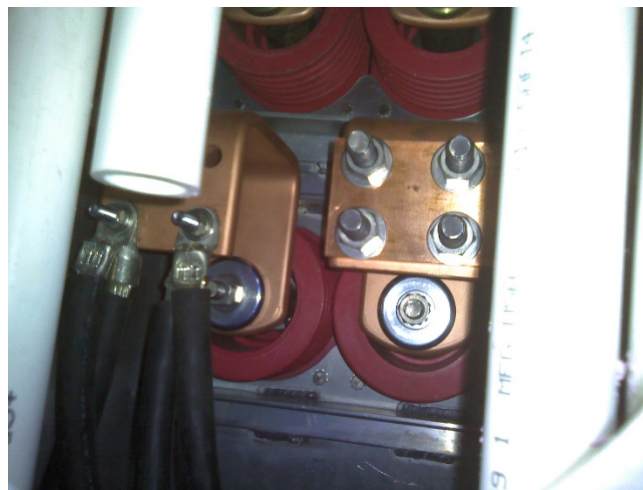
Figure 45 and Figure 46 below show the connections at Position C and the bolts on bus bar at Position D in two images taken at the same time. The visible image is a wider field of view, but puts the IR image in context. The camera lamp was on for the visible image.

Figure 45 Positions C and D with No Window

Figure 46 Visible Image of Positions C and D with No Window

Aside from the lack of reflection from the camera lamp in the visible image, these images are very similar to those taken through the windows.

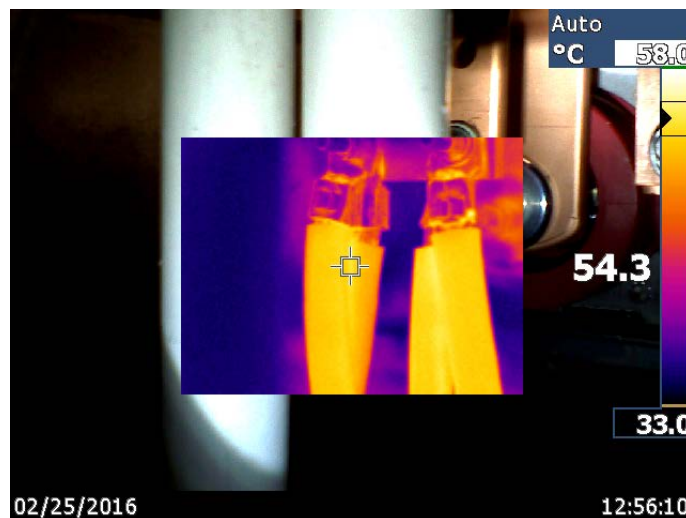
Figure 48 Fluke Camera Image of Cables at Position C, No Window

Figure 48 above shows the Fluke camera image of the same scene. A flashlight was held alongside the camera to illuminate the cabinet interior for the visible image. With the same transmissivity setting, the measured temperatures from the two cameras are much closer, the remaining differences due to the differing emissivity settings.

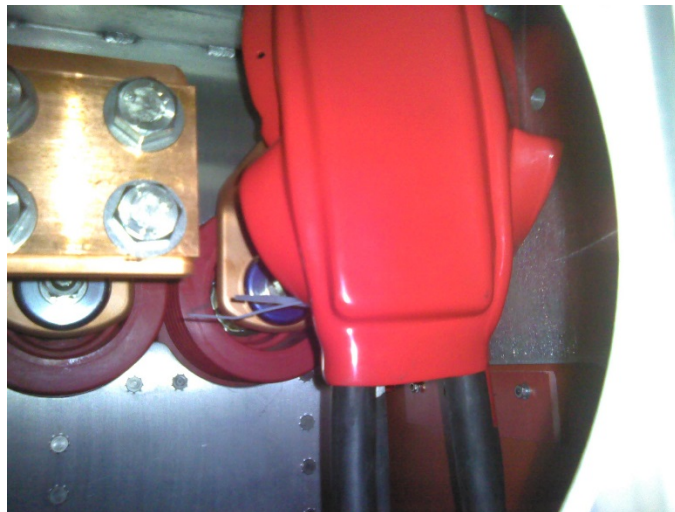
Figure 49 and Figure 50 were taken at the same time. The hotspot on the boot is measured against the bolt on the adjacent phase. The visible image shows both items in context. The camera lamp was on.

Figure 49 Positions A and B, No Window

Figure 50 Visible Image, Positions A and B, No Window

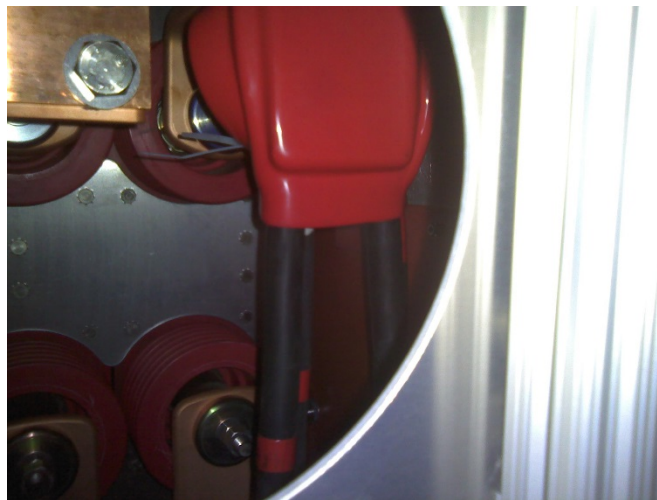
Figure 51 and Figure 52 below show the cables below the dust boot at Position B with the visible image taken at the same time for context. Again, these are similar to those taken through the window.

Figure 51 Cables below Position B, No Window

Figure 52 Visible Image, Cables below Position B, No Window
