# **GENERAL DYNAMICS**

## **NSRP Cleanable Non-Skid Deck Covering Project**

**BIW Process Control  
FY2023/24**

# BIW-Panel Project Scope of Work

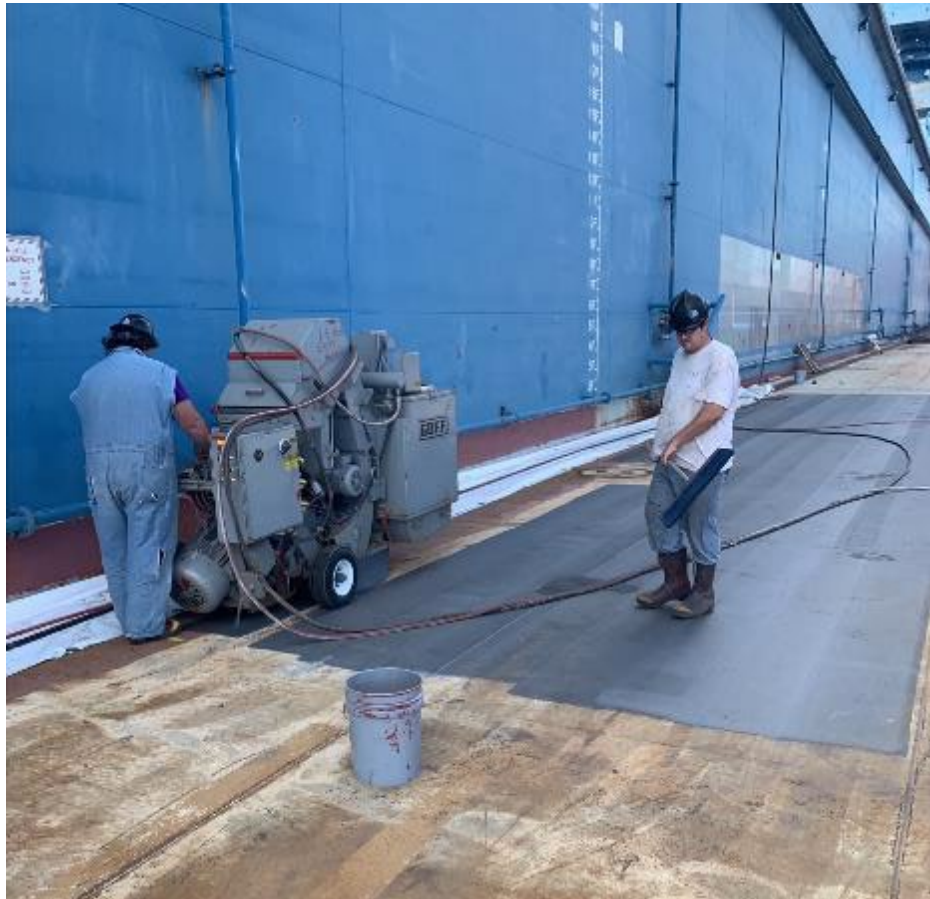
# Start Of Deck Blasting Surface Prep

460 steel shot a blast media

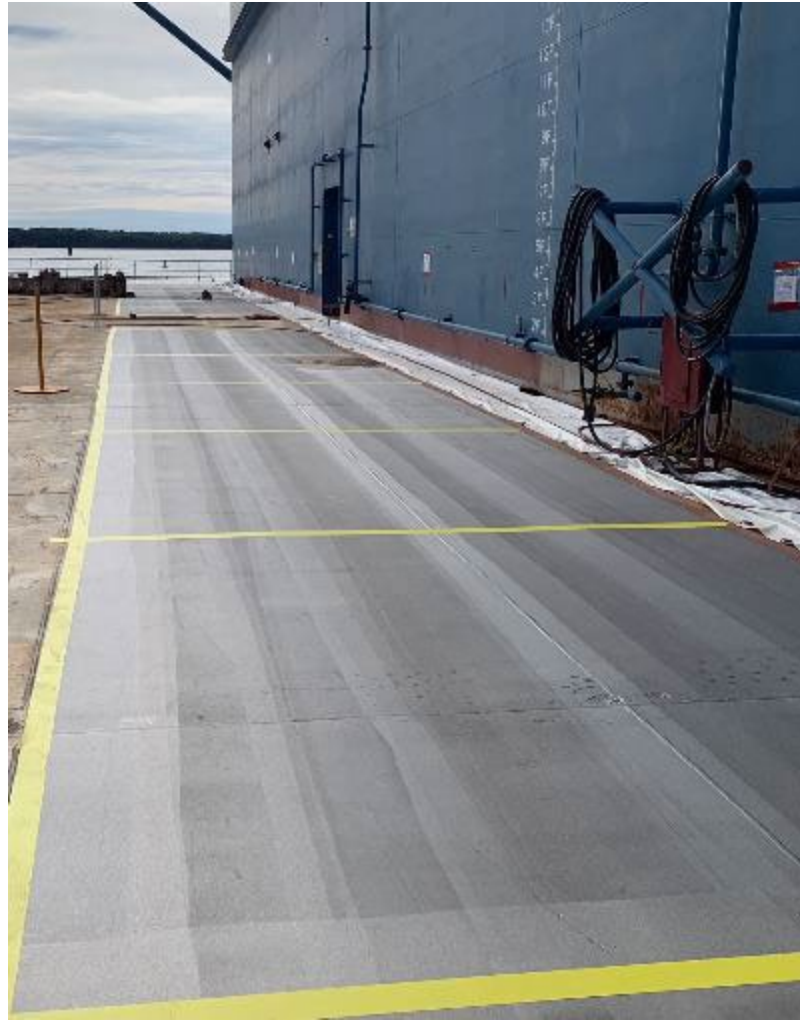
# Final Deck Blasting Surface Prep

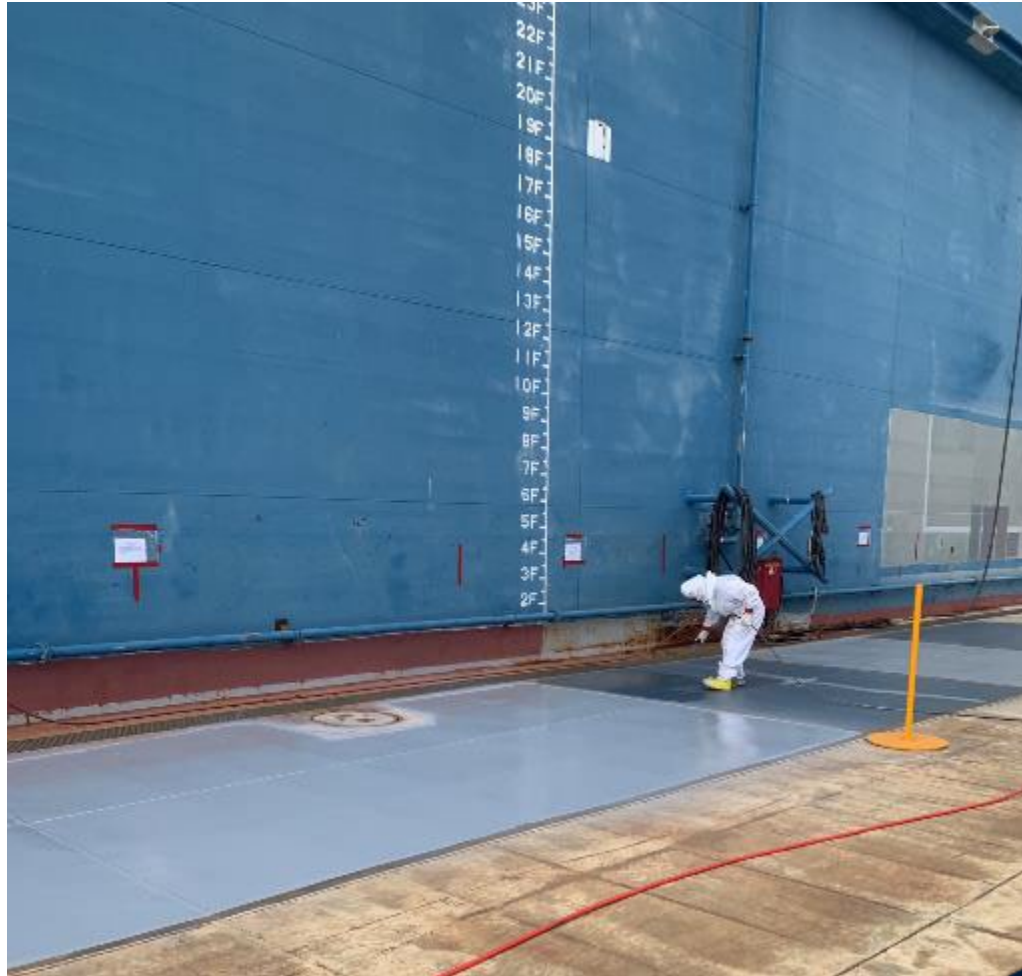
# 2 Coats Of Primer Prior To Non-Skid

Some With Proprietary And Some with 23236

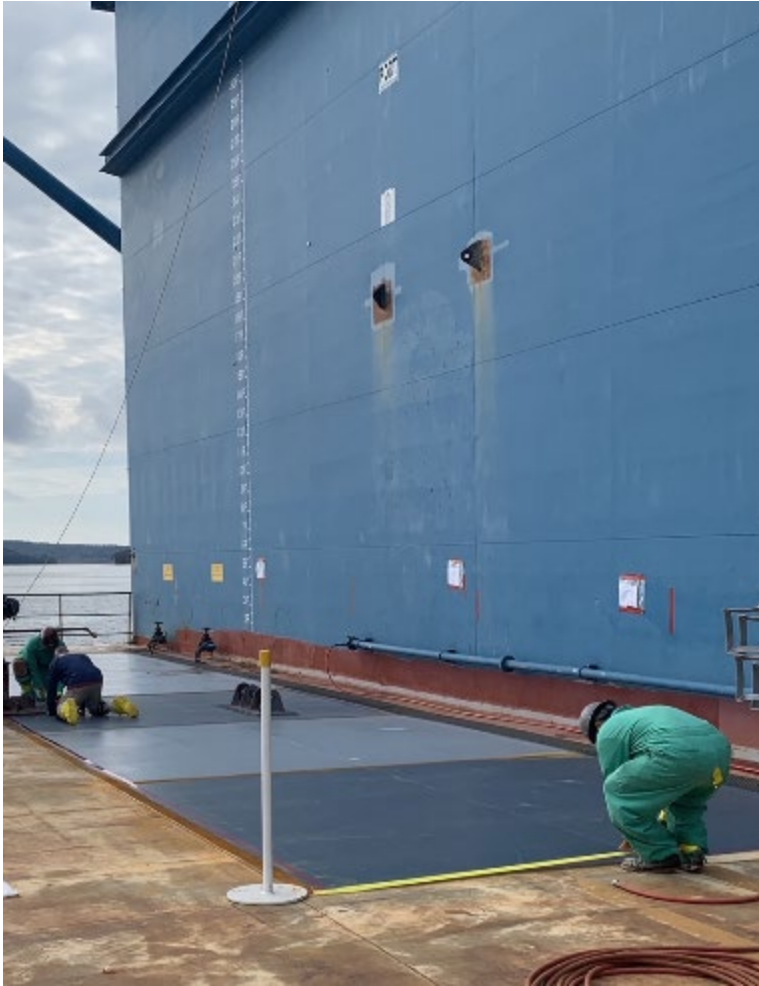
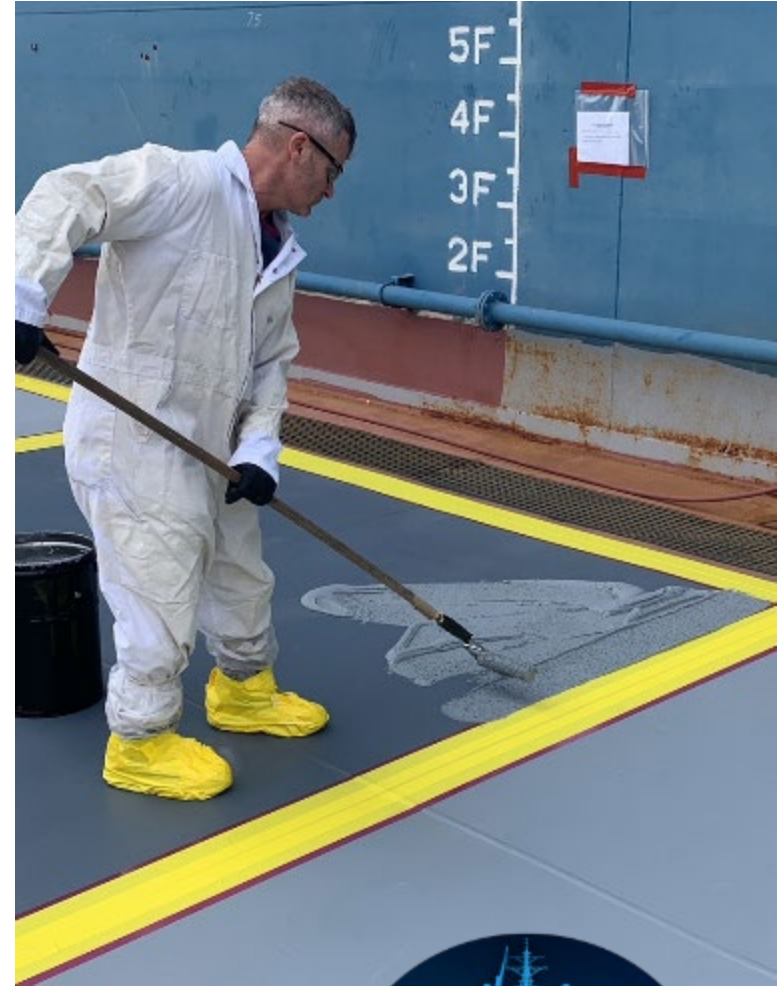
# Masking And Start Of Non-Skid

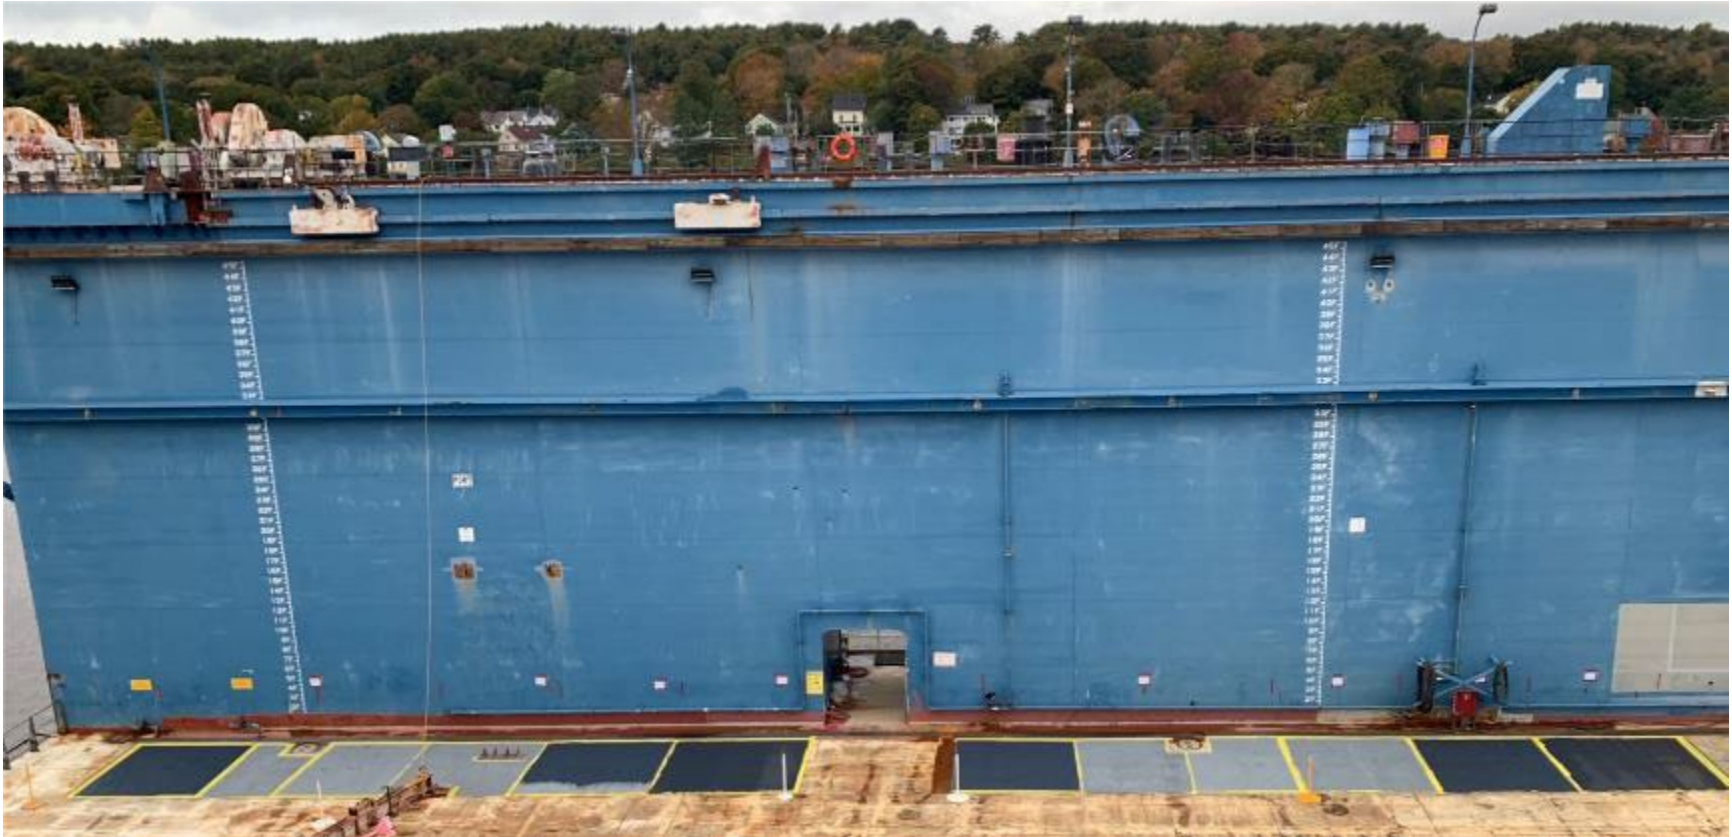
# Dry Dock Wing Wall View Of Completed Non-Skid

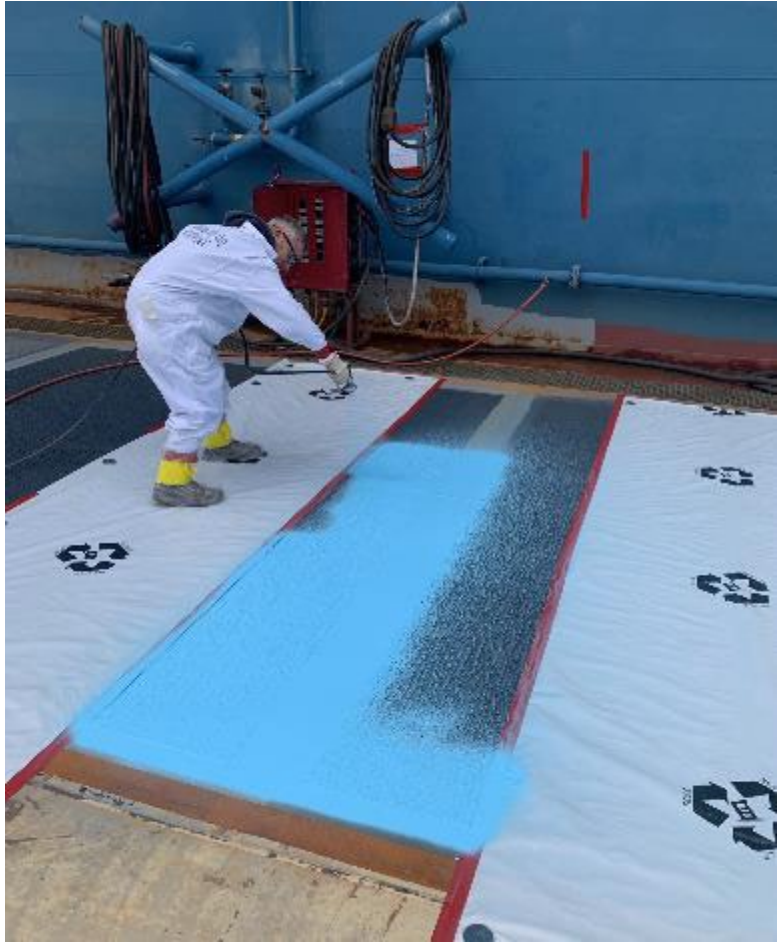
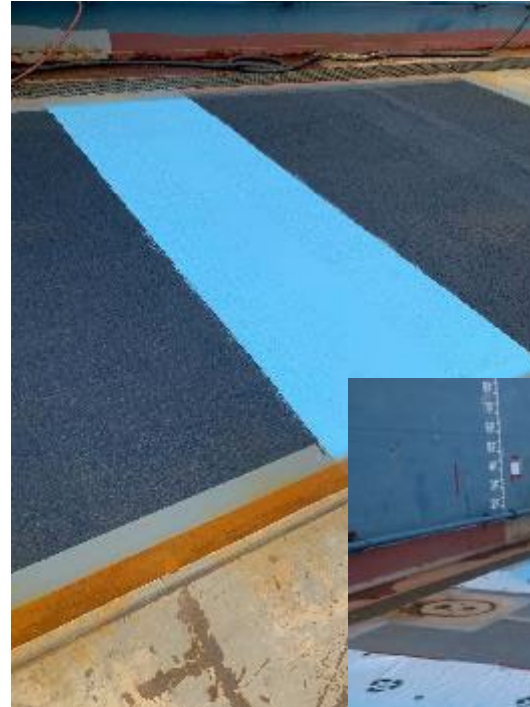
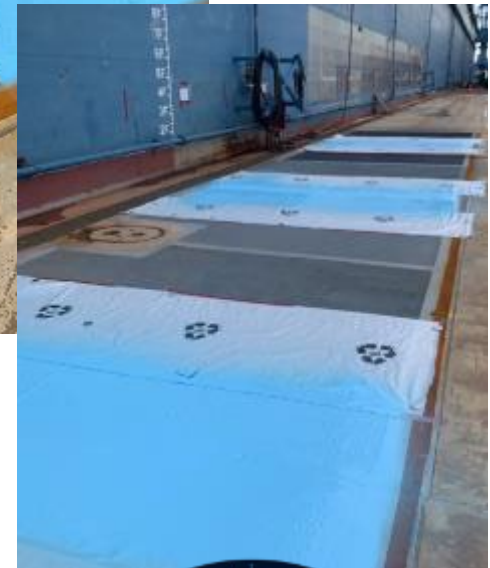
# No Care & Protection Area

IP5400 spray applied on approx. 18in of all sample sets

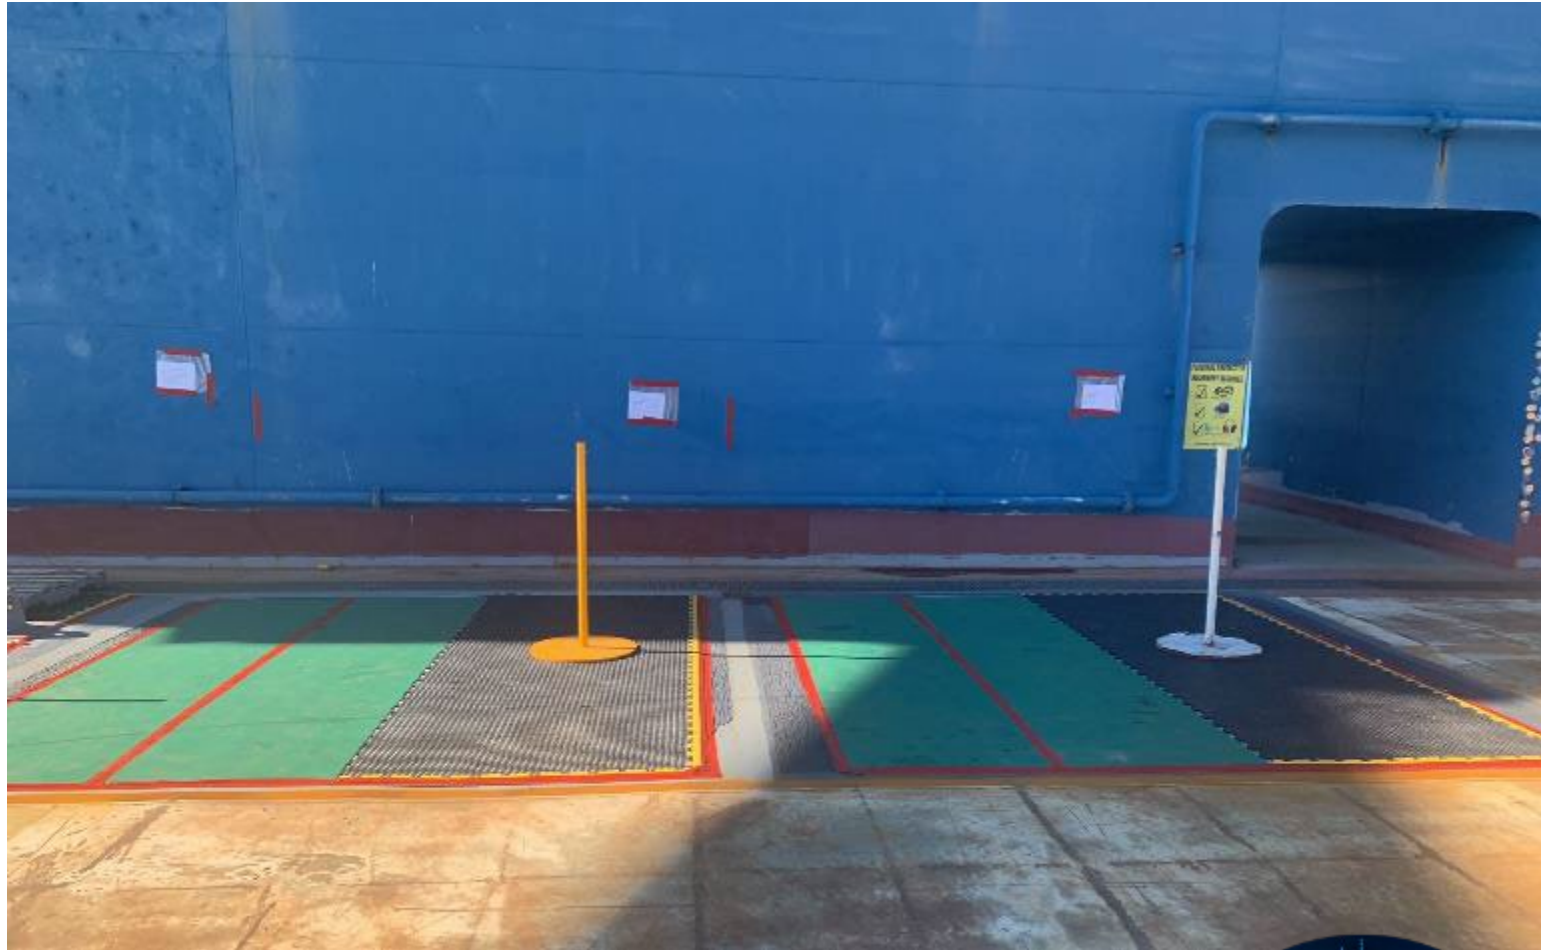
# Care & Protection Area

Green Rubber ½ & Rhino Tile with Breather Shield ½

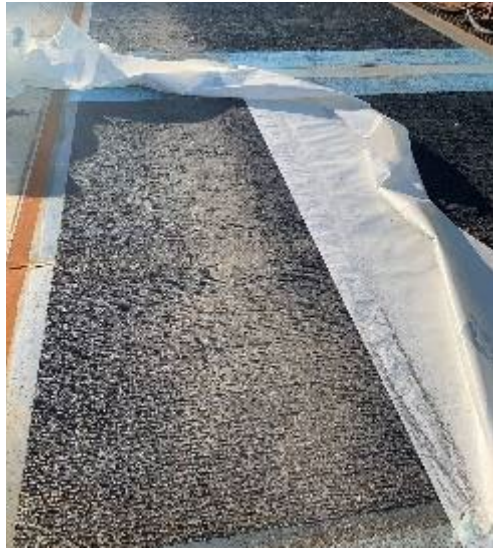
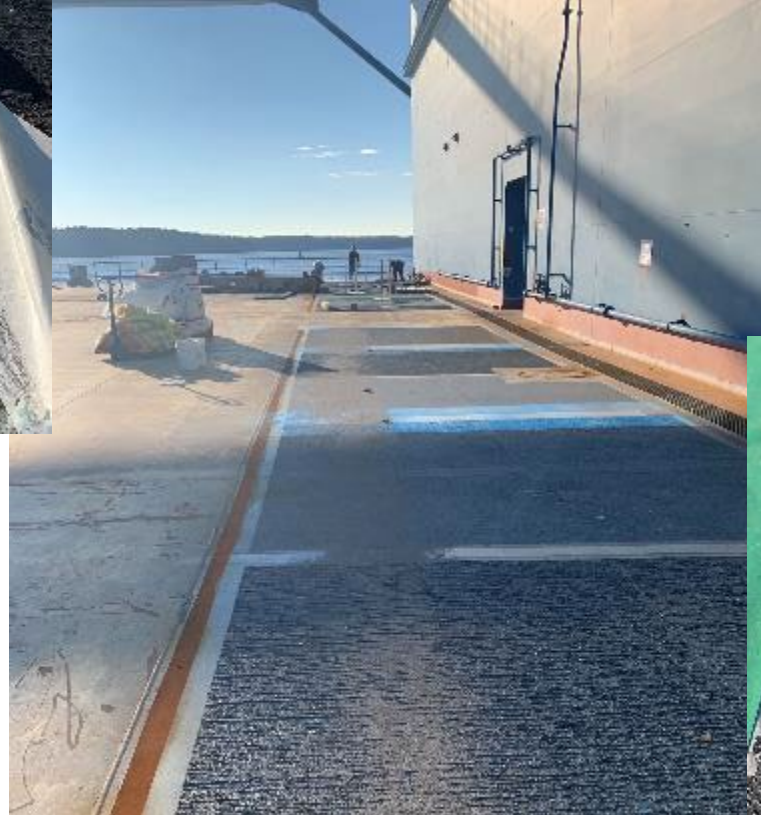
# Initial Contamination

40/50 Steel Grit on both C&P and Non-C&P

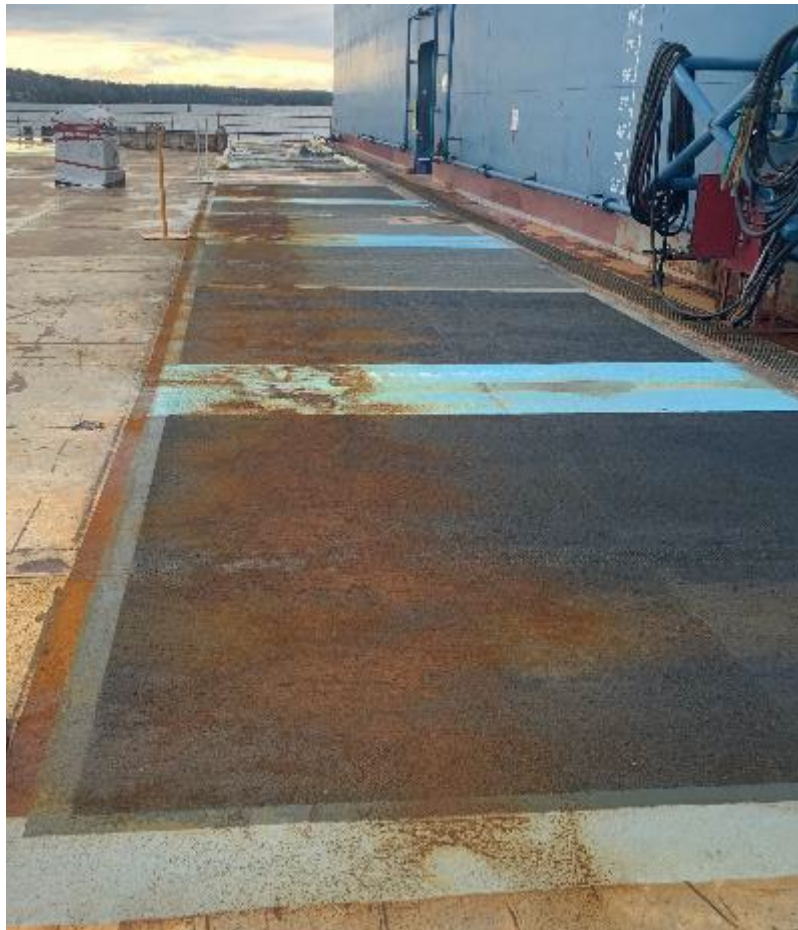
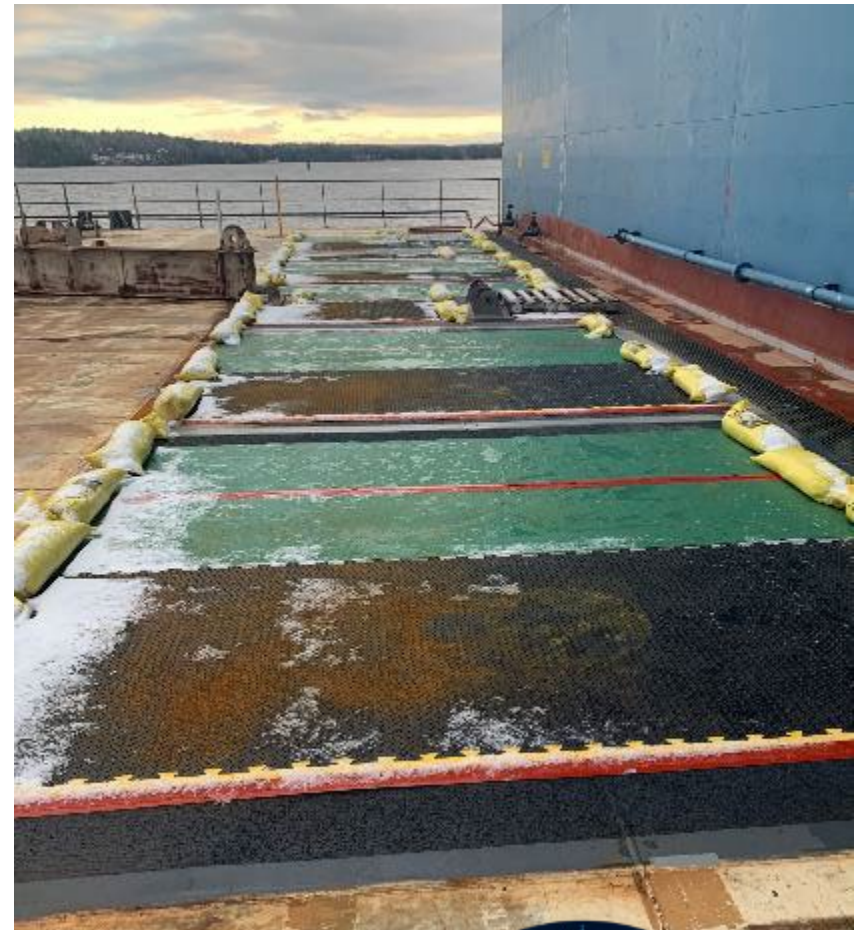
# Initial Weathered Contamination

40/50 Steel Grit on both C&P and Non-C&P

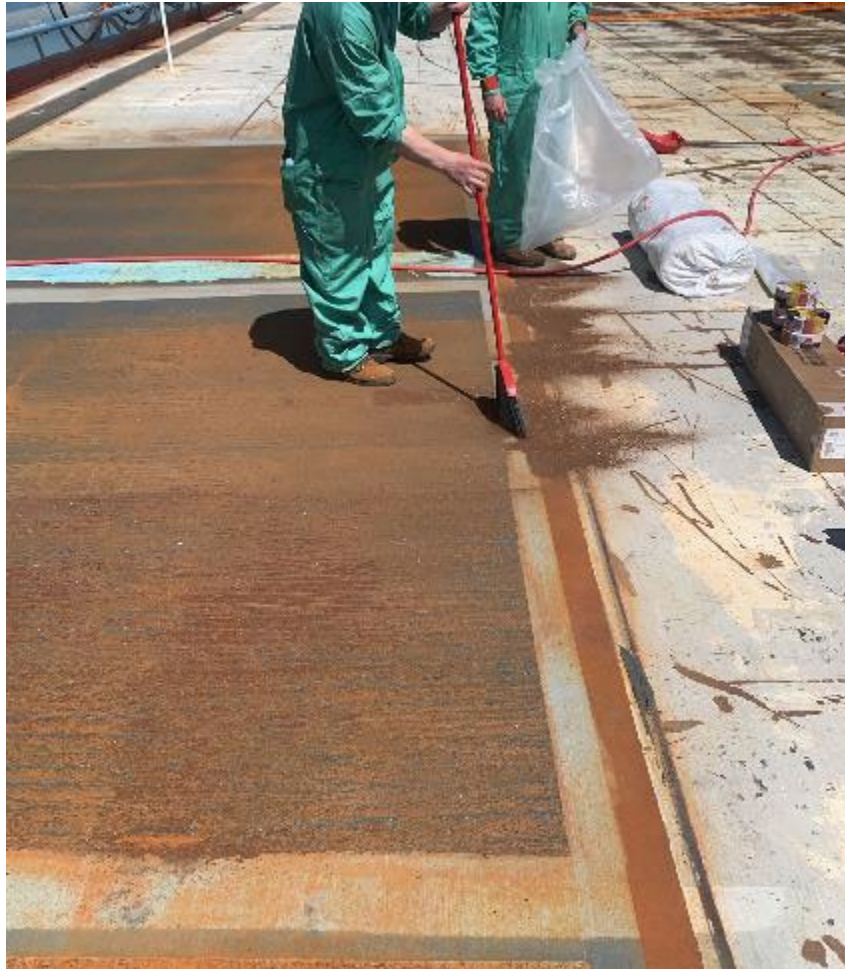
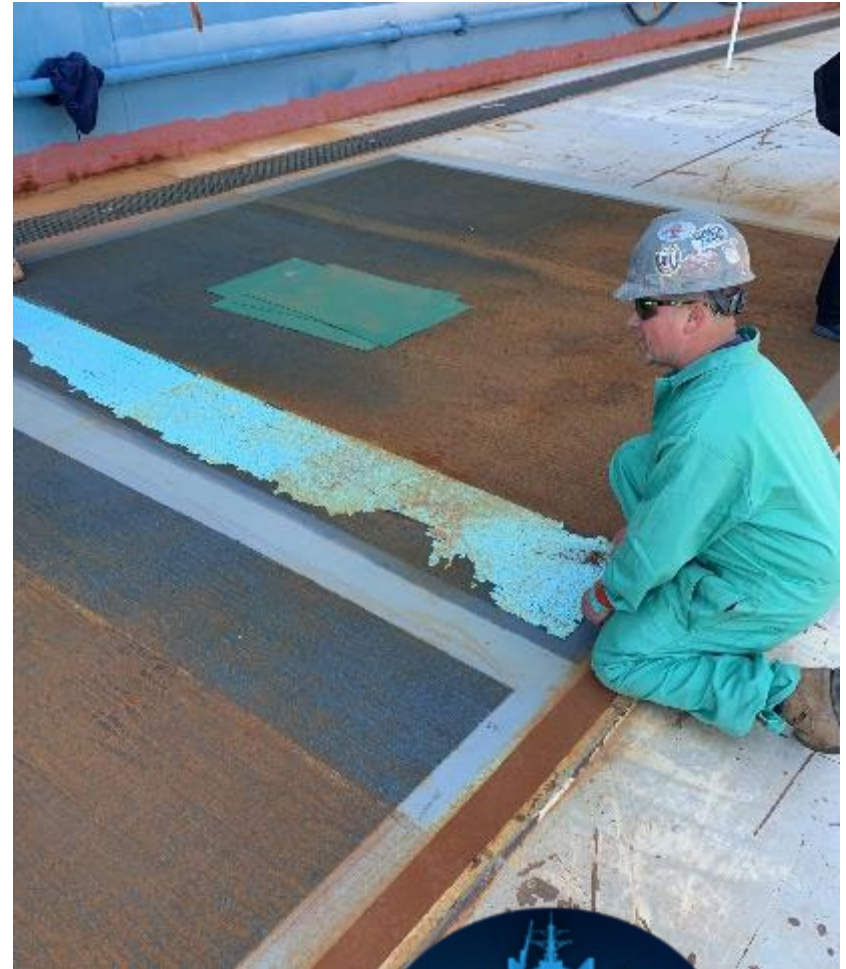
# Start Of Cleaning Testing 5/7 – 5/9

Light Sweep Of Heavy Contaminants & Inspection of 5400

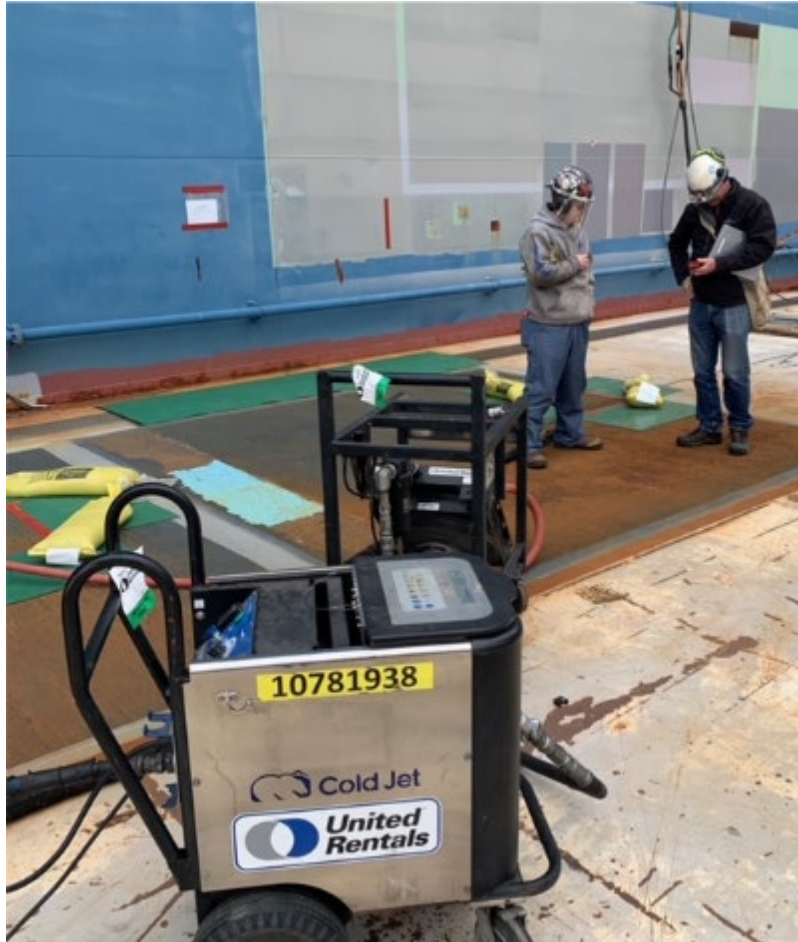
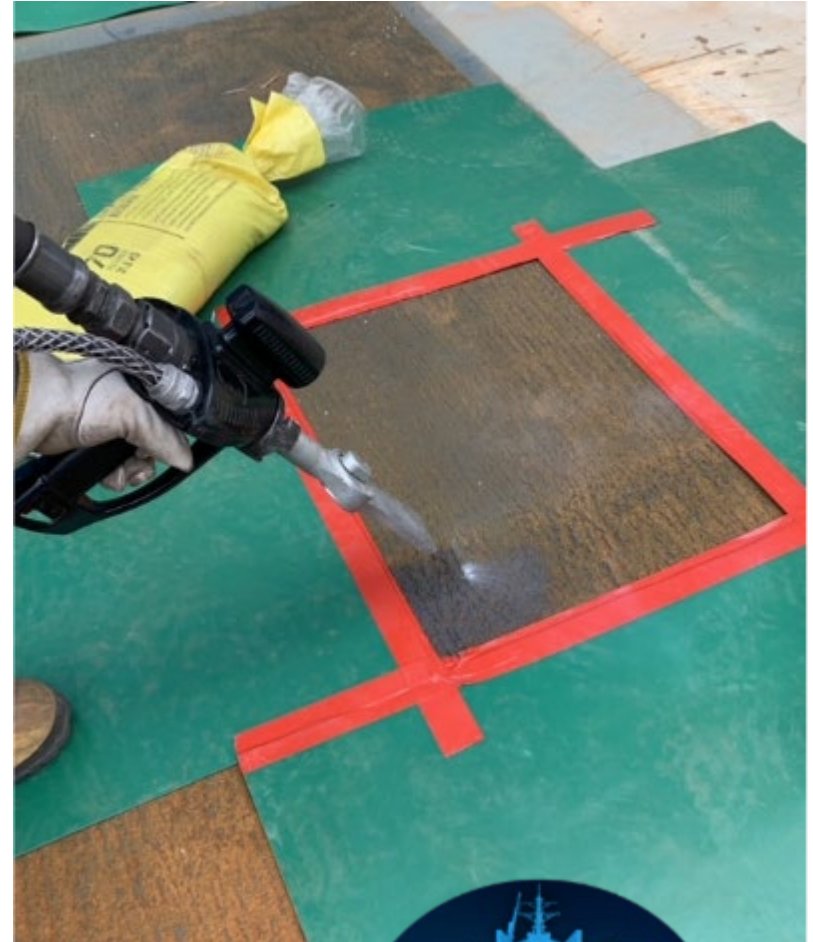
# Set Up Of Dry Ice Blasting 2.5 Pellets

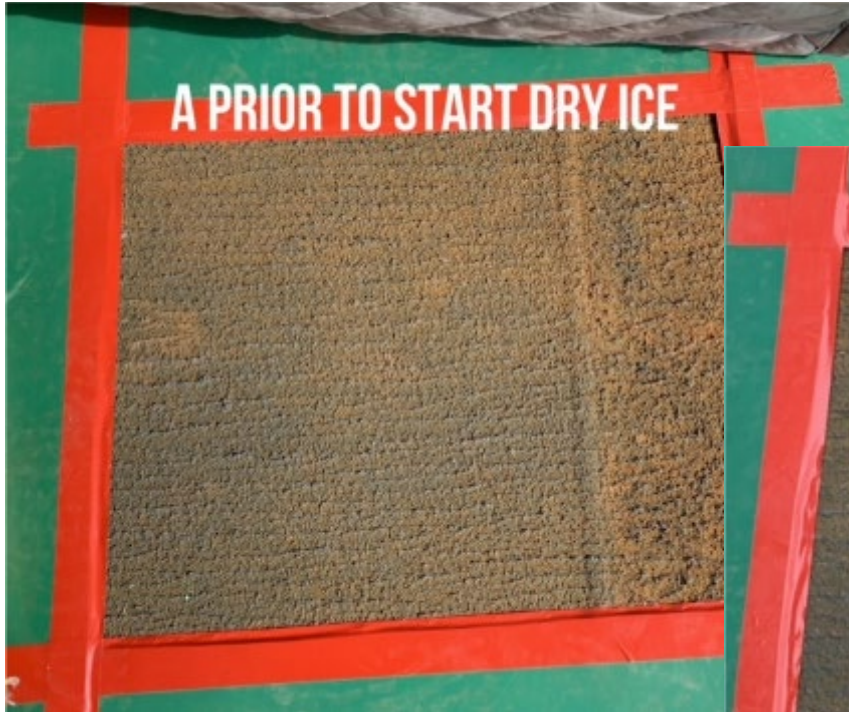
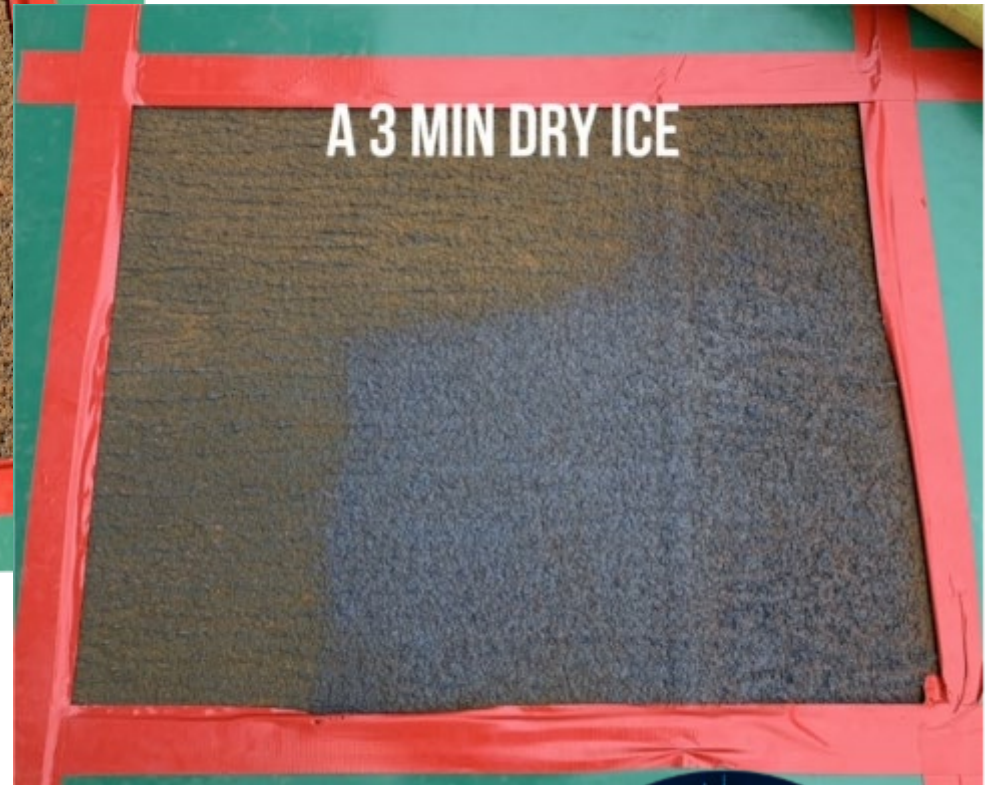
# Sample A Dry Ice Before & After

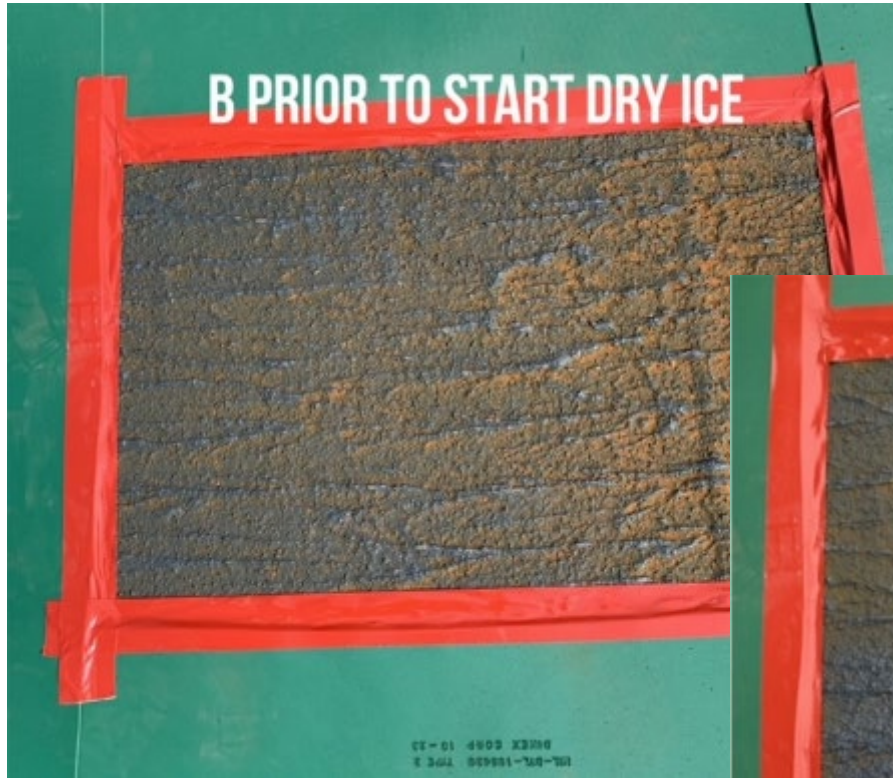
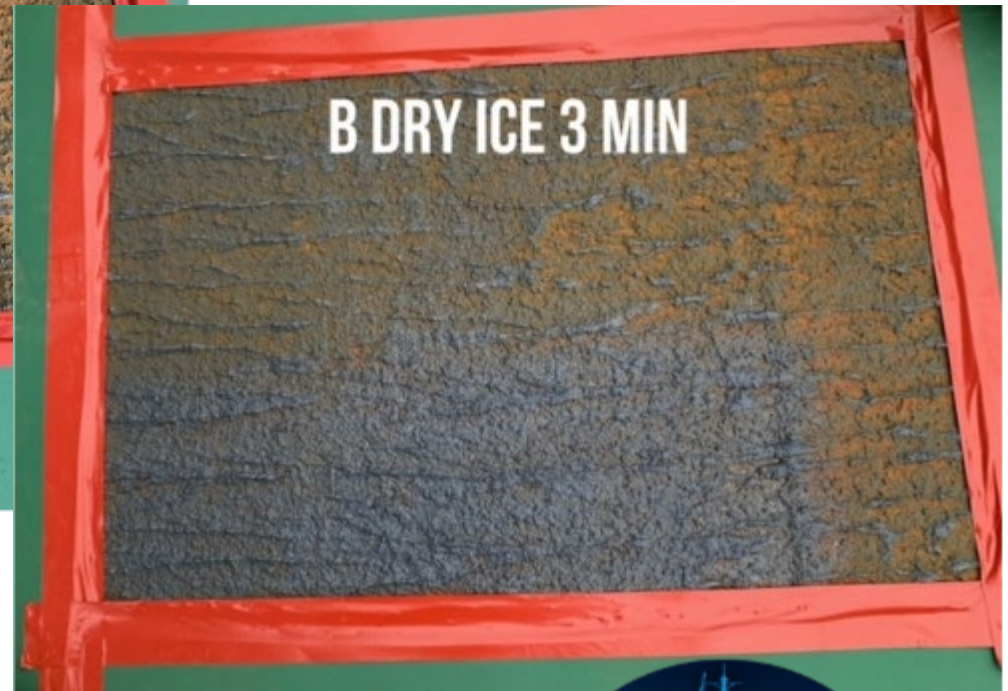
# Sample B Dry Ice Before & After

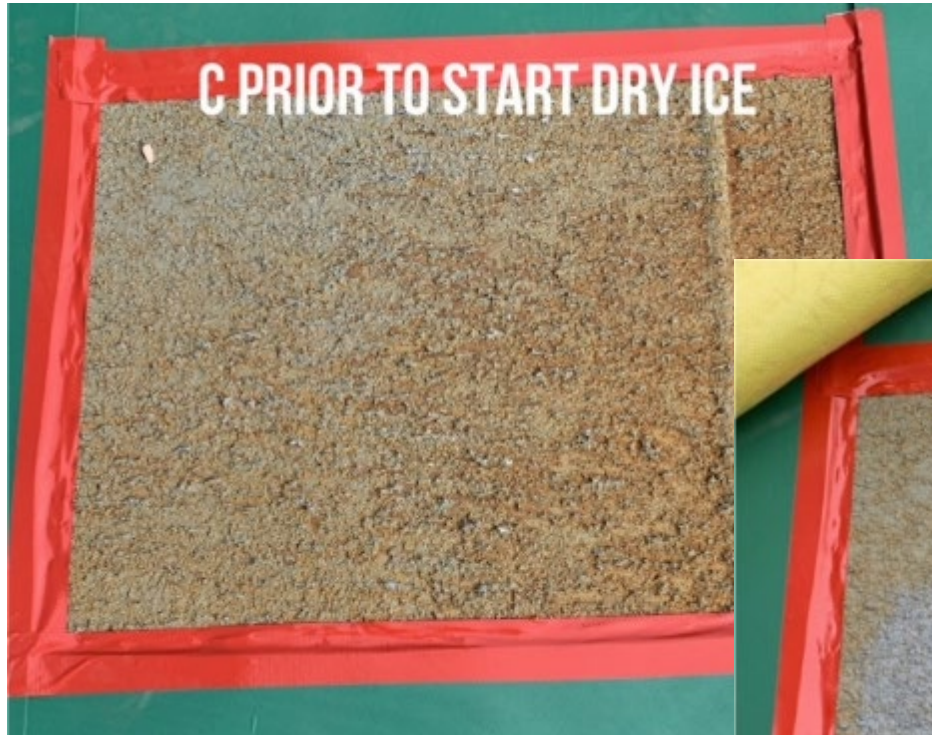
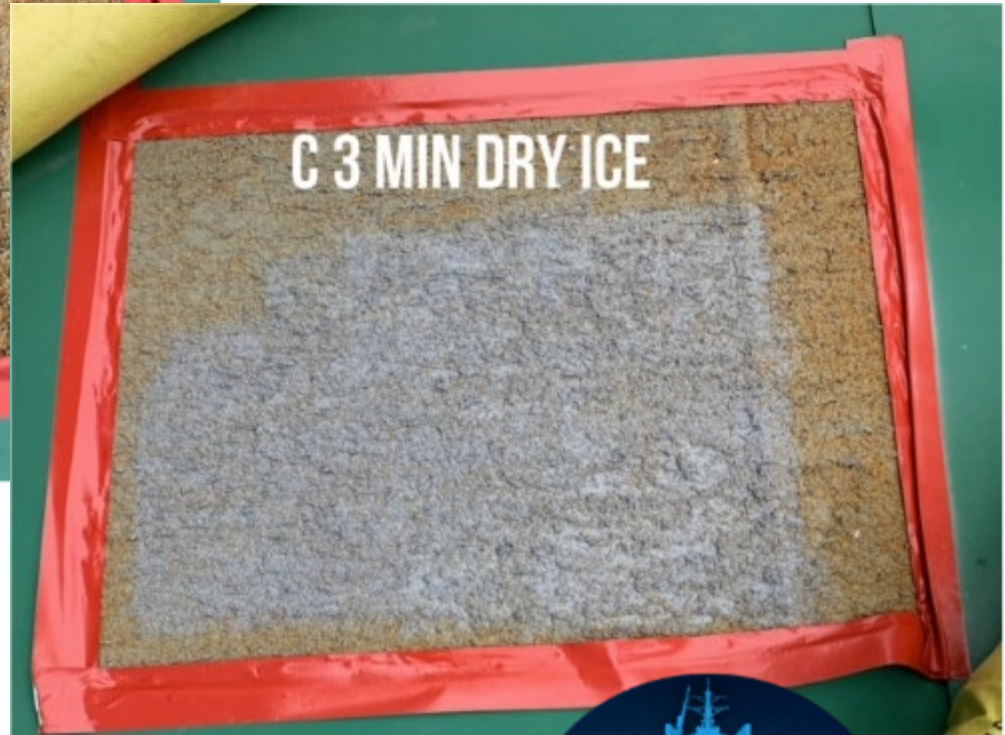
# Sample C Dry Ice Before & After

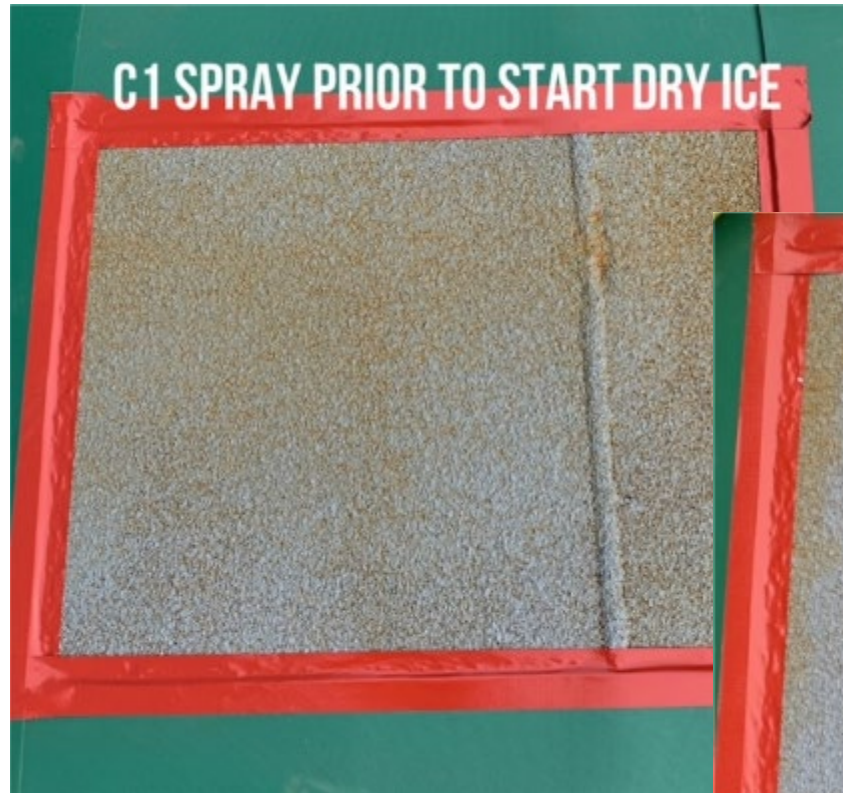
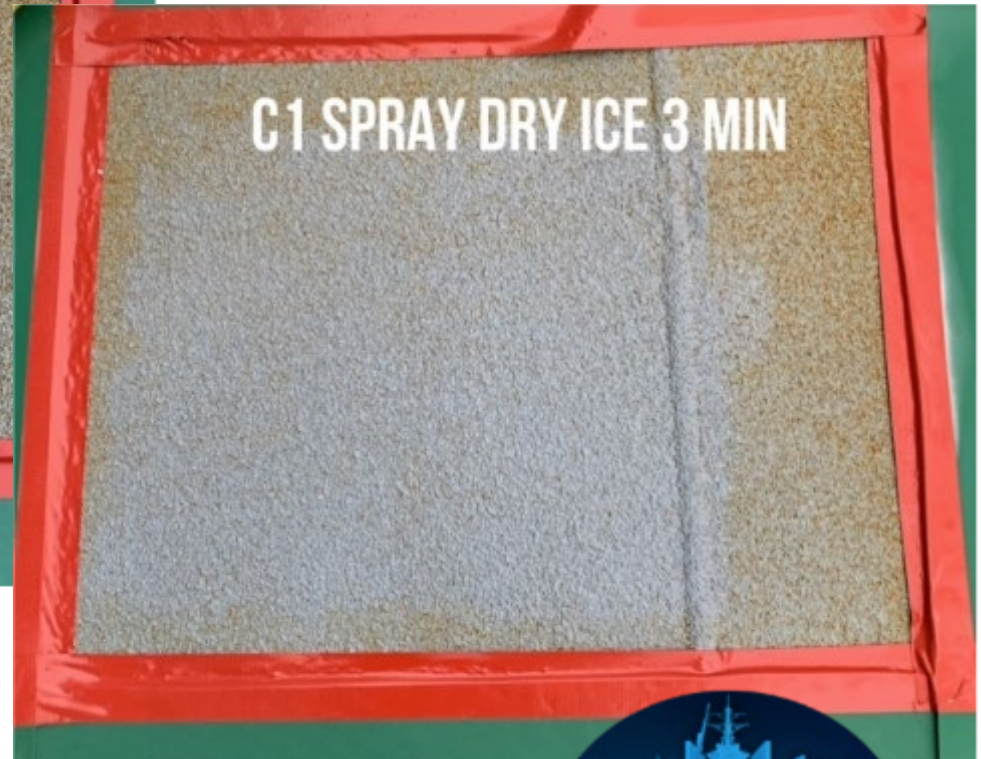
# Sample C1-S Dry Ice Before & After

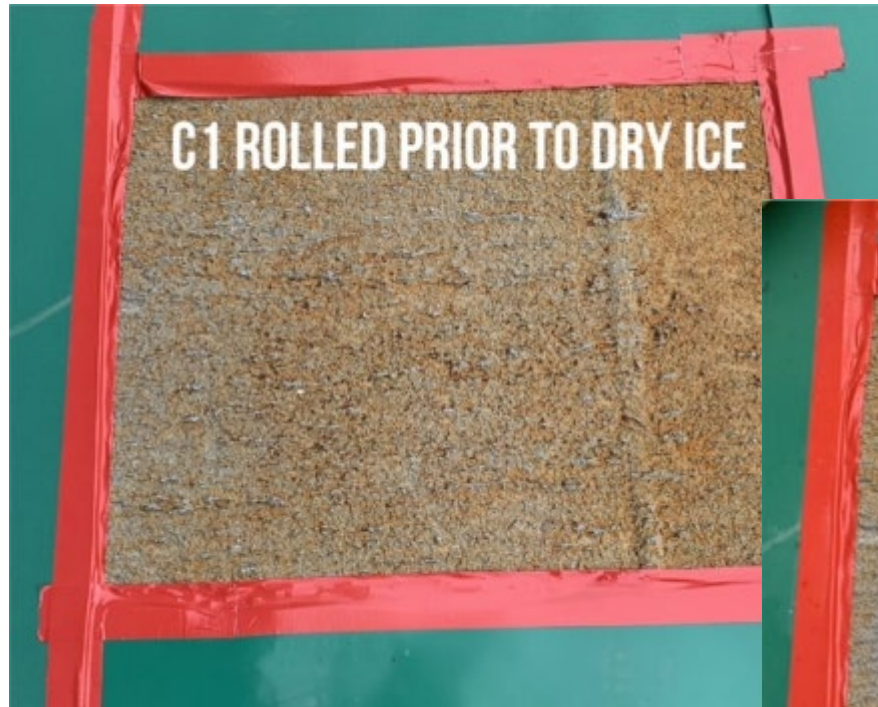
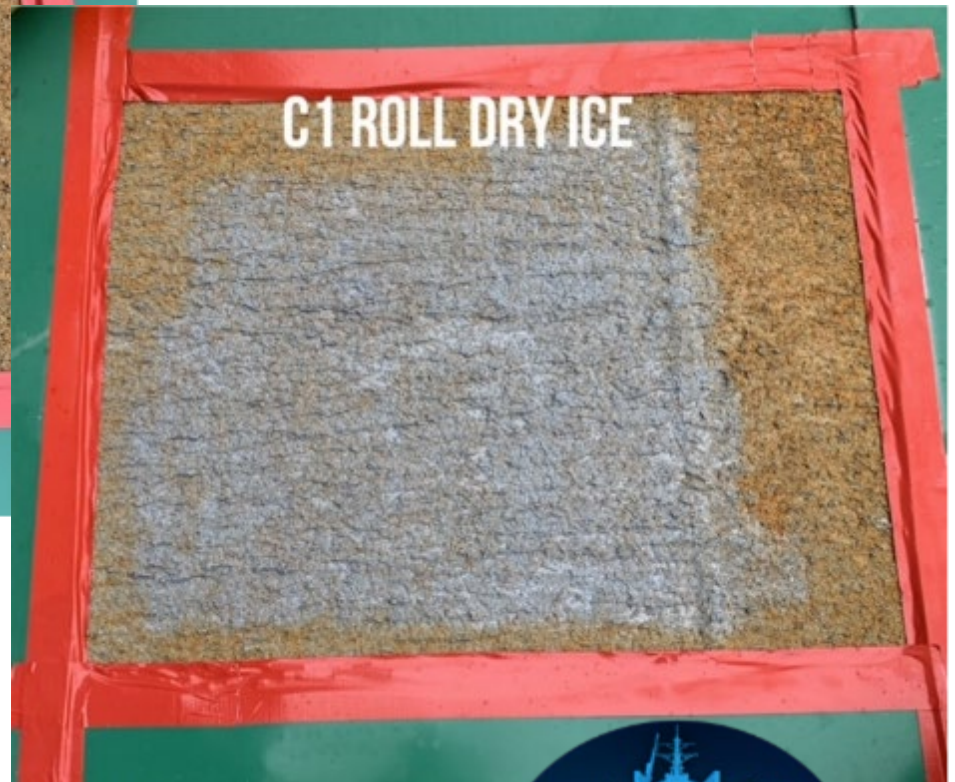
# Sample C1-R Dry Ice Before & After

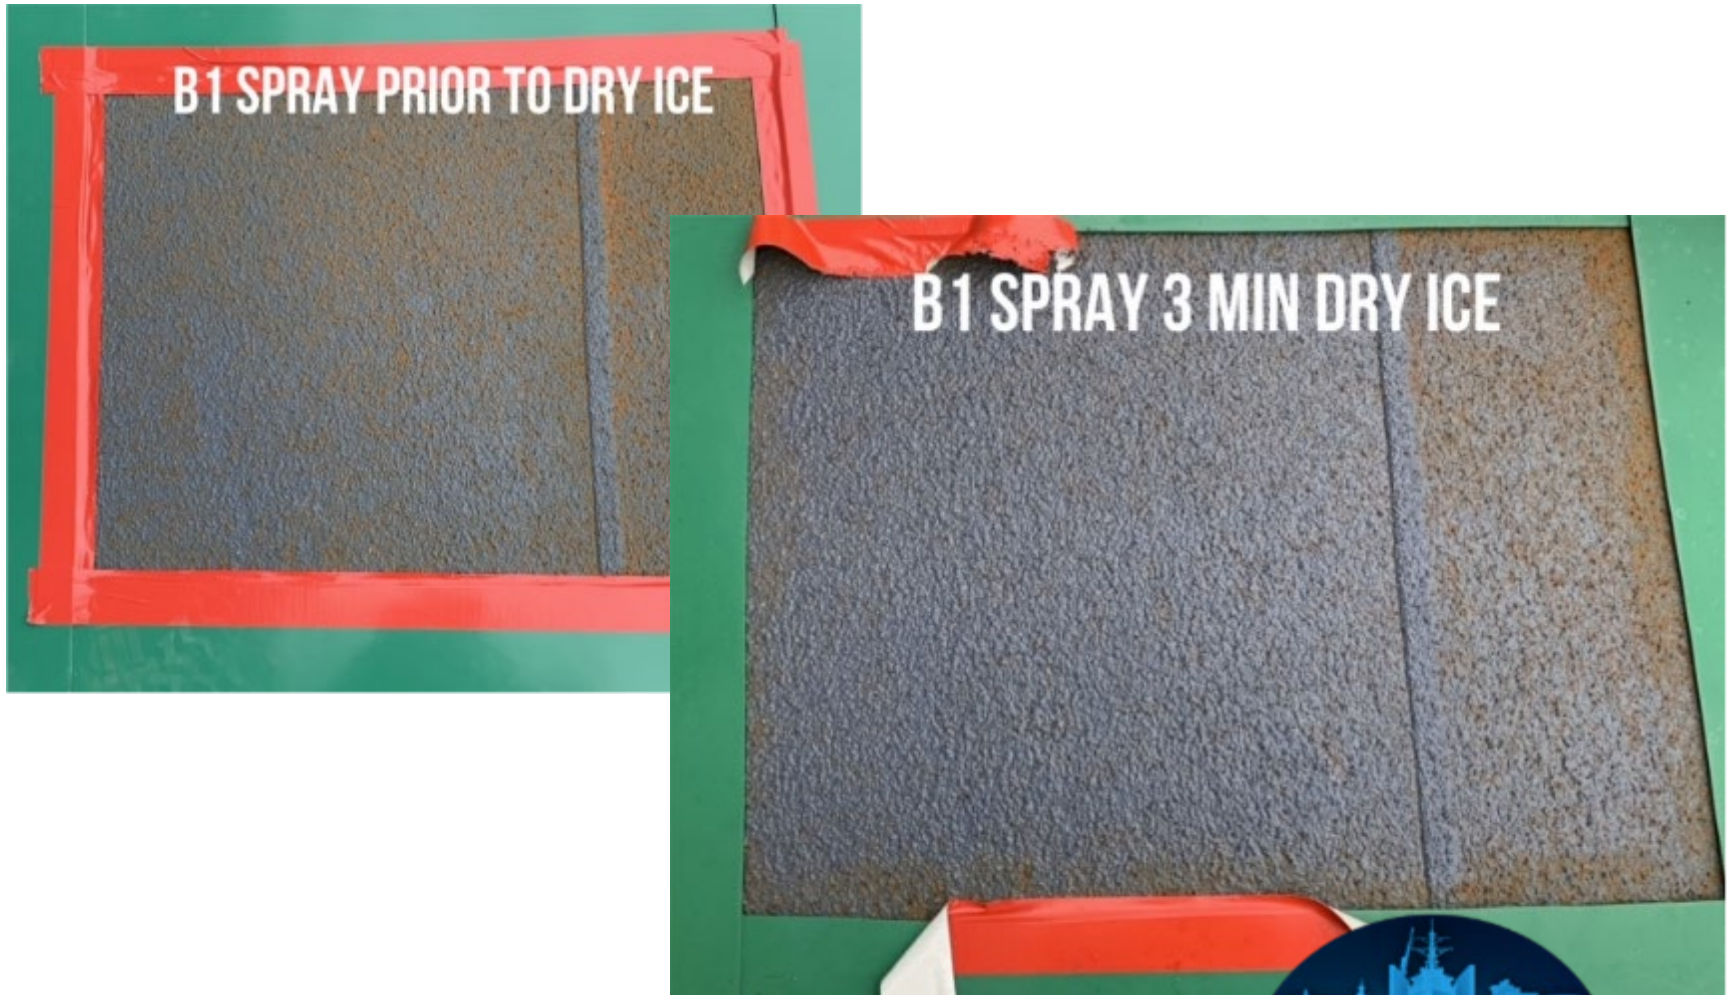
# Sample B1-S Dry Ice Before & After
