# **GENERAL DYNAMICS**

## **NSRP Cleanable Non-Skid Deck Covering Project**

**BIW Process Control  
FY2023/24**

# BIW-Panel Project Scope of Work

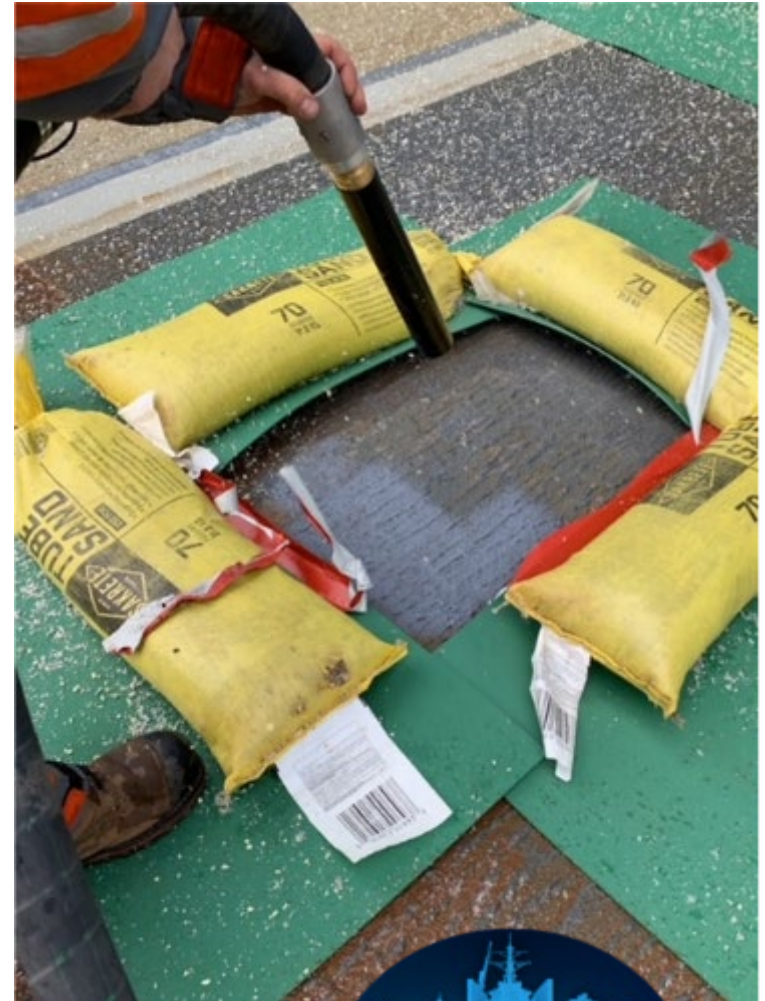
# Set Up Of SpongeJet Sponge Blast With Plastic Sponge

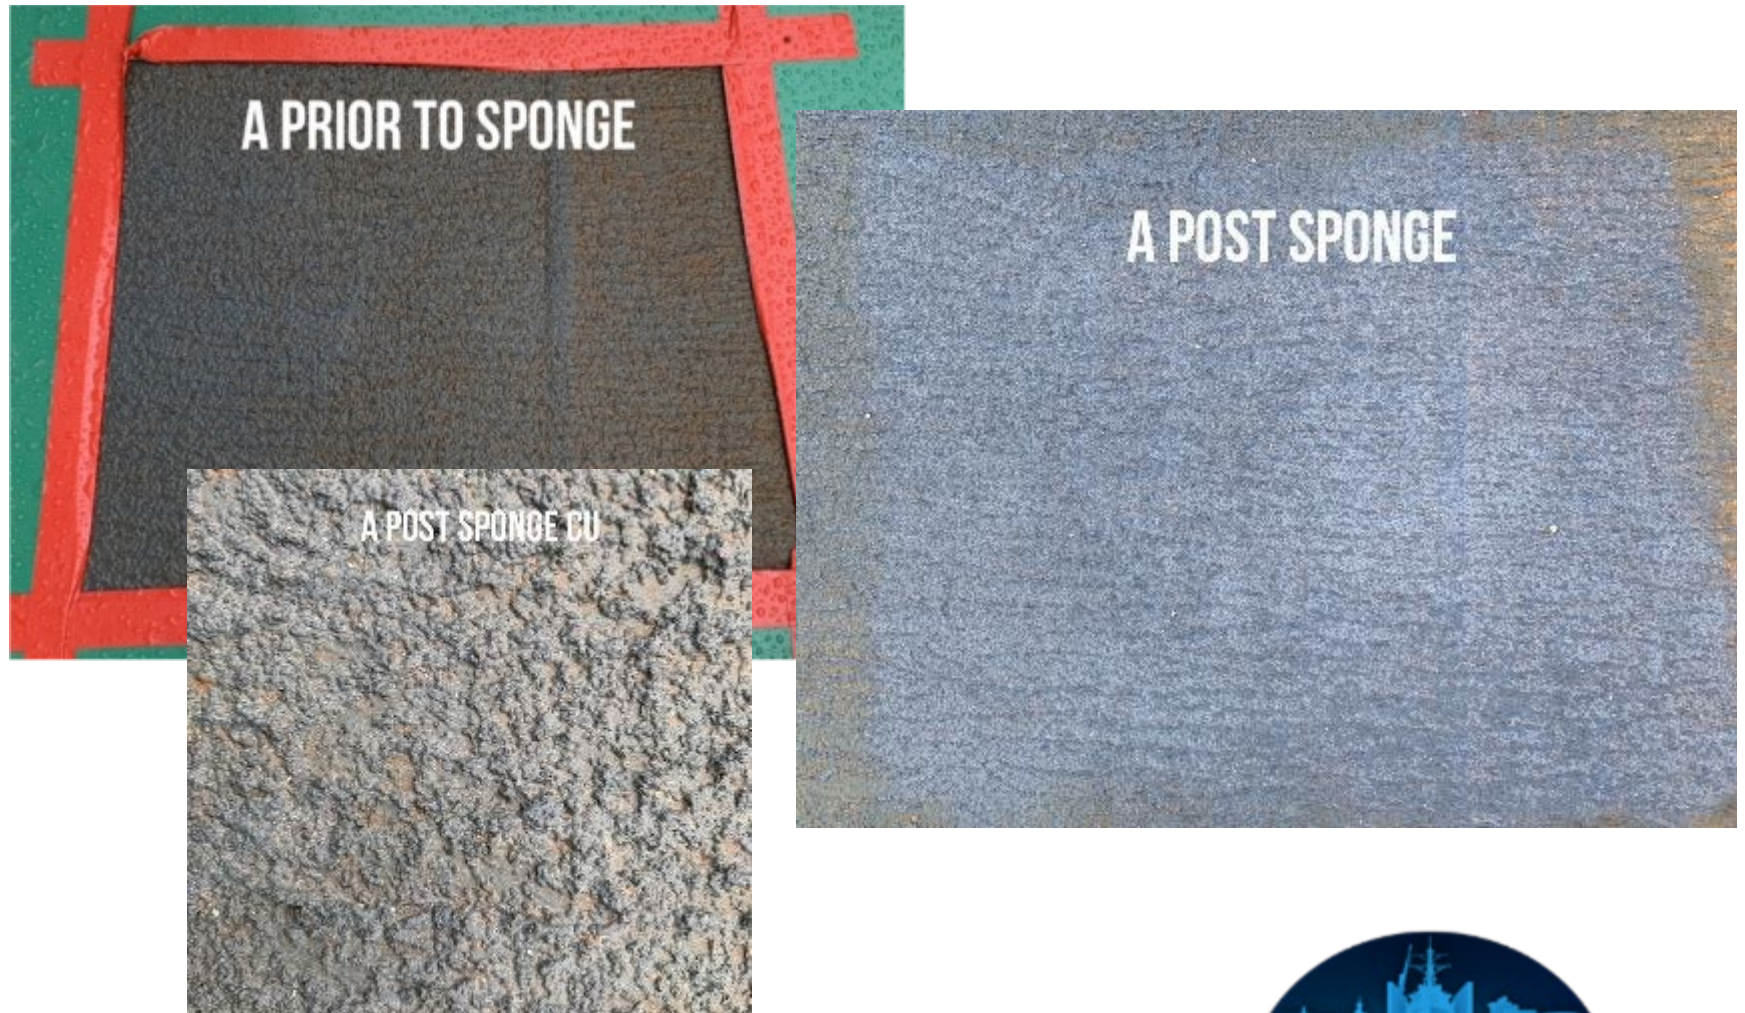
# Sample A SpongeJet Before, After & Close Up

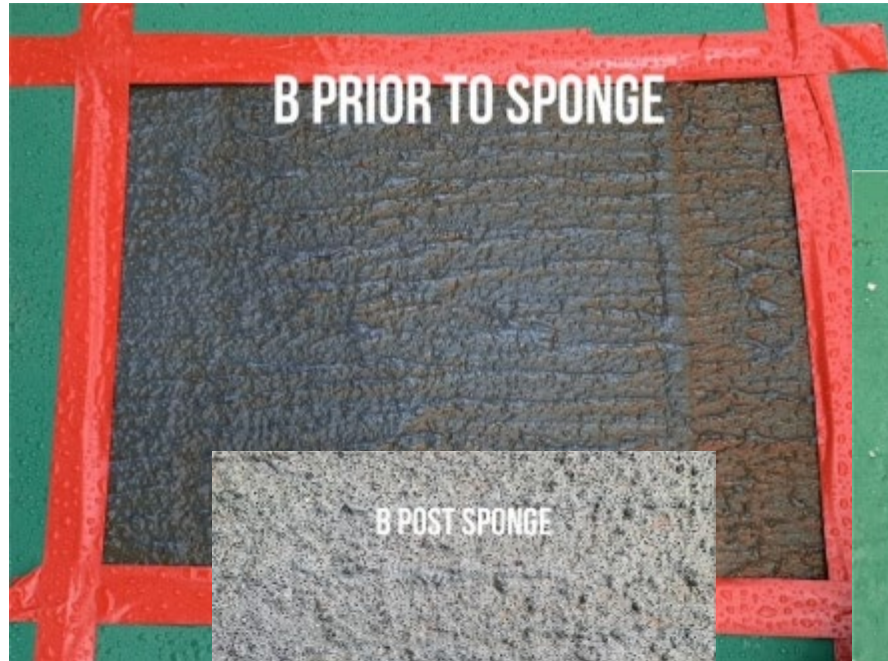
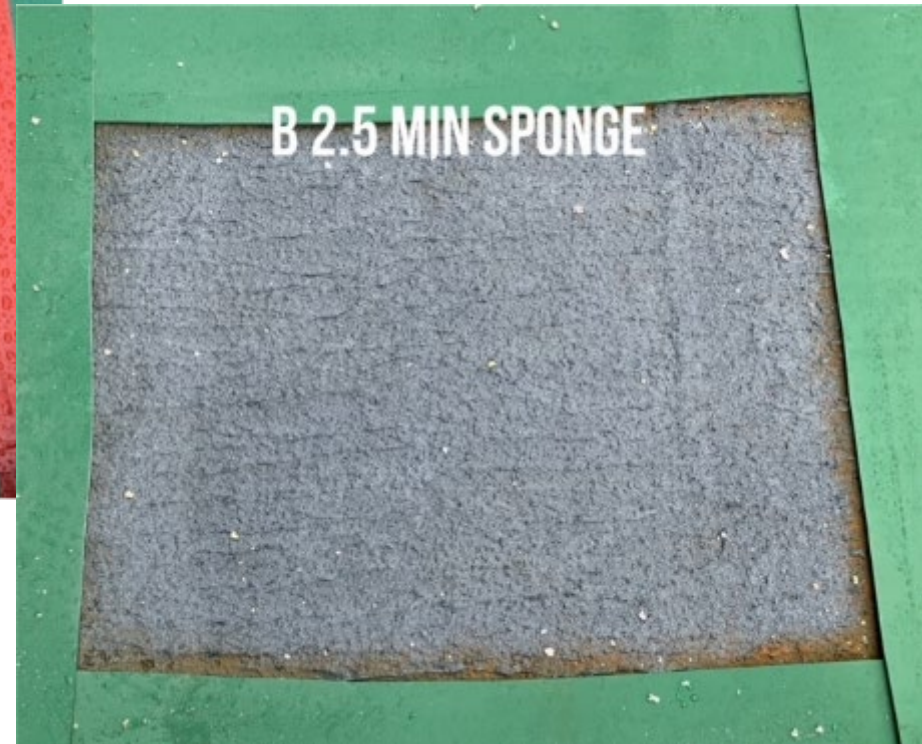
# Sample B SpongeJet Before, After & Close Up

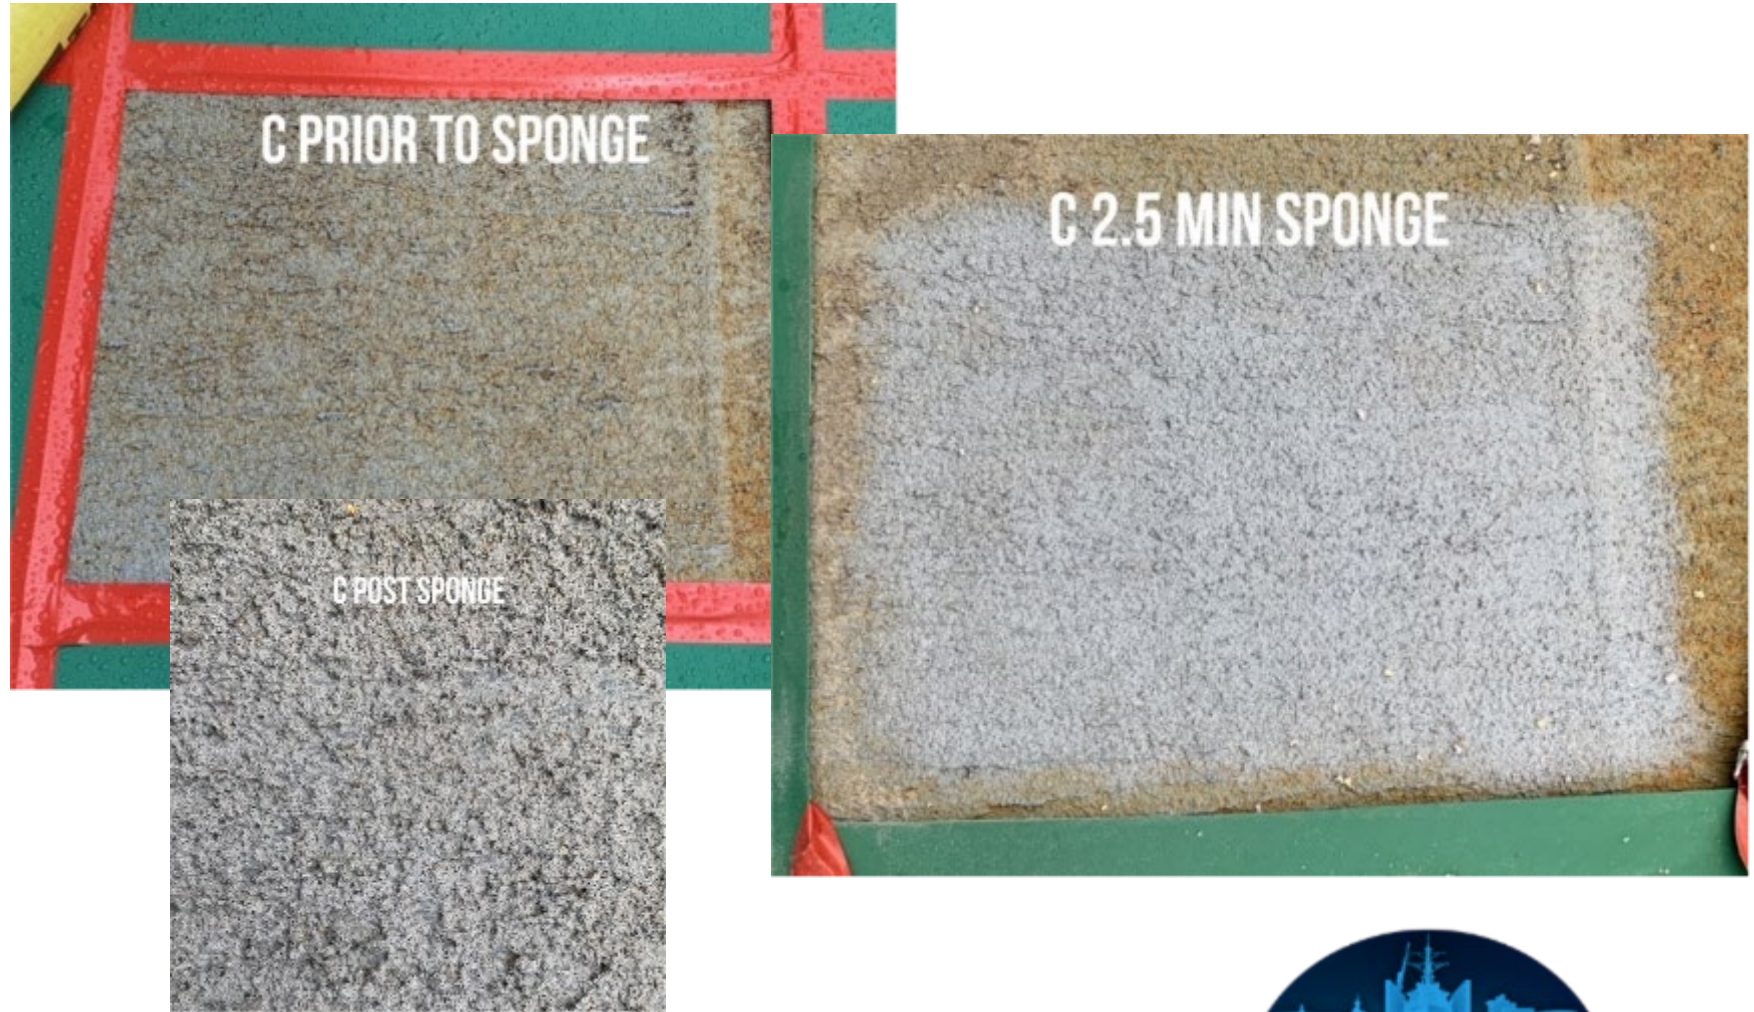
# Sample C SpongeJet Before, After & Close Up

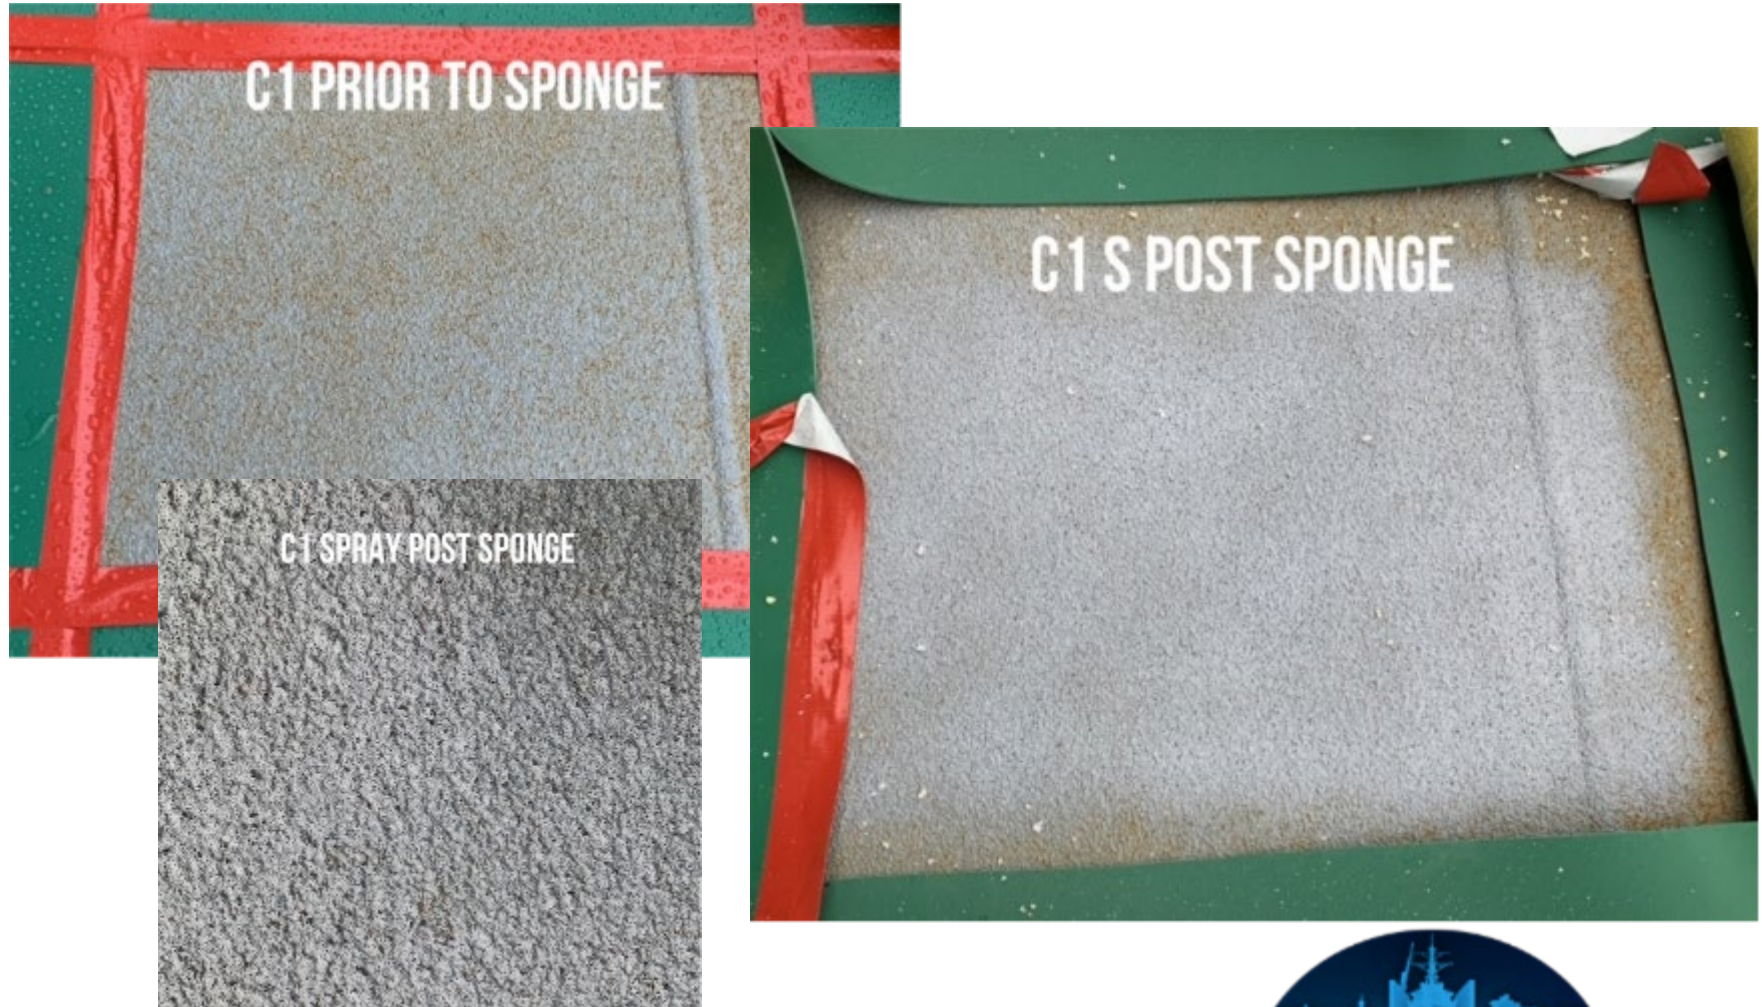
# Sample C1-S SpongeJet Before, After & Close Up

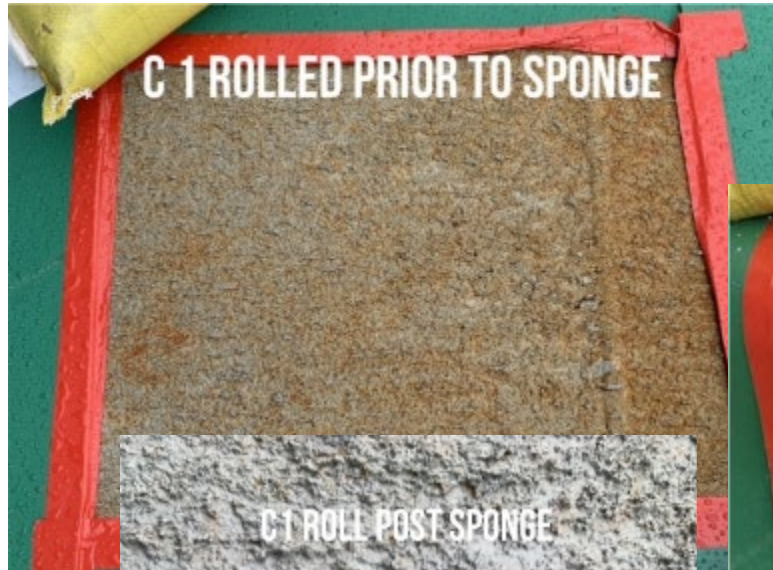
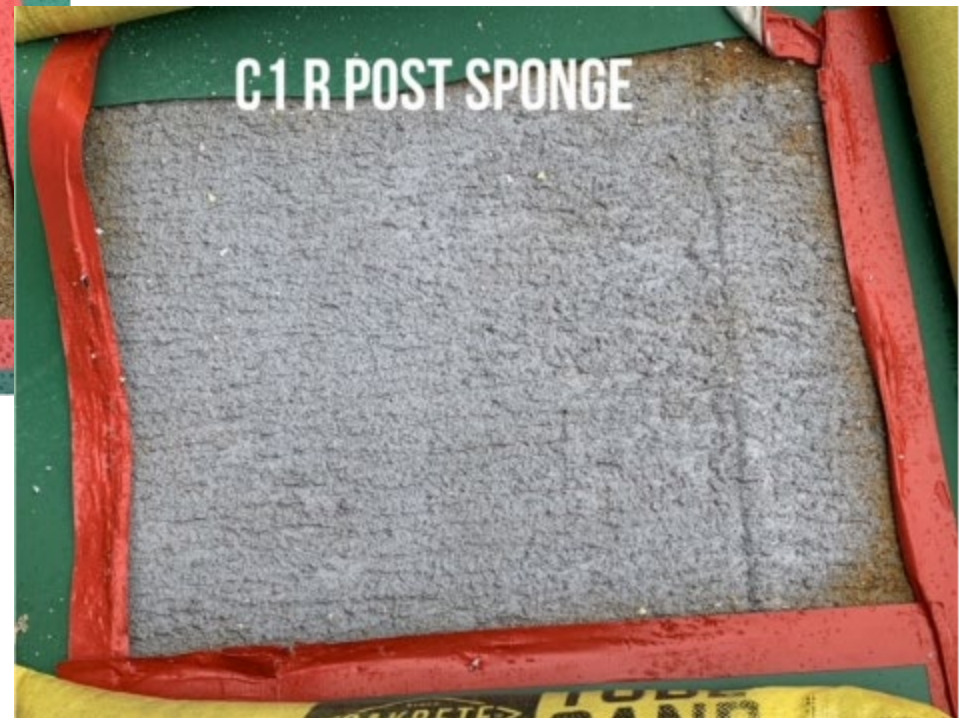
# Sample C1-R SpongeJet Before, After & Close Up

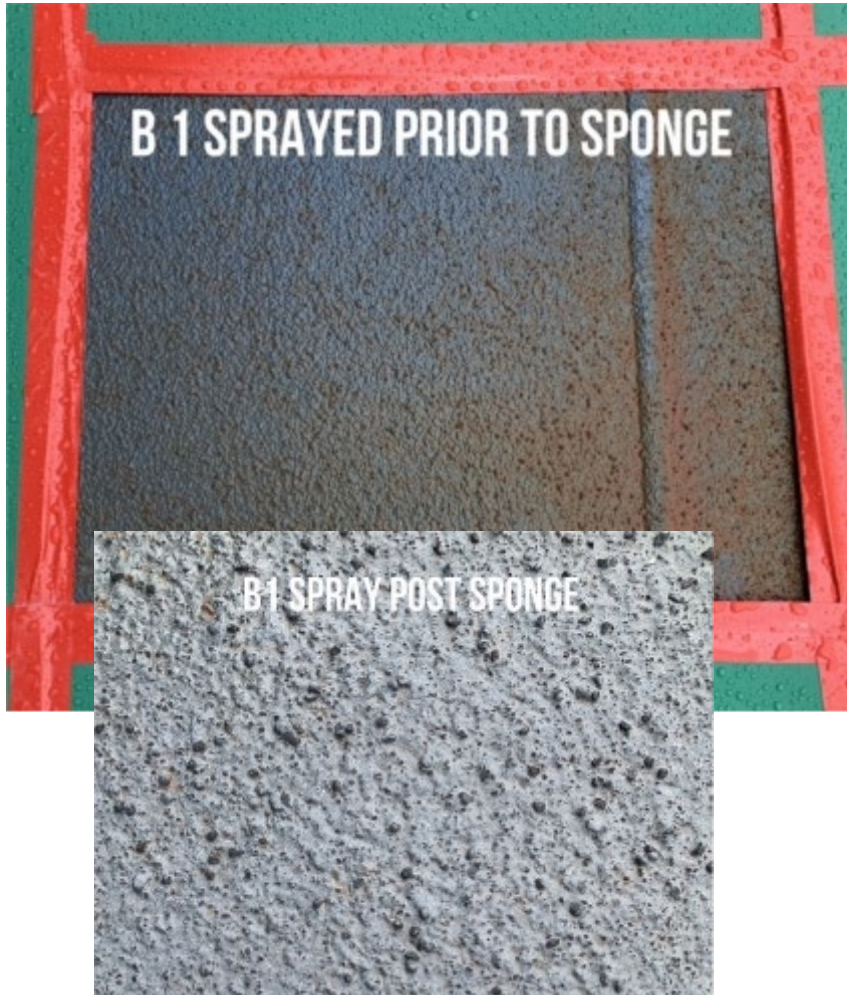
# Sample B1-S SpongeJet Before, After & Close Up

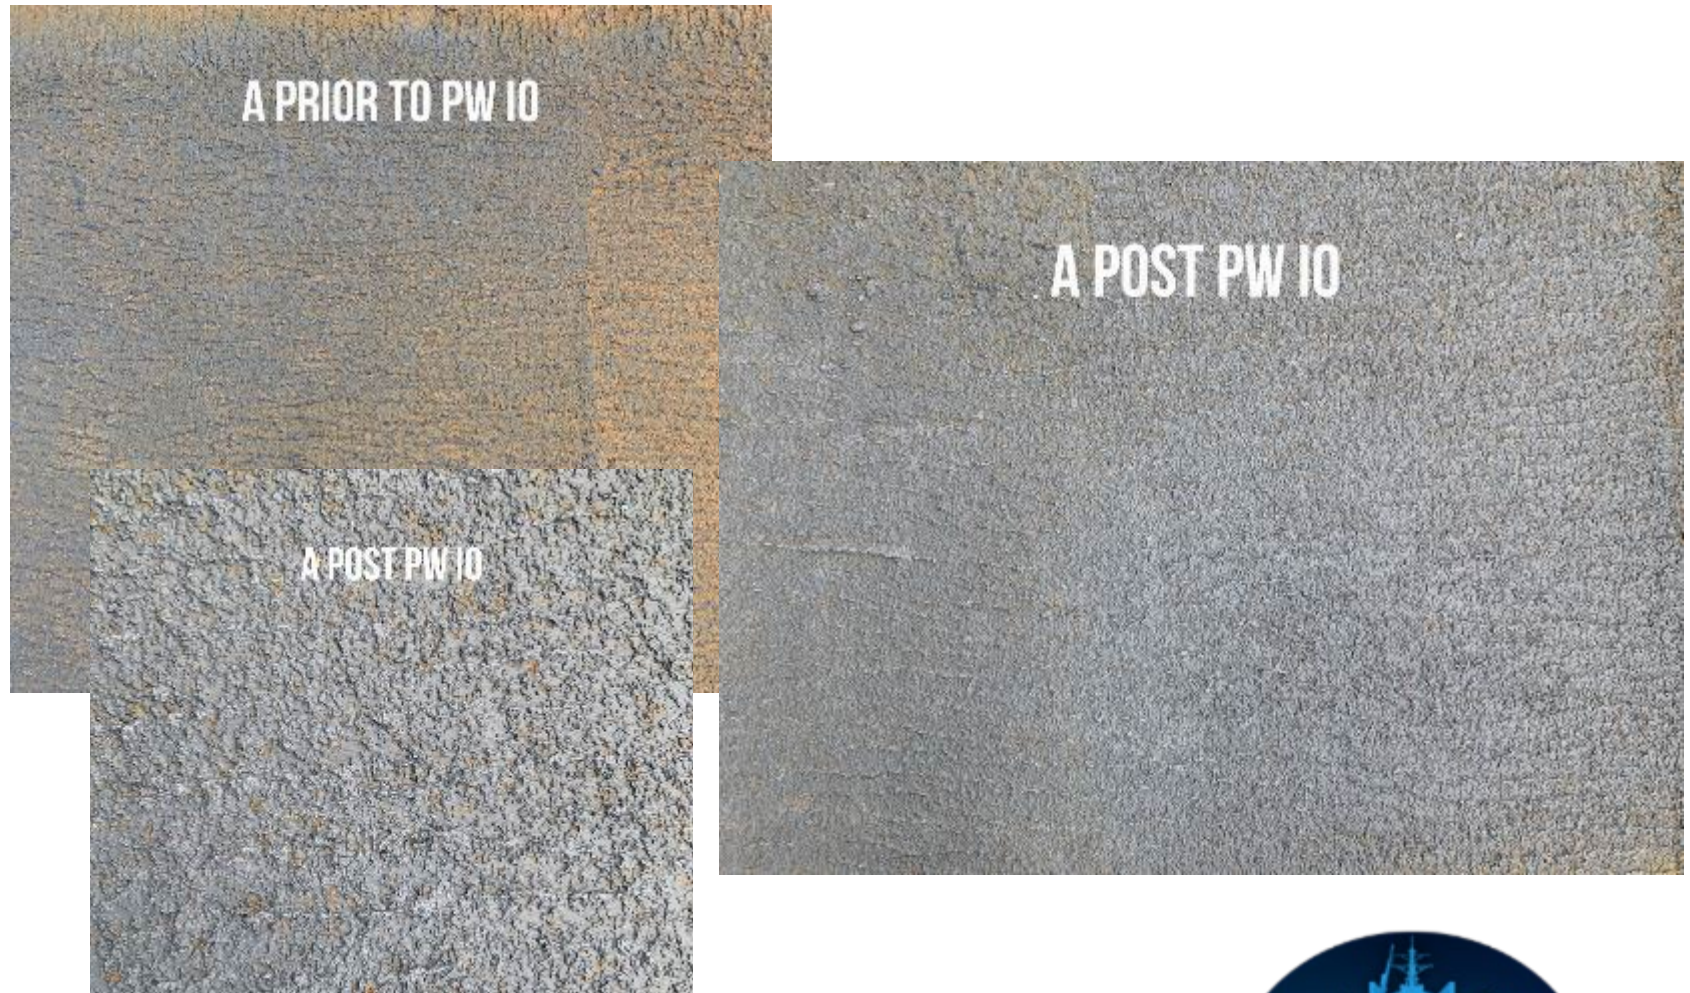
# Sample A Pressure Wash With Iron Out Before, After & Close Up

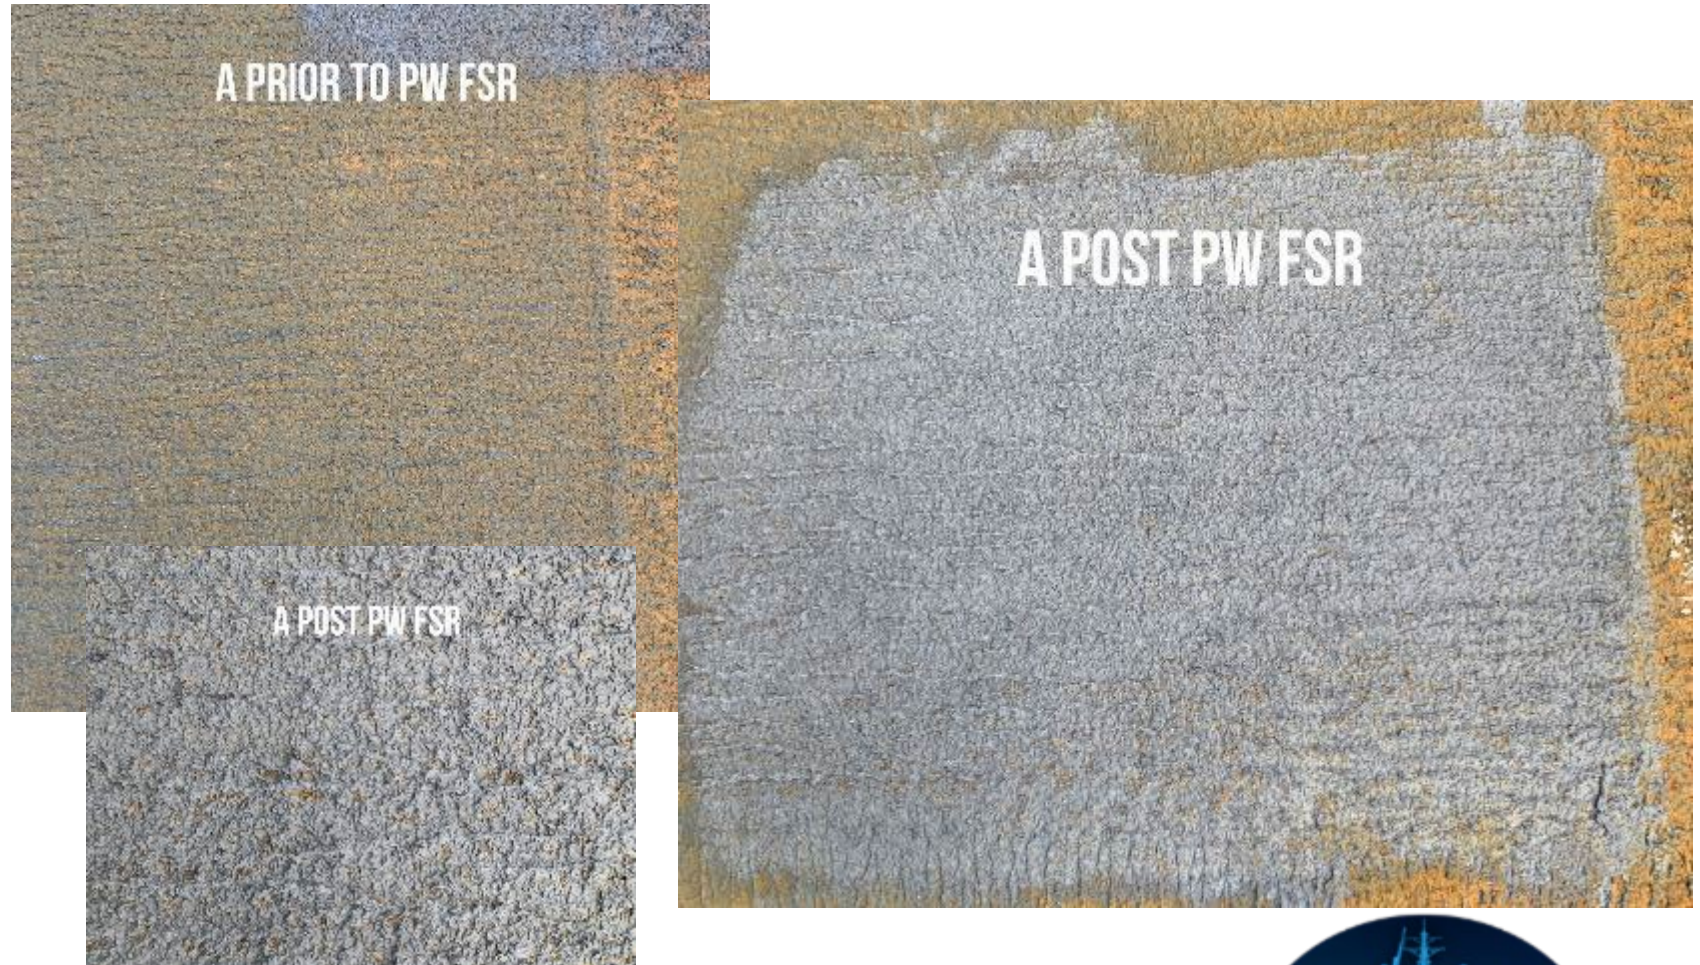
# Sample A Pressure Wash With FSR Before, After & Close Up

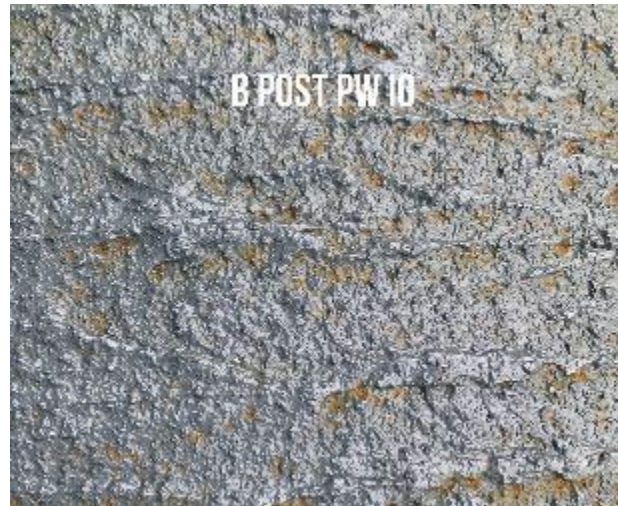
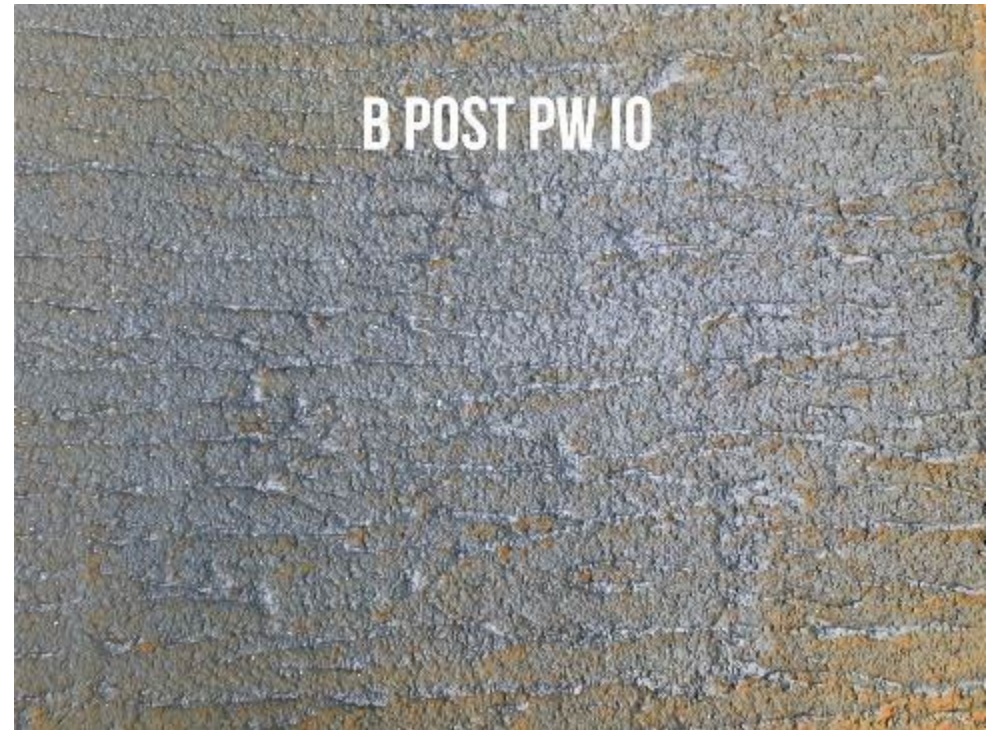
# Sample B Pressure Wash With Iron Out Before, After & Close Up

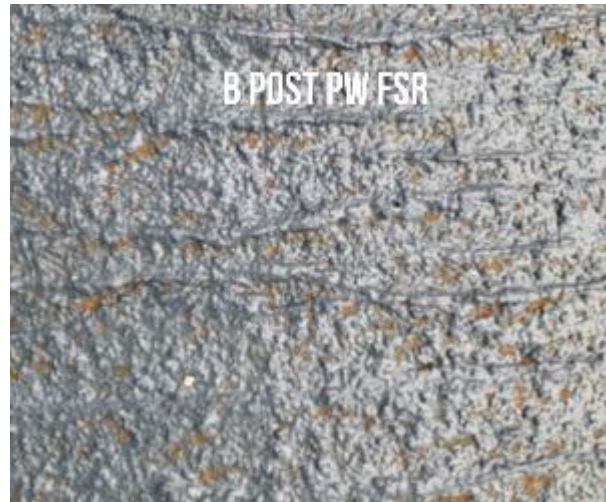
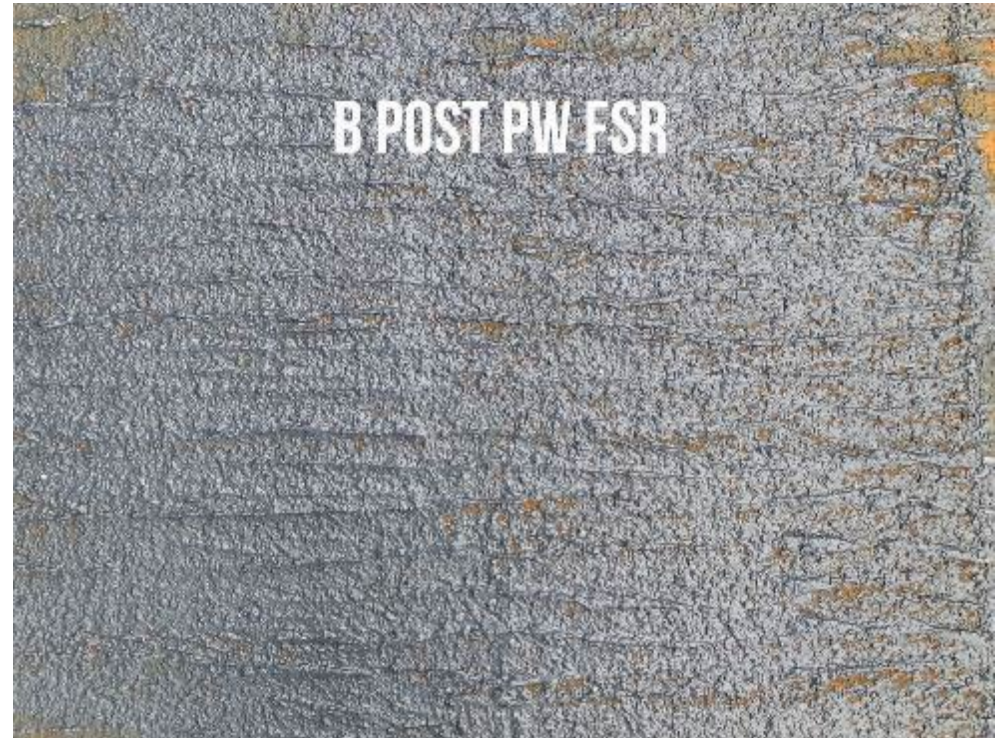
# Sample B Pressure Wash With FSR Before, After & Close Up

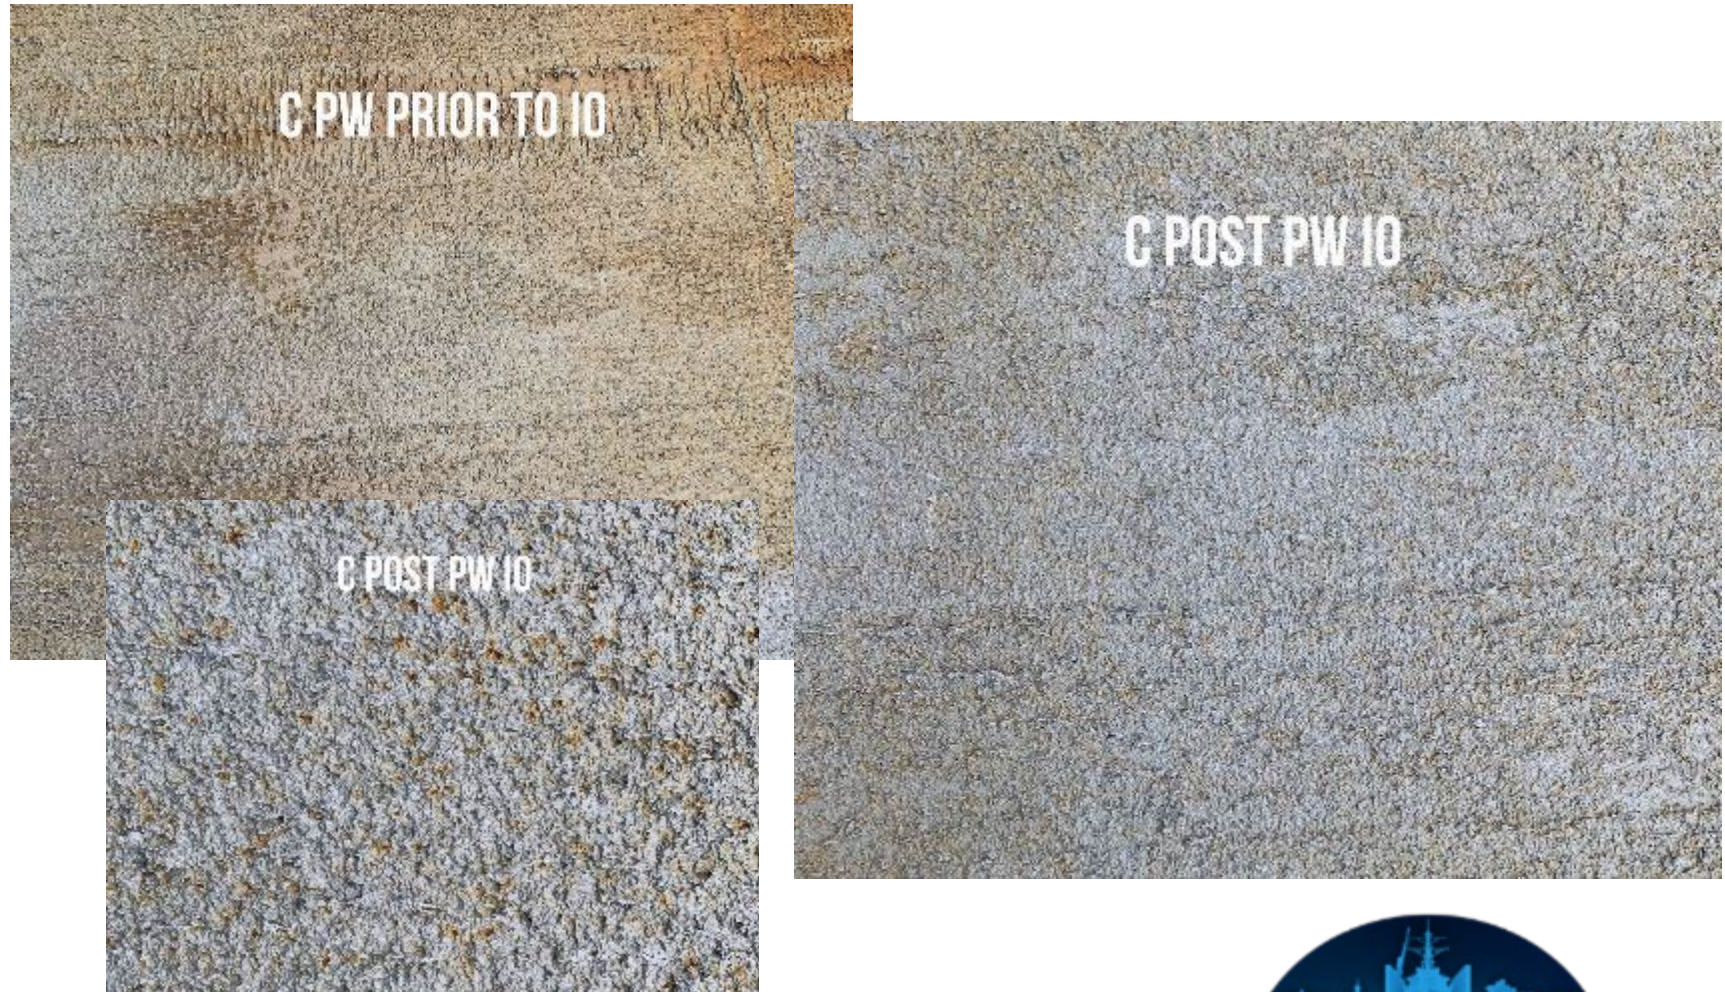
# Sample C Pressure Wash With Iron Out Before, After & Close Up

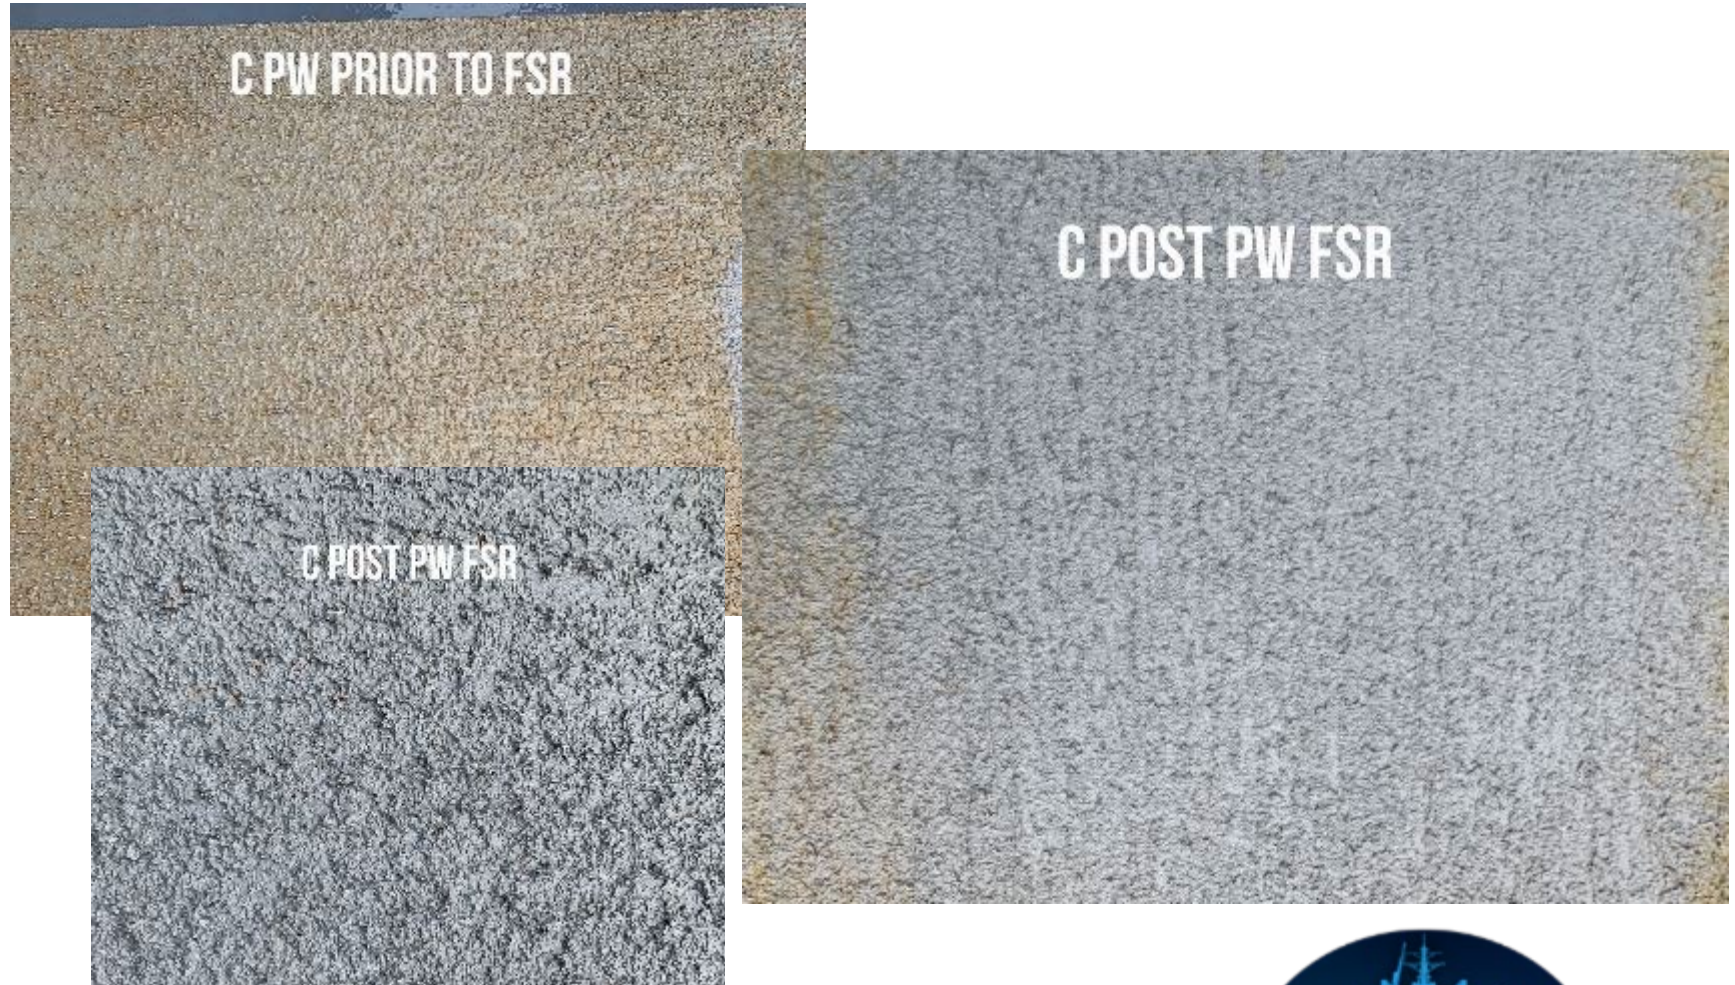
# Sample C Pressure Wash With FSR Before, After & Close Up

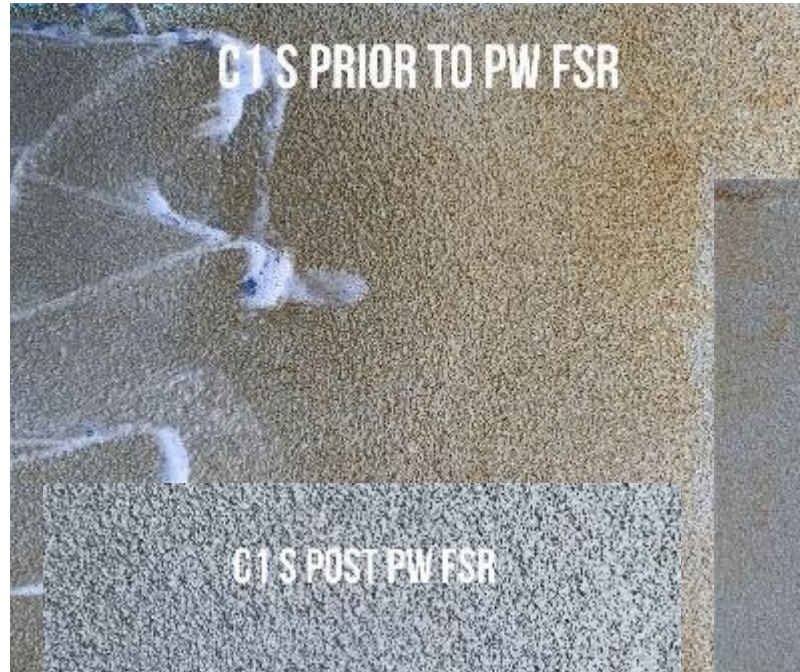
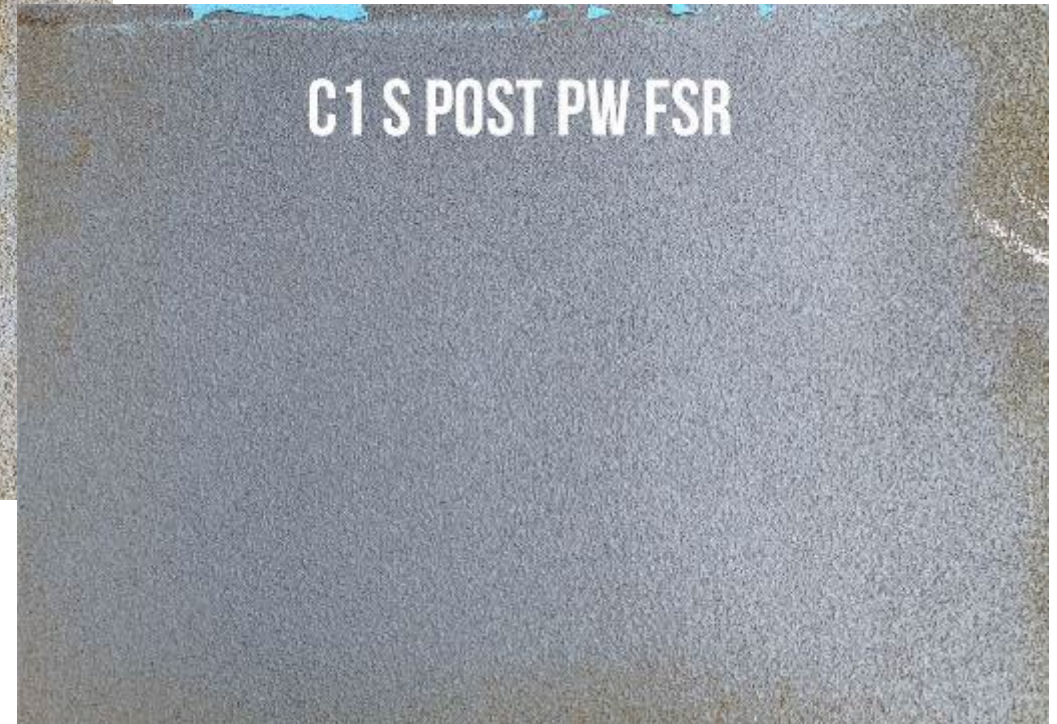
# Sample C1-S Pressure Wash With FSR Before, After & Close Up

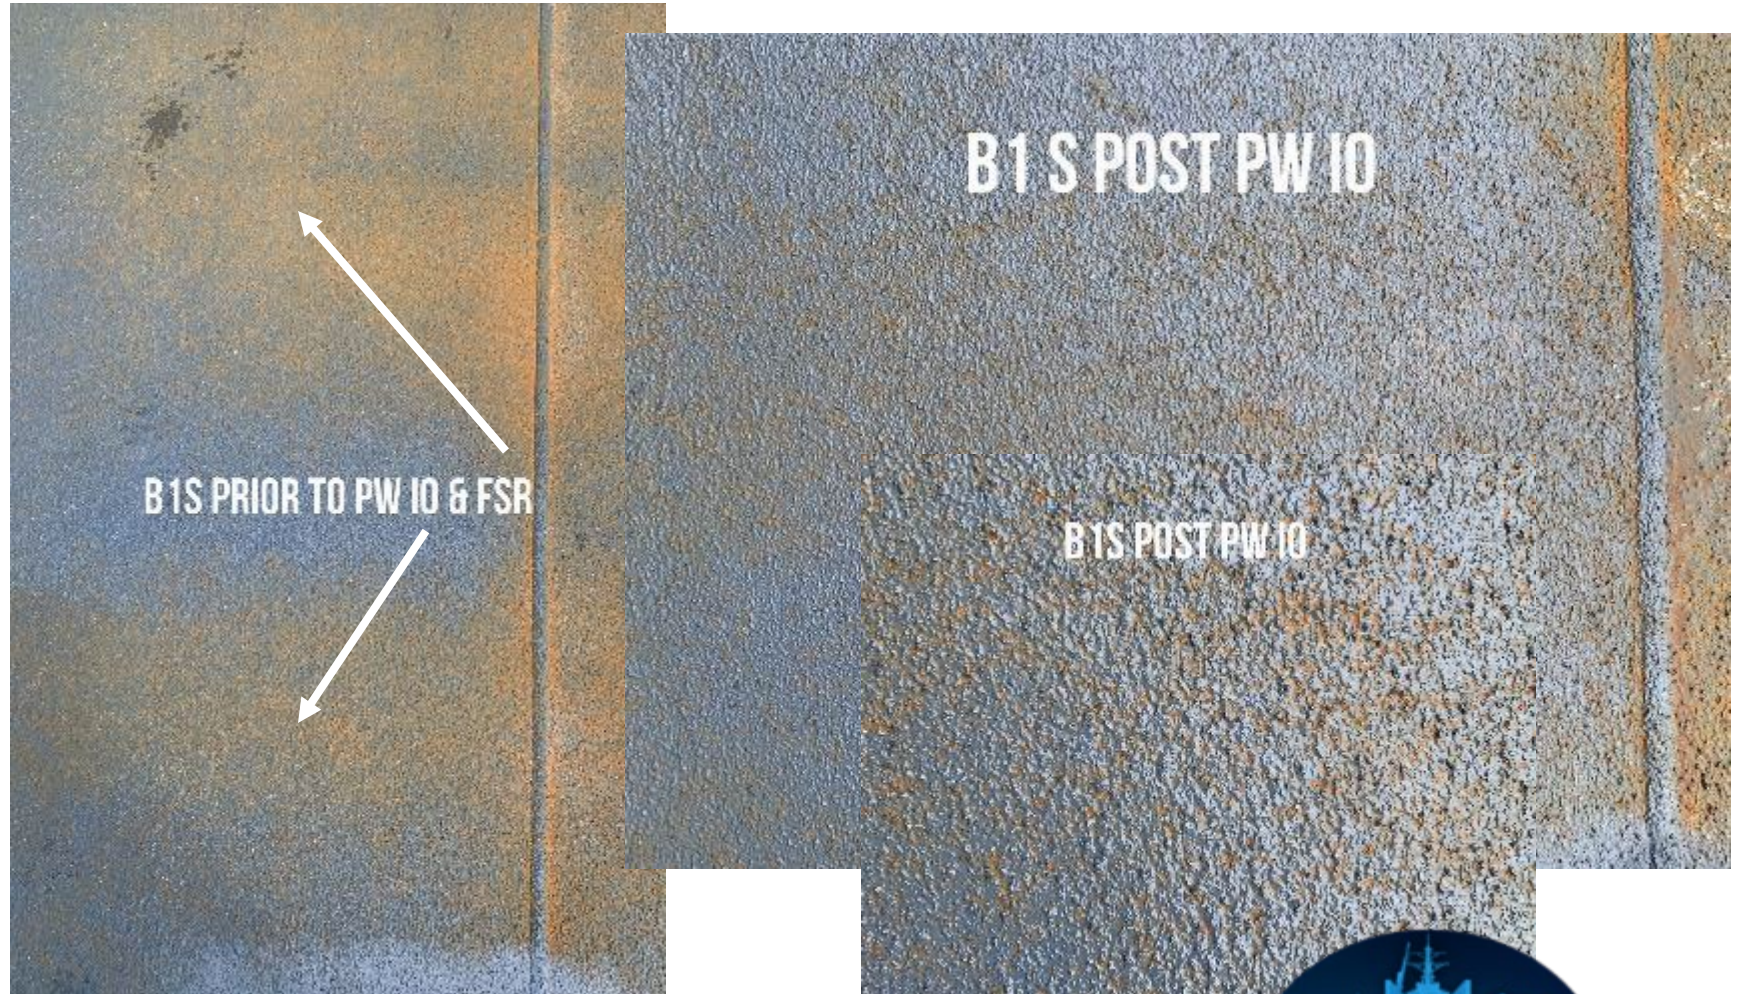
# Sample B1-S Pressure Wash With Iron Out Before, After & Close Up

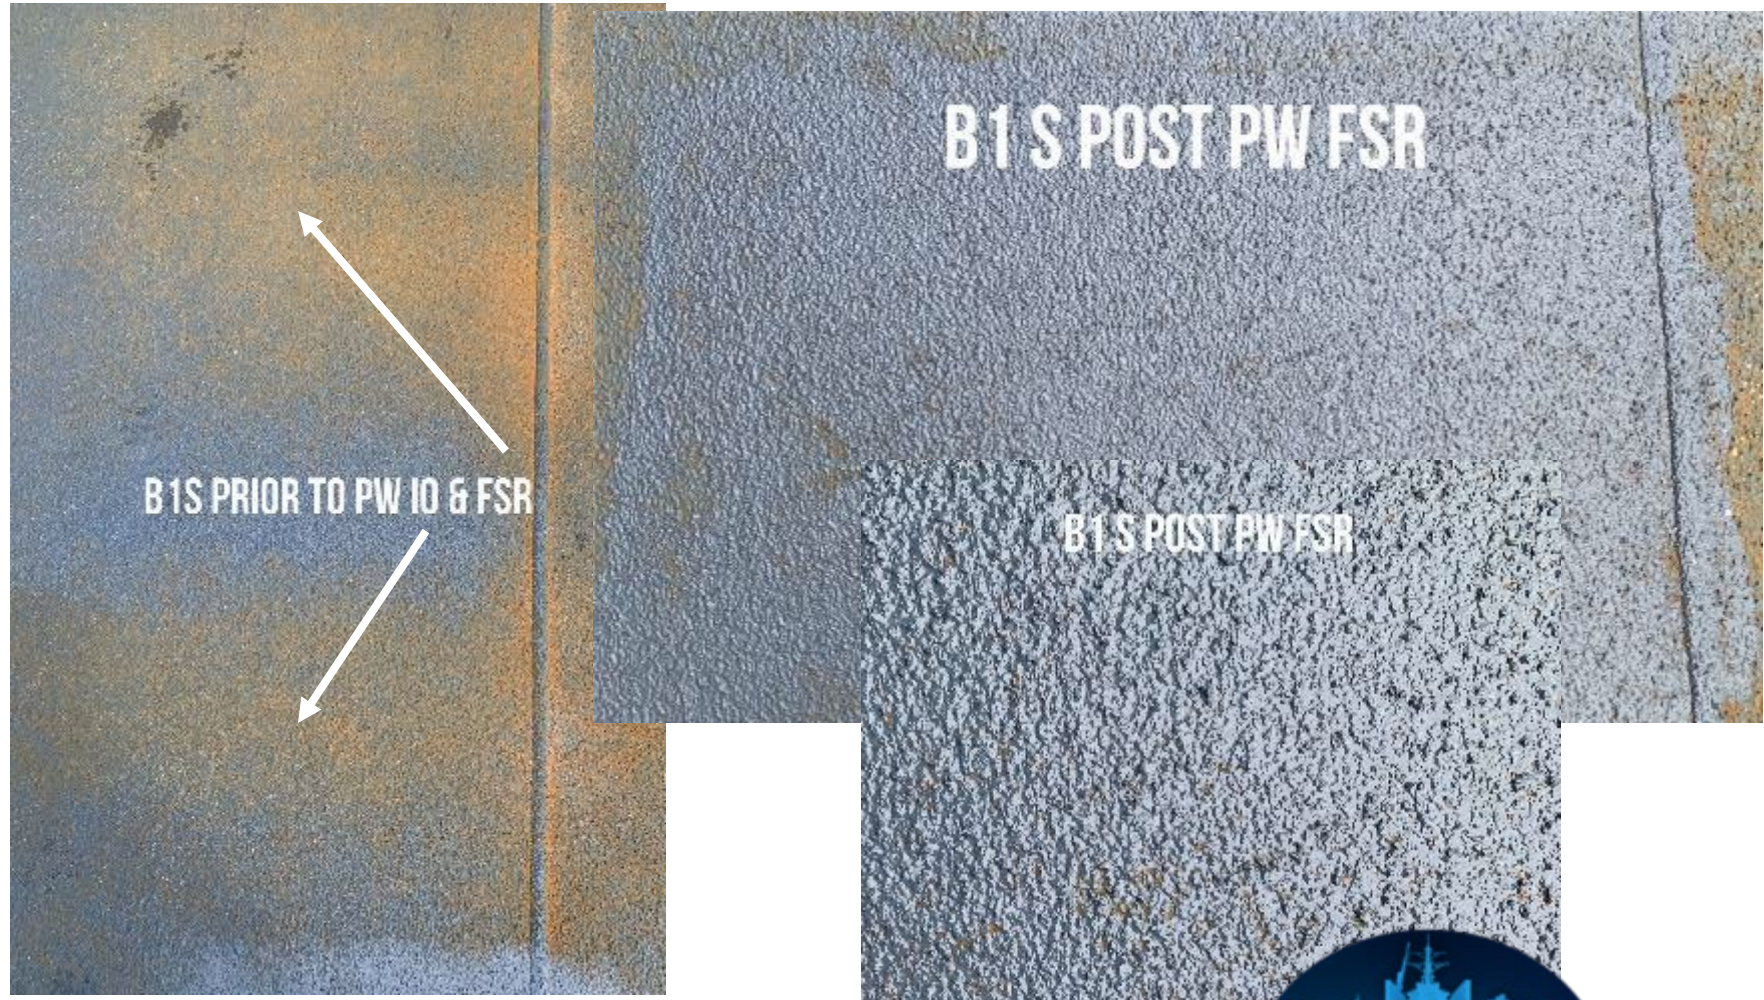
# Sample B1-S Pressure Wash With FSR Before, After & Close Up
