# **GENERAL DYNAMICS**

## **NSRP Cleanable Non-Skid Deck Covering Project**

**BIW Process Control  
FY2023/24**

# BIW-Panel Project Scope of Work

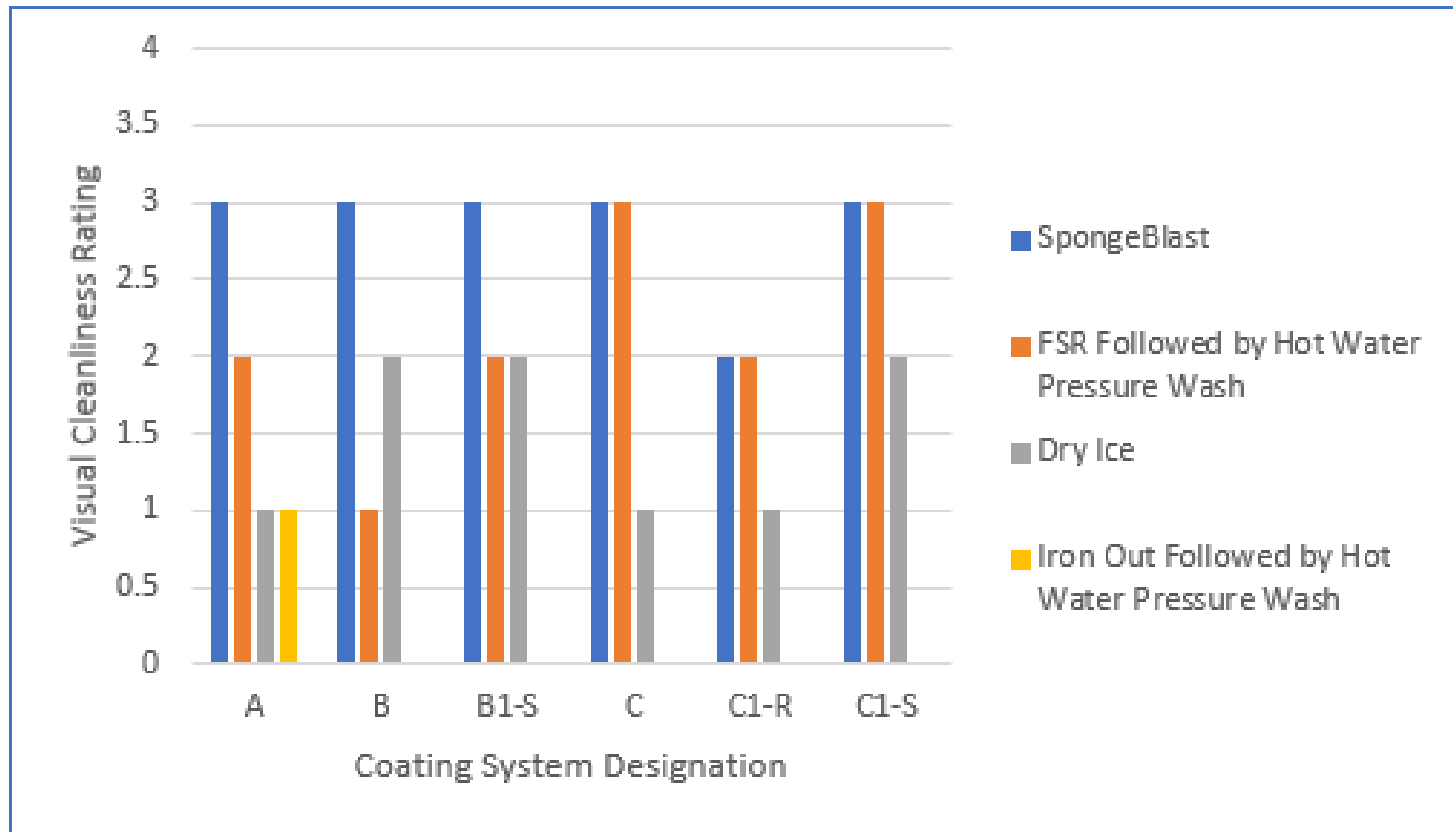
# Overall Ranking 0-5 Represented in Graph Per Non-Skid System

- **SpongeJet blasting left the least amount of corrosion staining with approximately 10% remaining. FSR followed by hot water pressure washing resulted in approximately 25% staining. Dry Ice yielded approximately 50% staining. And, Iron Out yielded greater than 50% staining.**
  - Although SpongeJet left the least amount of staining it did remove some of the wear layer of the non-skid and did expose aggregate on some samples.
  - Additional testing at different pressures and standoff point would be advisable.

- **Additional analysis shows that on average, less staining remained on the surface of the spray applied non-skids than the rolled alternatives. This is likely due to fewer deep ridges for rust and debris to be trapped within the peak to valley patterns.**

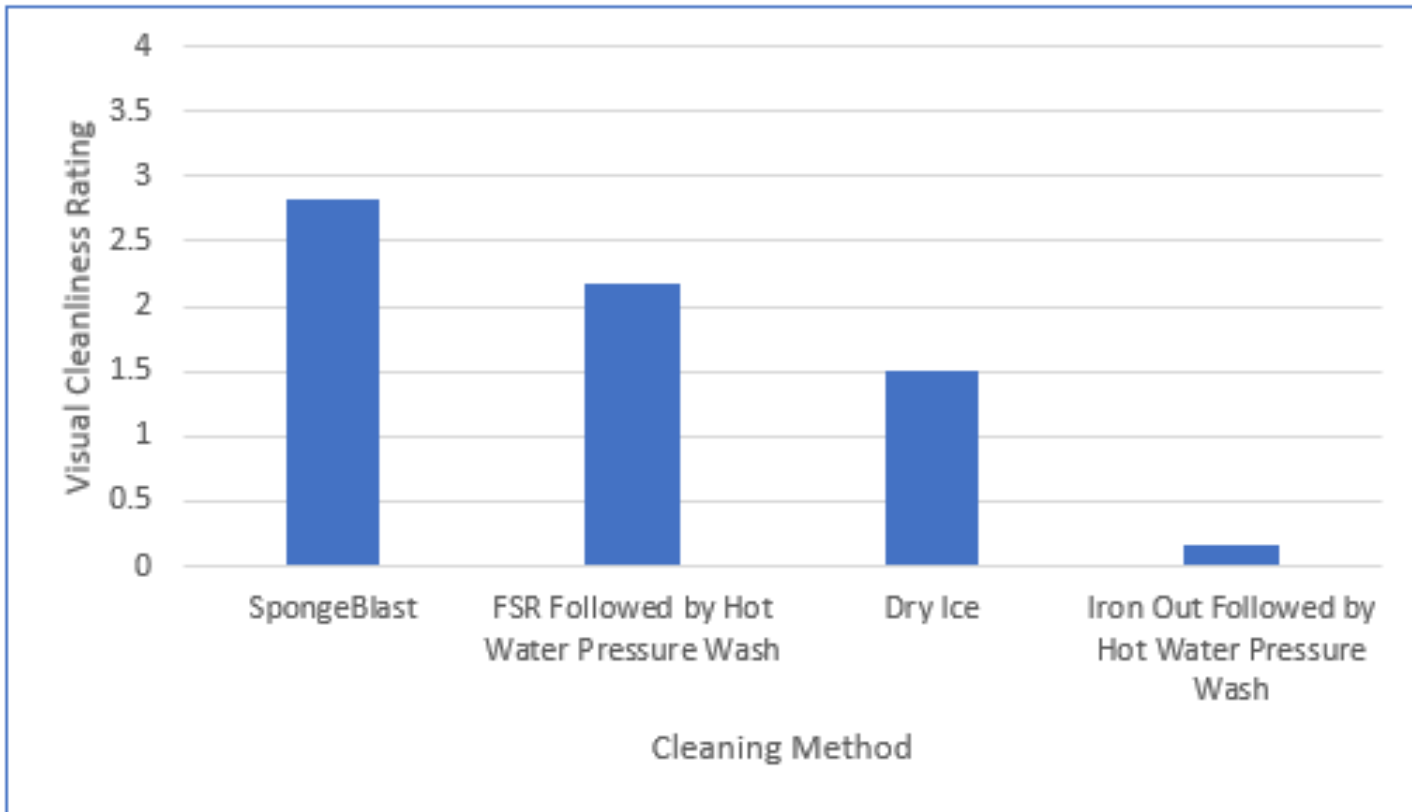
# Overall Ranking By Cleaning Method

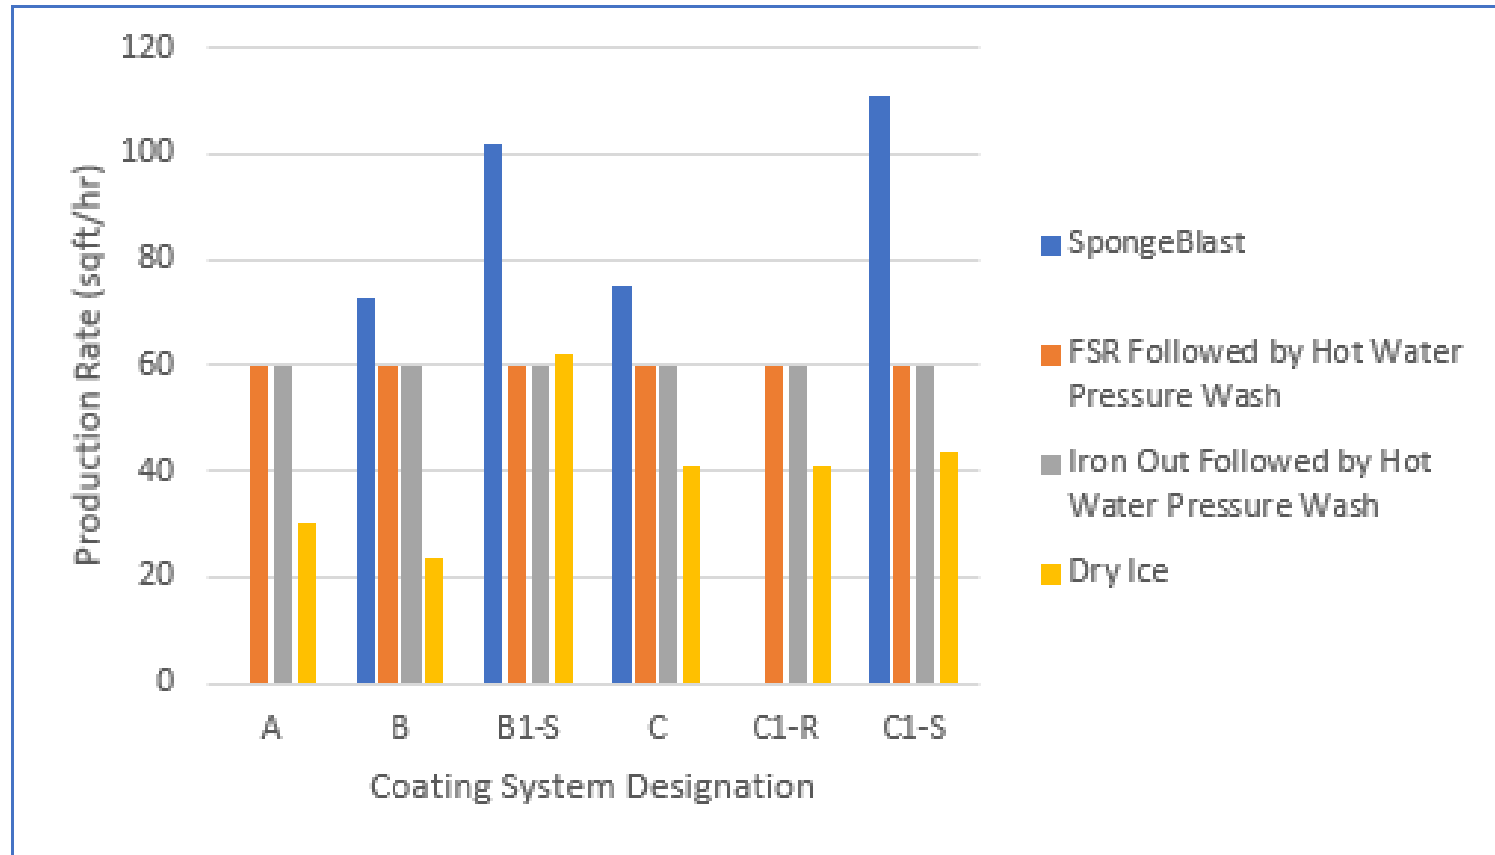
# Results Of Production Rates Per Cleaning Method

- **It was determined that utilizing FSR with hot water pressure washing would leave an acceptable level of staining. The polysiloxane non-skids had even better results especially on spray application. Production rates were deemed acceptable as well.**
